# Dekko Garments Ltd

Nayanpur, Mawna, Sreepur, Gazipur.

08<sup>th</sup> April 2019

# Observation

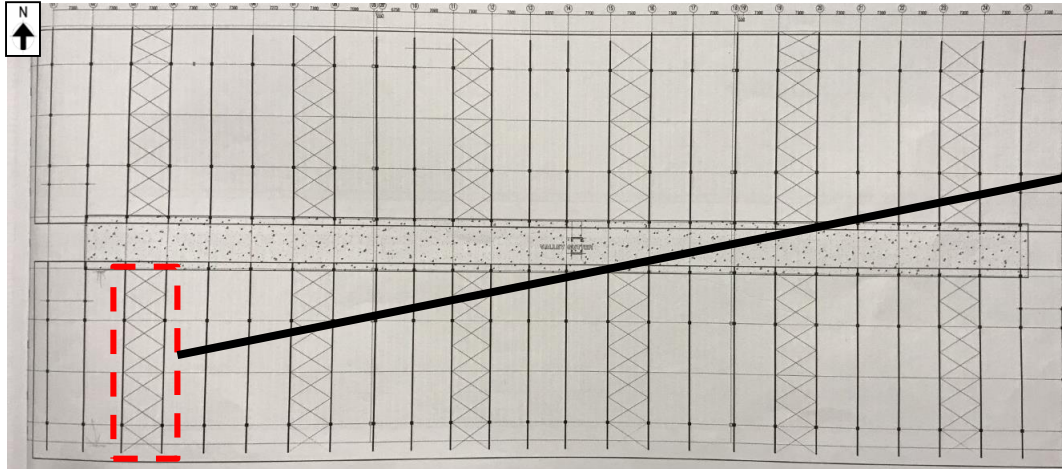
Horizontal bracing layout

On the marked location, horizontal bracing was not observed

At one location horizontal bracing was not found on site. At some splice locations of beam on top floor bolt was found missing. Factory is required to install the missing elements as shown in the as-built drawings.

Item No.	Observation	Recommended Action Plan	Recommended Timeline
1	(Main Production building) Missing bolts and horizontal cable bracings	Factory is required to install the missing elements as shown in the as-built drawing.	6-weeks
2	(Main Production building) Significant gap in steel beam and RC column joint at several locations	Identify all the locations and carryout suitable remedial works where necessary.	6-weeks
3	(Main Production building) Insufficient information in drawings	Factory Engineer to survey the whole structure and update a full set of “as-constructed” drawings.	6-weeks

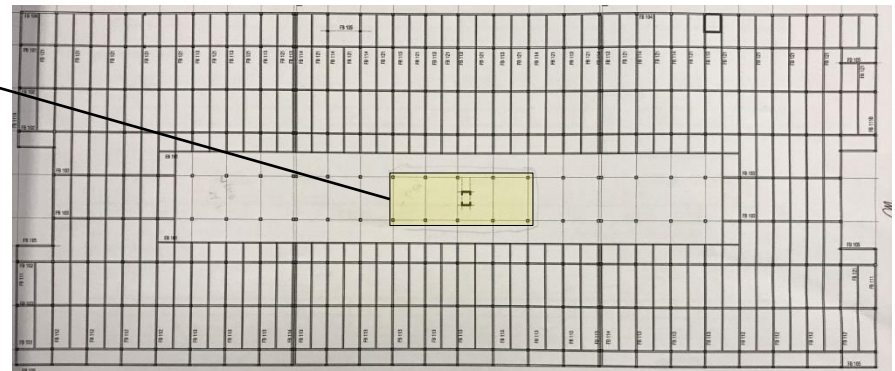
No connection detail was found in drawing for the steel roof structure around the lift.

Position marking of the steel roof structure.
