# **Pan Pacific Sweaters Ltd (9310)**

# **D&S Pretty Fashions Ltd (9287)**

South Salna, Joybedpur, Gazipur, Dhaka -1230, Bangladesh

19.MARCH.2014

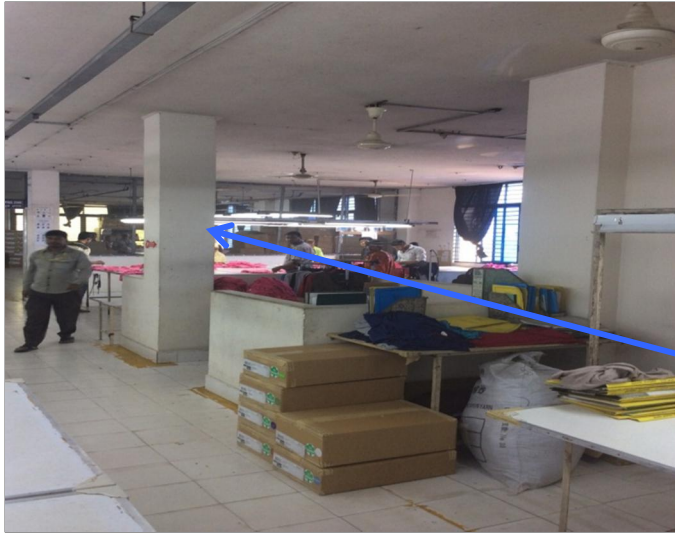
## 1st Priority 1 concern

Based on the load run-down analysis following the agreed minimum design live load assignment, the columns' factor of safety falls between 1.25 and 1.5, giving a AMBER warning. Factory Engineer to review design, loads and columns stresses. Equipment are located at the same place, level to level. This means that the same columns are over used compared to others.
