Montex Fabrics Ltd

03 & 26 February & 16 March 2020

Structural Inspection Report

Observations & Actions

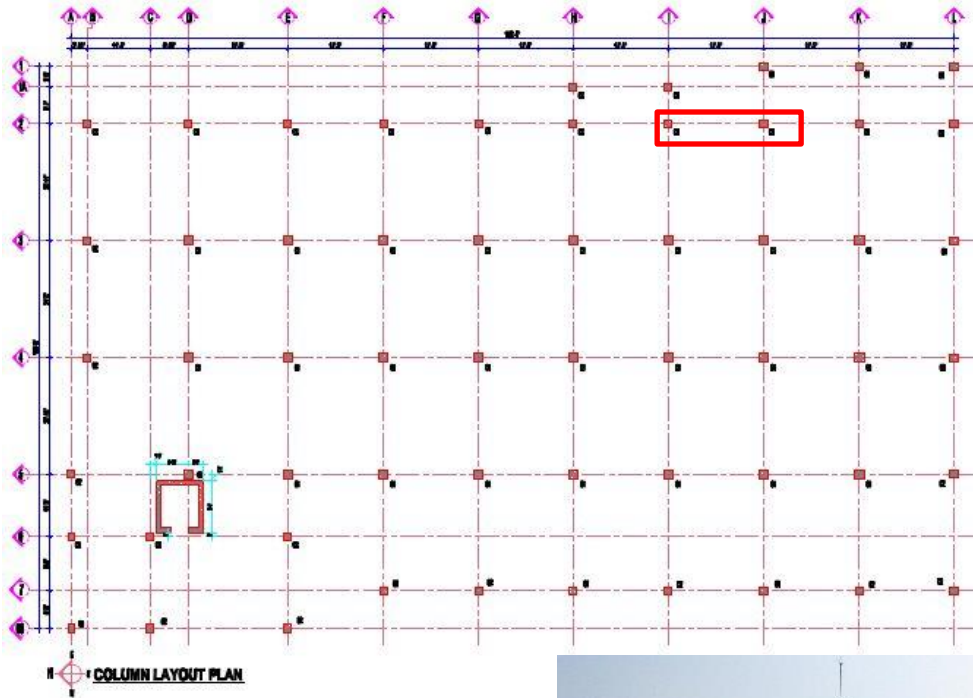
COLUMN LAYOUT PLAN

High stress levels in columns that require immediate review

Preliminary calculations indicate high stresses in the columns based on the concrete strength (from core test report) and observed load plan. Moreover, as per the provided DEA report, most of the columns are inadequate and column strengthening has been suggested. The building engineer is required to review design, load & column stresses in the areas identified above as per building code.

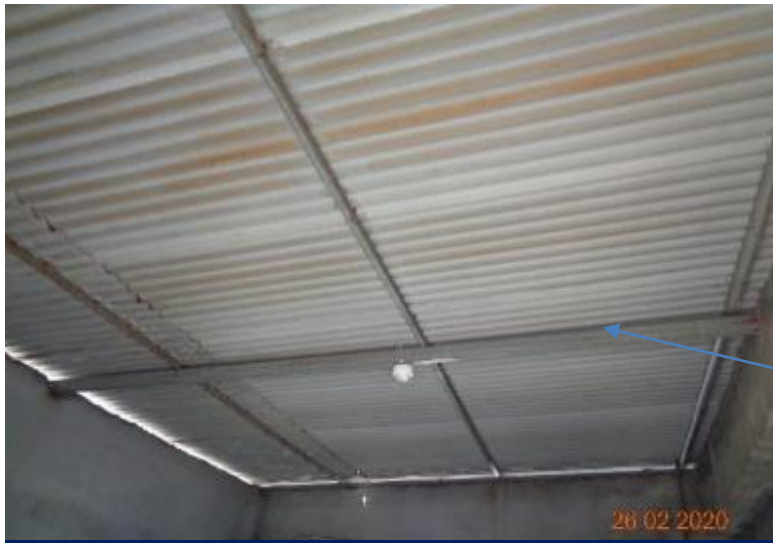
Rafter supported on brick wall

Non-engineered shed at roof

Non-engineered shed was found at roof level.
The connections of the truss/rafter with wall are non-engineered.

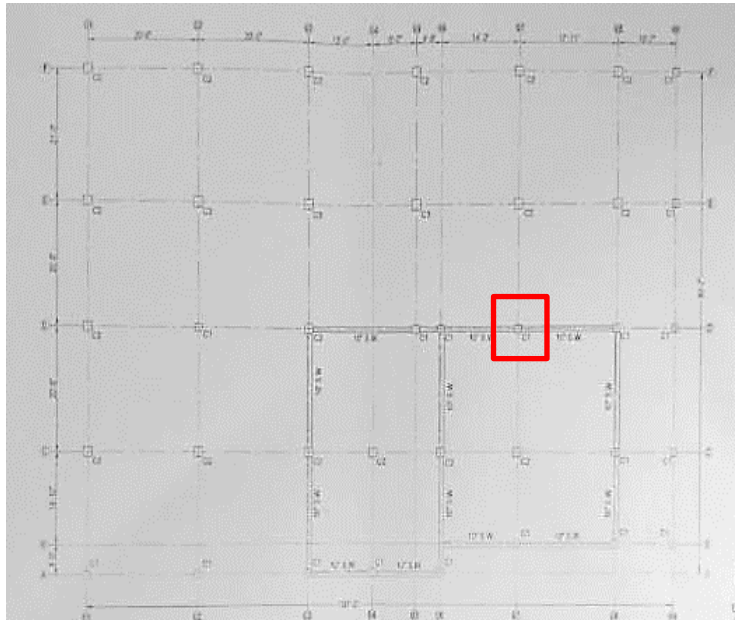
Column Layout

Columns to be stressed above normal design limits

Cursory Calculation indicate that the working stress of the highlighted column at ground floor level appear to be stressed in excess of normal design limits

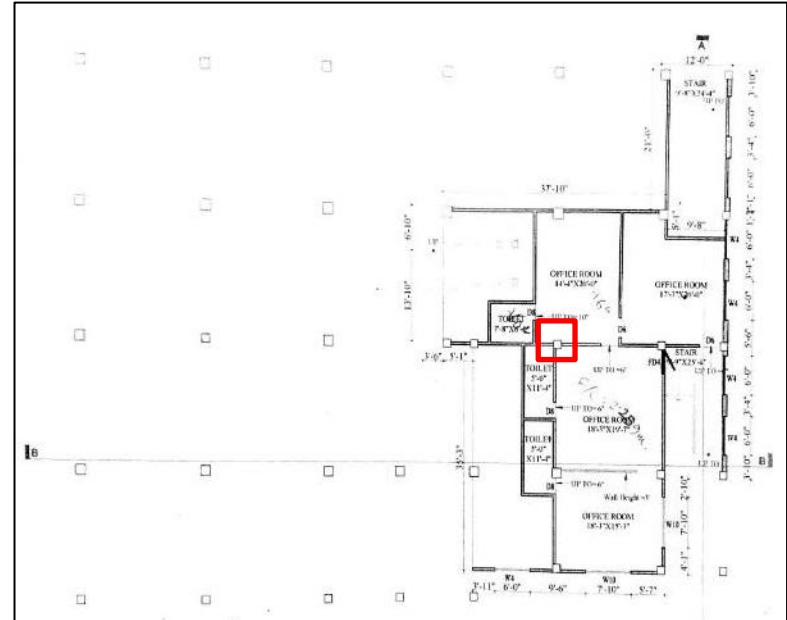
Column Shown in Mezzanine floor area

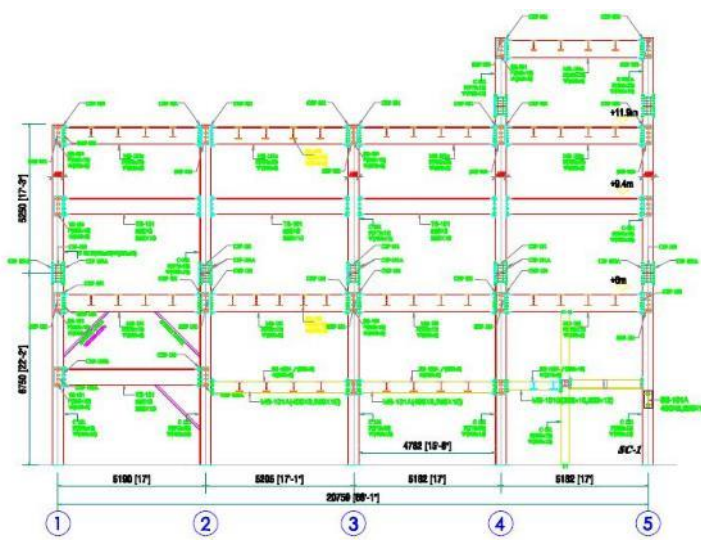
MAIN FRAME @ GRID A

Irregular bracing system
