Rahman Knit Garments Ltd.

Hariharpara, Panchabati, Fatullah, Narayanganj
(23.63014, 90.48090)

30th December 2020 & 24th January 2021.

Observations

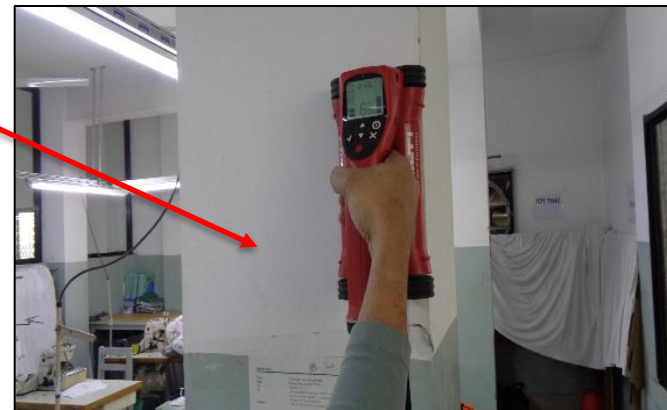
Column Layout plan. Column re-bar was verified by ferro-scanning at marked location (4th floor).

14 number of rebar was found for the column C1 instead of 16 number rebar.

Factory engineer is required to survey the whole structure and update the as-built drawing as per on-site condition. Also, review the column stress according to the floor capacity.

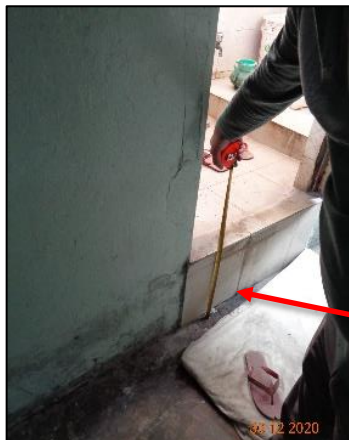
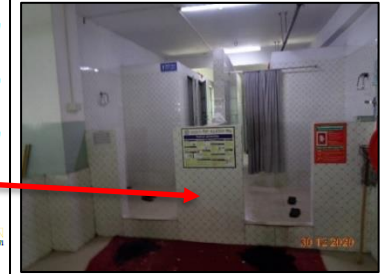
Toilet areas in different floor have built-up approx. 140 mm. This built-up areas are not shown in as-built drawing. The factory engineer is required to survey the whole structure and update the as-built drawing as per on-site condition.

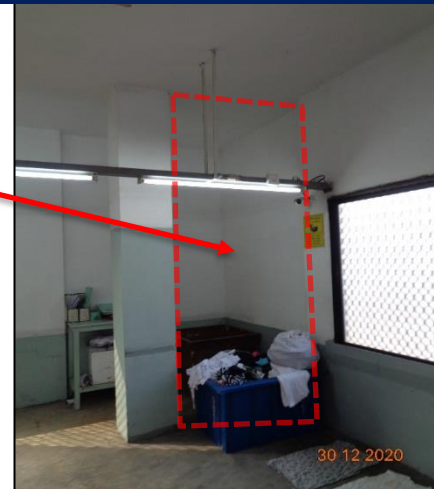
Cantilever slab was found in highlighted periphery areas measured 1.42m on site but dimension was not mentioned in as-built drawing. Factory engineer is required to survey the whole structure and update the as-built drawing as per on-site condition.

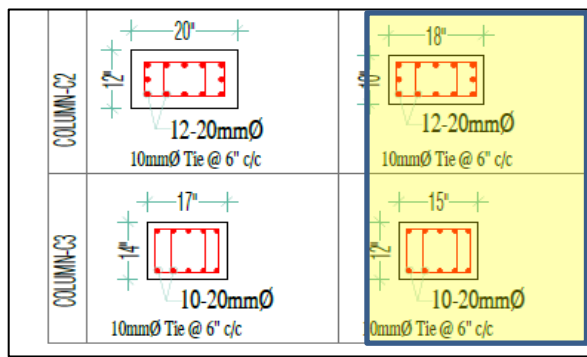
12 & 10 numbers of rebar shown in as-built column schedule for column C2 & C3, respectively.

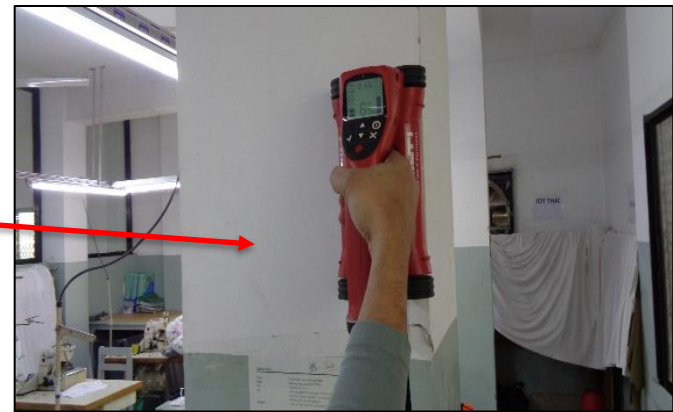
Column Layout plan. Column re-bar was verified by ferro-scanning at marked location.

8 & 6 numbers of rebar was found for the column C2 & C3, instead of 12 & 10 number rebar, respectively.

Factory engineer is required to survey the whole structure and update the as-built drawing as per on-site condition. Also, review the column stress according to the floor capacity.

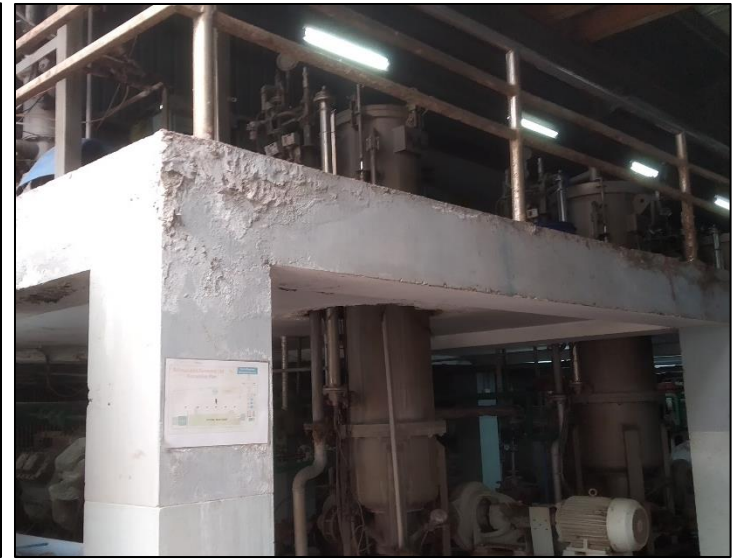
Dampness in column

An undocumented Mezzanine floor was found inside Building-3 (Dyeing Shed (part-B)) and no drawing was available for this structure. Dampness was visible in column and a hole was found in slab. Factory engineer is required to survey the whole structures and produce as-built drawing for this structure. Check the adequacy of the slab and repair if required. Also, repair all damp areas by the guidance of factory engineer.

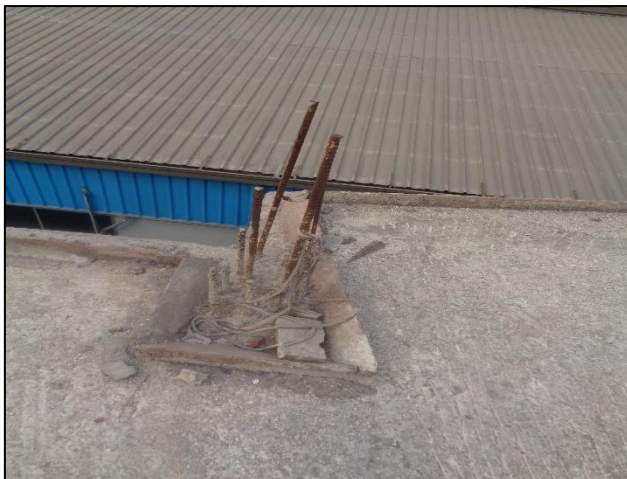
Exposed rebar

Exposed rebar was found at roof level which is prone to corrosion. Factory is required to provide rust proof paint on all exposed rebar to protect from corrosion. Otherwise remove all the exposed rebar.

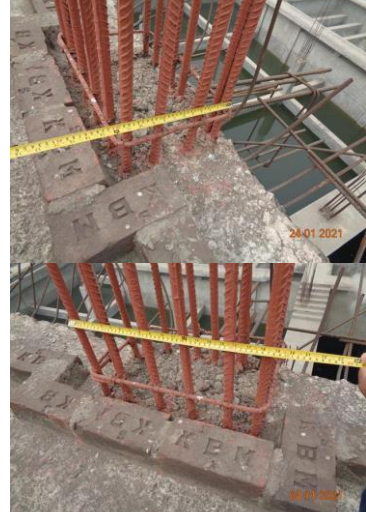
Column Schedule

Column was found 600X400mm. Re-bar: #16Ø20mm

The columns of the marked locations (Rectangle) were only found at ground floor. These columns were not extended at upper floors. Also, columns at circular marked location was found 600X400 mm. Neither column ID for those columns shown in column layout nor dimension of those columns matched with any type of column shown in column schedule. Factory engineer is required to survey the whole structure and update as-built drawing as per onsite condition.

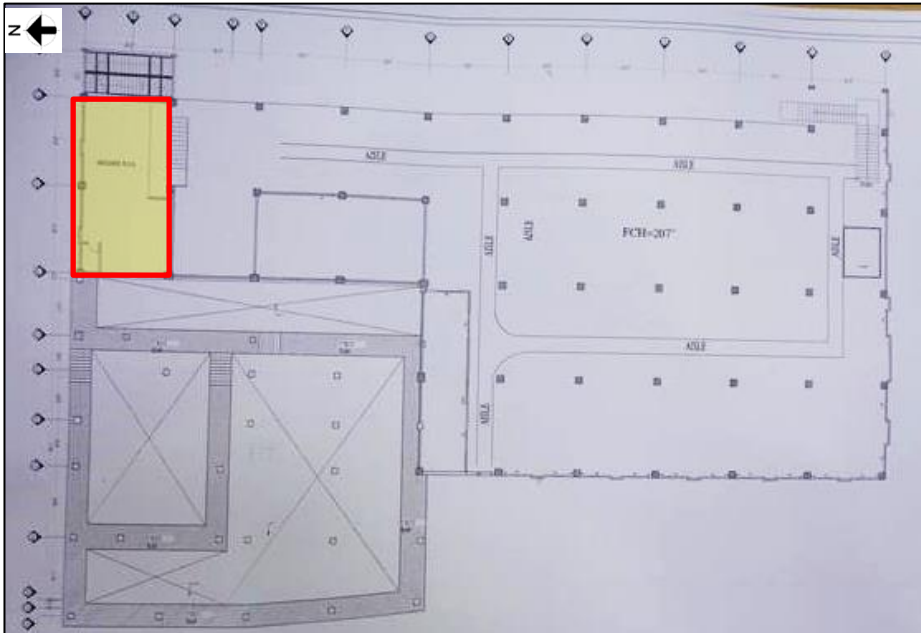
Mezzanine floor layout plan

Mezzanine floor is supported by steel Beam and Column frame structure. But no structural information has been provided in drawing regarding this steel structure.

Factory engineer is required to survey the whole structure and update the as-built drawing.

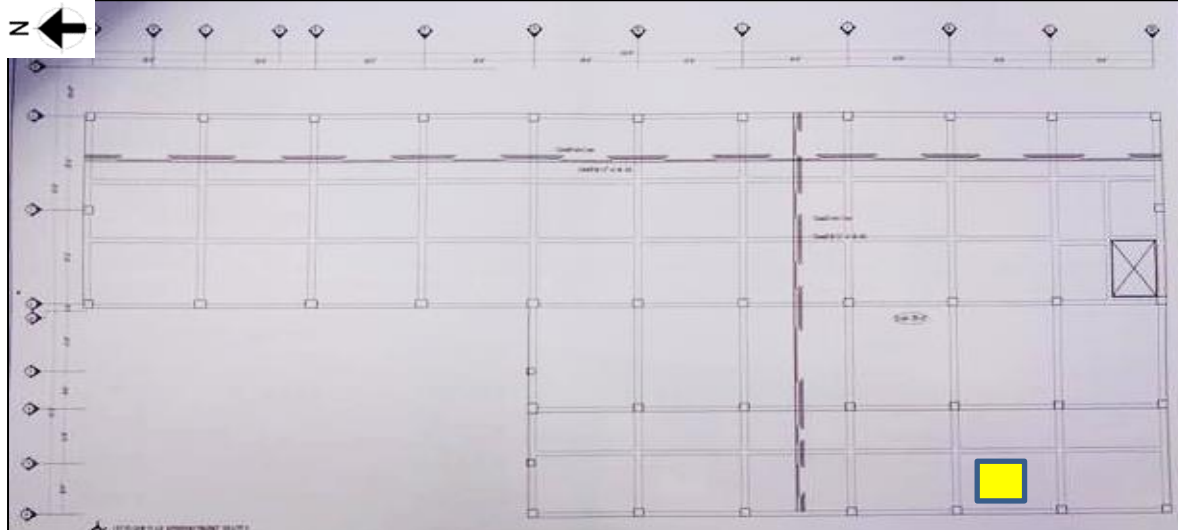
Slab reinforcement Details

As per BNBC every building or structure designed shall have its design documents prepared in accordance with the provision of Section 1.9.1. The design document shall include a design report, and a set of structural drawings, which shall be prepared in compliance with section 1.9.1.1 and section 1.9.1.2 as per BNBC. At the time of inspection, no Design report was available for this structure and only as-built drawing was available. Factory engineer is required to produce the Design report in accordance with section 1.9.1.1 and update the as-built drawing in accordance with the section 1.9.1.2 (BNBC part-6) considering all highlighted discrepancies.

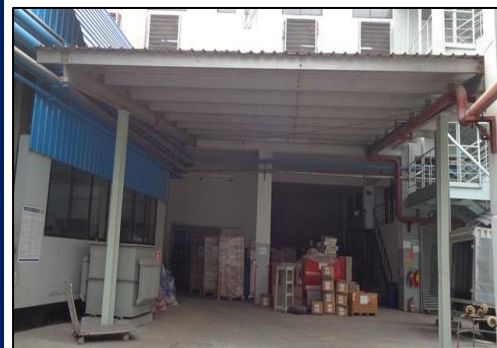
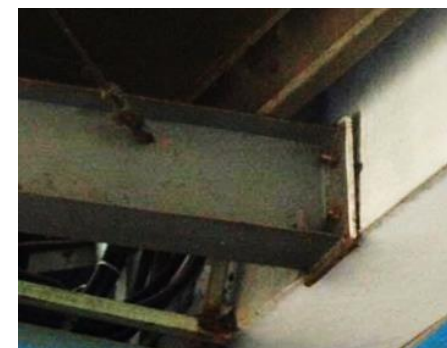
Undocumented canopy was found at entry of the building which is structurally connected with Building-5. No information has been provided in drawing.

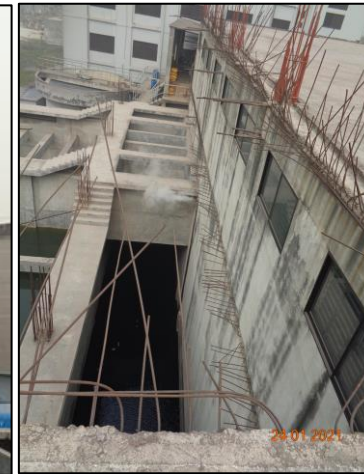
Building was found constructed up-to two storied. Factory authority has verbally informed that they are intended to extend the building vertically in future. Also, extended column, beam and slab rebar was found for future extension. Architectural and Structural drawing were found only for the two storied. Factory engineer is required to prepare Detail Engineering Assessment (DEA) including full set of as-built drawing for the structure prior to commencement of further extension work.

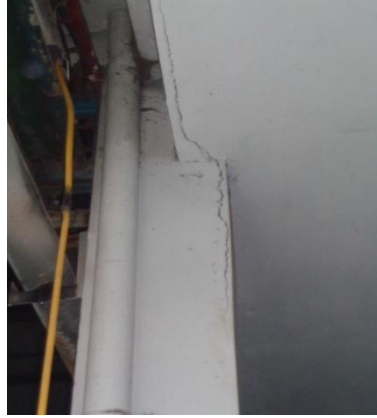
Building 03-dyeing shed (part-A) was found structurally connected with Dyeing Office and Utility shed. Also, Utility Shed was found structurally connected with Building 02 (knitting building). Factory engineer is required to survey the whole structure and update the as-built drawing as per on-site condition. Also, analyze these structures separately as independent structure.

Slab of dyeing office appears to be connected with column of dyeing shed (part-A)

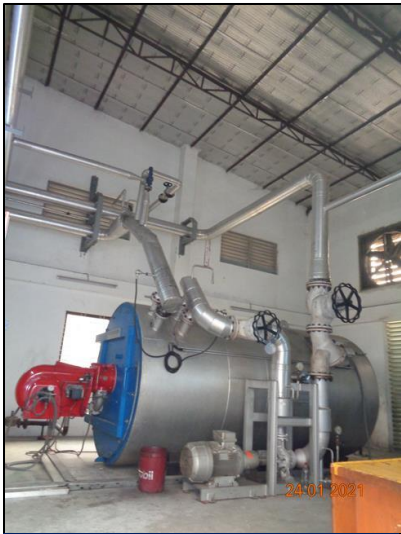
Interior part of
Boiler Shed

The connections of these sheds appear to be non engineered and steel members appear to be undersized. Building engineer is required to check the adequacy of the sheds or Replace with the engineered sheds.
