# Lida Textile & Dyeing Limited- Extended Buildings- new unit

Shaheed Mosharaf Hossain Road, Purbo chandora, Shofipur, Kaliakoir, Gazipu  
(24.038054, 90.272752)

20<sup>th</sup> October 2020

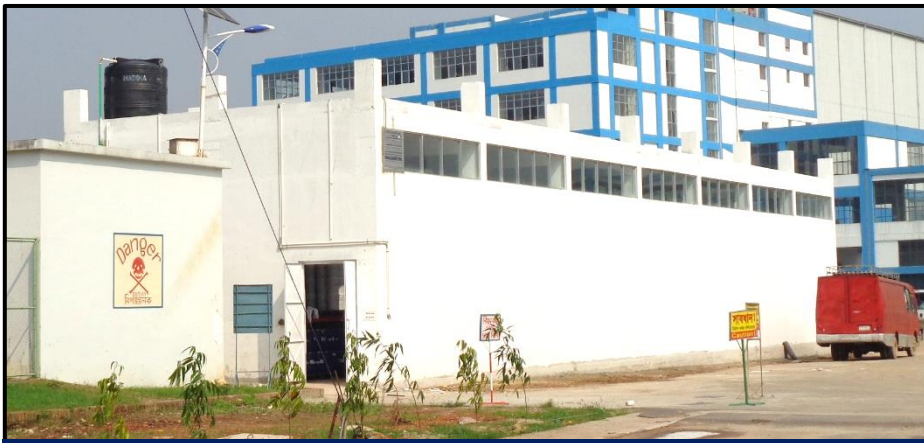
Chemical Store

There were no credible as-built drawings and documents to review except permit drawing from Pourashava and Industrial layout from DIFE. Provided drawings were insufficient to represent the as-built structures. Factory engineer is required to survey the structures and prepare as-built drawings that are in compliance with section 1.9.1.2 as per BNBC.

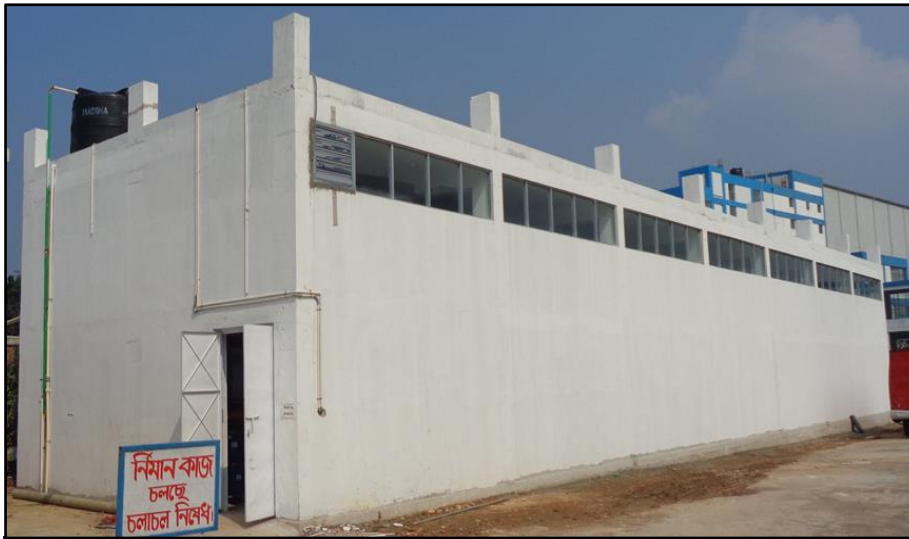
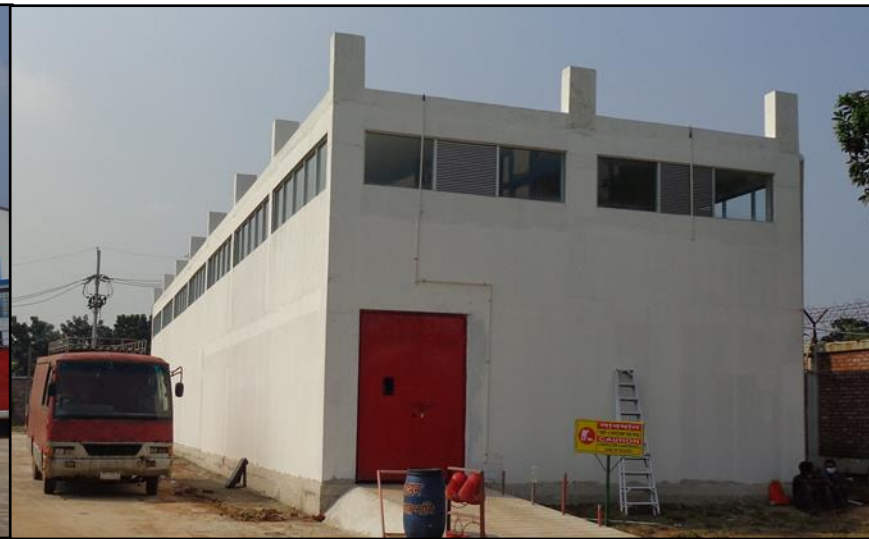
Isometric view of chemical store

As per BNBC every building or structure designed shall have its design documents prepared in accordance with the provision of Section 1.9.1. The design document shall include a design report, and a set of structural drawings, which shall be prepared in compliance with section 1.9.1.1 and section 1.9.1.2 as per BNBC. During the inspection, the as built drawings & design report has not been found which is required to be prepared in compliance with section 1.9.1 (part-6, BNBC).

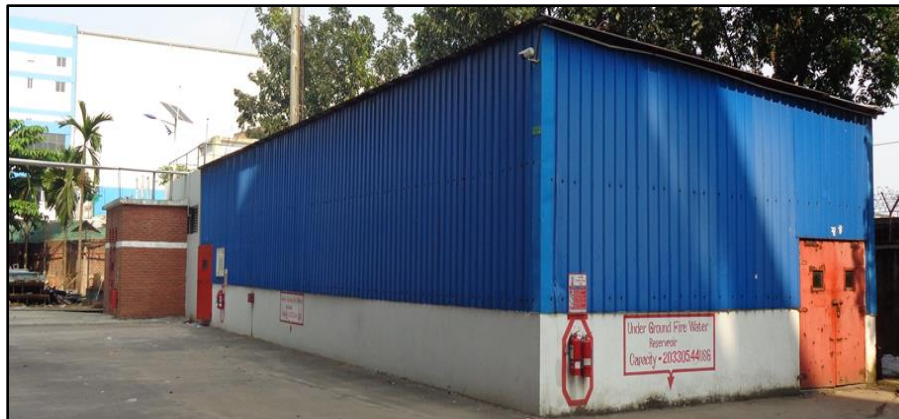
Shed-2 ( Wastage store & Boiler room )

There were no credible as-built drawings and documents to review except permit drawing from Pourashava and Industrial layout from DIFE. Provided drawings were insufficient to represent the as-built structures. Factory engineer is required to survey the structures and prepare as-built drawings that are in compliance with section 1.9.1.2 as per BNBC.

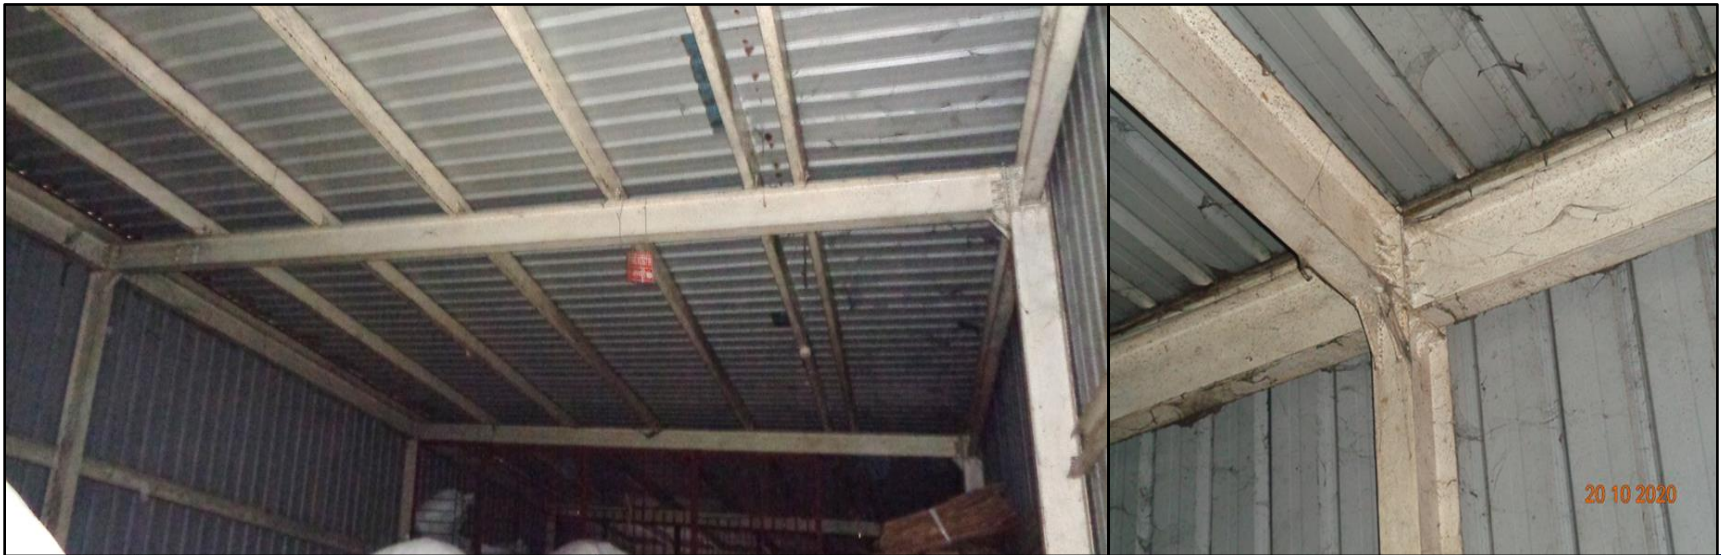
Interior of Jhut Building

As per BNBC every building or structure designed shall have its design documents prepared in accordance with the provision of Section 1.9.1. The design document shall include a design report, and a set of structural drawings, which shall be prepared in compliance with section 1.9.1.1 and section 1.9.1.2 as per BNBC. During the inspection, the as built drawings & design report has not been found which is required to be prepared in compliance with section 1.9.1 (part-6, BNBC).
