# KM Nobely Garments Ltd.

Zorun, Konabari Gazipur-1702.

21<sup>st</sup> December 2020

# Observations

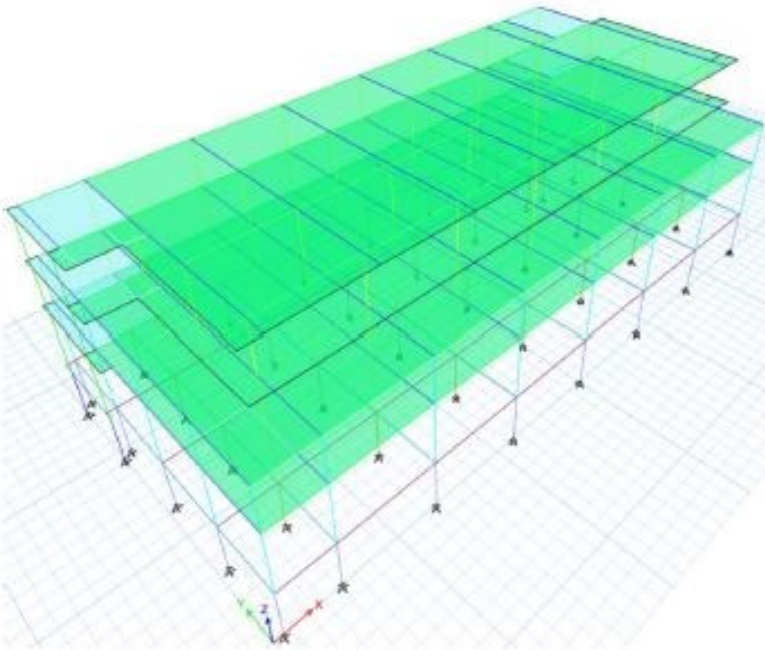
Allowable bearing capacity considered in the design report does not match with the recommendation of geotechnical investigation report. No calculation is provided regarding the considered value.

Recommendation of geotechnical investigation report (Allowable bearing capacity 1.5 Tsf)
