# Al-Muslim Washing Ltd. & Al-Muslim Garments Accessories Ltd.

14 No. Gedda, Karnapara, Ulail, Savar.  
(23.8276, 90.2586)

24<sup>th</sup> February & 29<sup>th</sup> March 2021

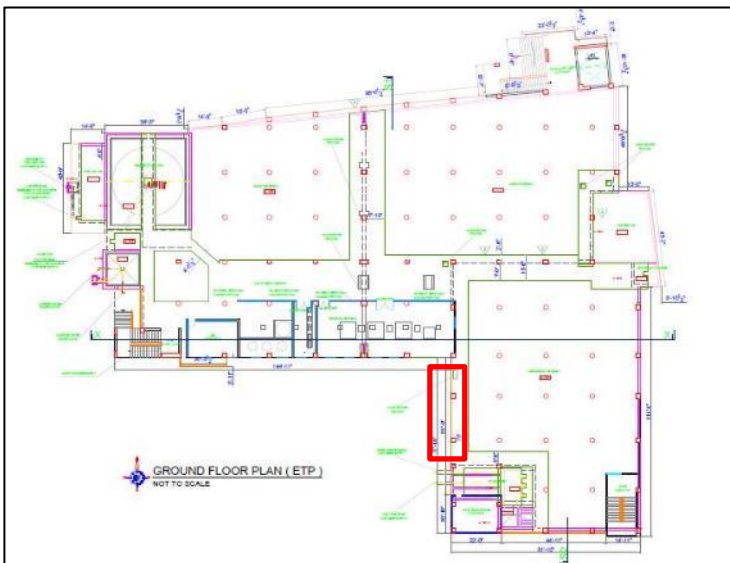
Ground floor layout plan

# **Water leakage & crack on the retaining wall**

**Observations: Building 2**

Water seeping observed through the retaining walls. Building engineer is required to investigate the cause of the water ingress and check whether the retaining walls have sufficient structural capacity. Also check the extent & formation of the cracks.
