# Faiza Industries Ltd. Extended Building

R.S - 425, Baimail, Konabari, P.O.- Kashem Cotton Mill, Thana- Joydebpur, Gazipur  
(24.006853, 90.337155)  
1st October 2020

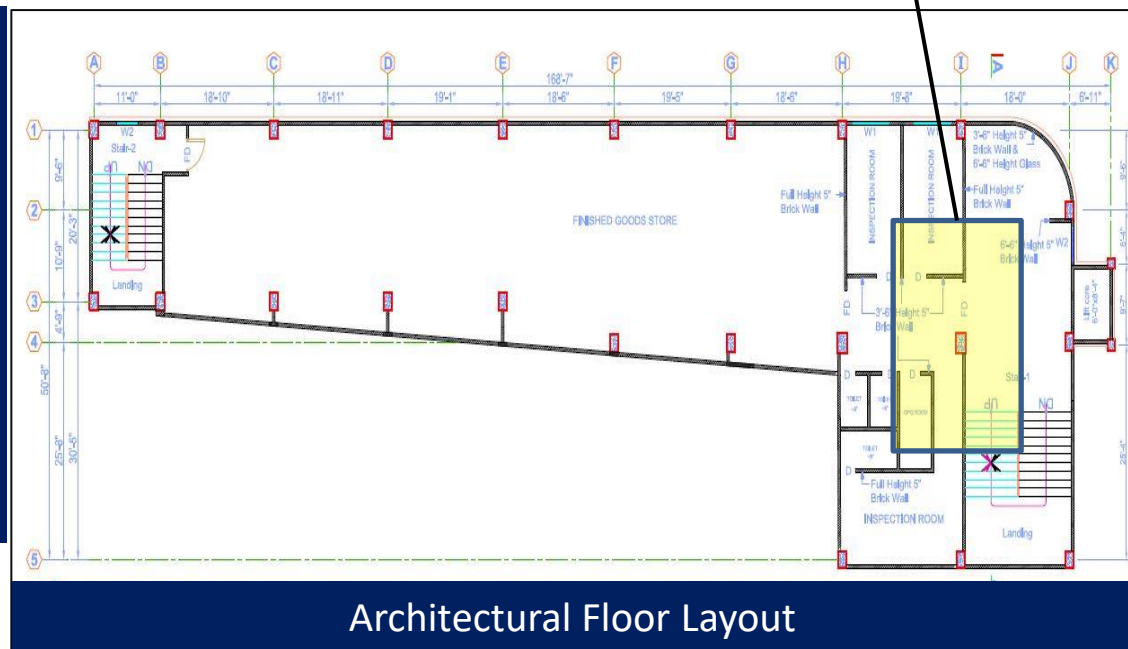
**Observations: Production Building-2**

Cursory calculation indicates that column is stressed above normal design limits considering 5 kPa live load on typical floor & minimum concrete strength for stone chips. Building Engineer to review design, loads and columns stresses. Also, prepared load plan need to be revised based on floor, column and foundation capacity.

| Item No. | Observation | Recommended Action Plan | Recommended Timeline |
|---|---|---|---|
| 02 | Column and Footing stressed above normal design limits. | Verify in-situ concrete strength and aggregate type by taken min. 4 nos. 100mm dia. core samples or existing cylinder test reports from ground floor columns & foundation. | 6-weeks |
| 03 | Column and Footing stressed above normal design limits. | Produce and actively manage a loading plan for all floor plates within the factory, considering floor, column and foundation capacity. | 6-weeks |
