# Ibrahim Knit Garments Pvt. Ltd. Extension-1

Ailpara Pathantoli, Siddirganj, Naranganj

16th February 2021

1. Building-4 (G+5)
2. Building-5 (Proposed G+5) (Completed G+2)

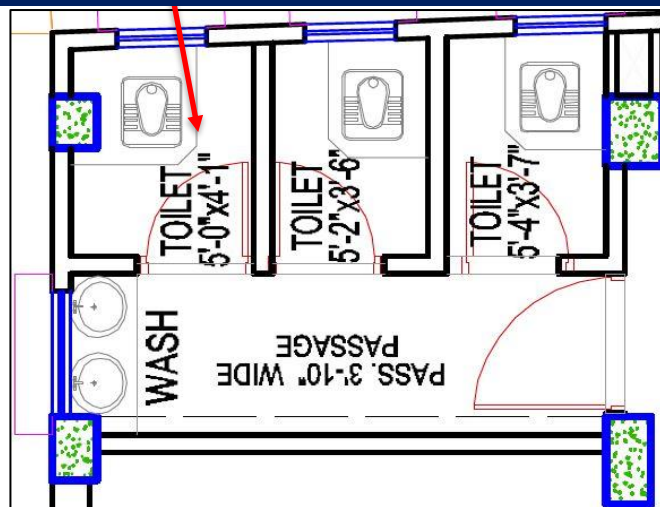
Floor build up found 100 mm

Floor build up and wall height not shown in as-built drawing

In as-built architectural drawing, the height of the toilet partition wall and floor build up were not shown. However, the height of the partition wall was found 1.98 m and floor build up was found 100 mm.

Factory engineer is required to survey the whole structure and update the as-built drawing. Also, Factory engineer to update the design document including in compliance with section 1.9.1 as per BNBC 2006.

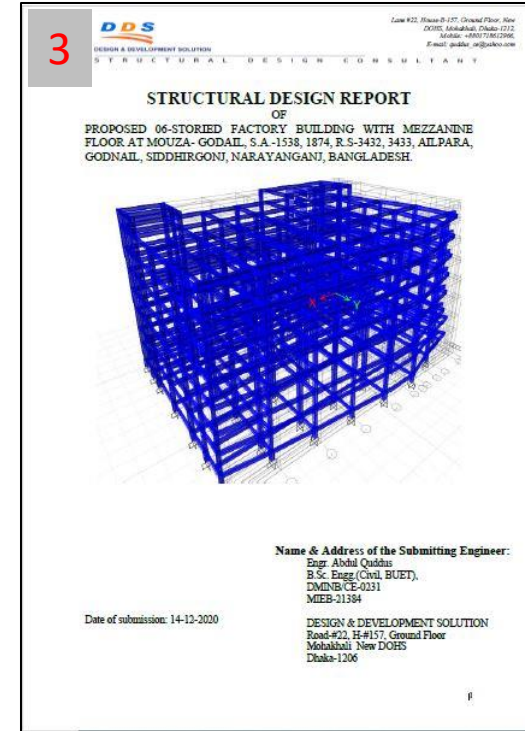
1. Building is currently three storied 2. Extended re-bar at roof for vertical extension 3. Design report prepared for 6 storied structure.

This building is permitted for 6 storied (G+5) storied from local authority. Currently, the building is three storied (G+2). Design documents of the structure has been prepared considering 6 storied building. Also, extended portion of column rebar was found at roof level which indicates the possibility of vertical extension.

**Foundation to be stressed above normal design limit considering possible vertical extension**

Cursory calculation indicates that the marked foundation is stressed above normal design limit considering prepared live load plan (5 KPa for typical floor and 1.5 KPa for roof).  
Factory engineer is required to carry out a Detail Engineering Assessment (DEA) complying with BNBC prior to any vertical extension.

| Item No. | Observation | Recommended Action Plan | Recommended Timeline |
|---|---|---|---|
| 07 | Foundation to be stressed above normal design limit considering possible vertical extension (Building-5) | Factory engineer is required to carry out a Detail Engineering Assessment (DEA) in compliance with BNBC 2006 prior to any vertical extension. | 6-weeks |
