# Snowtex Sportswear Ltd.

B-65/4, Lakuriapara, Dhulivita, Dhamrai  
(23.910371, 90.206833)  
3<sup>rd</sup> March 2021

# Building Information

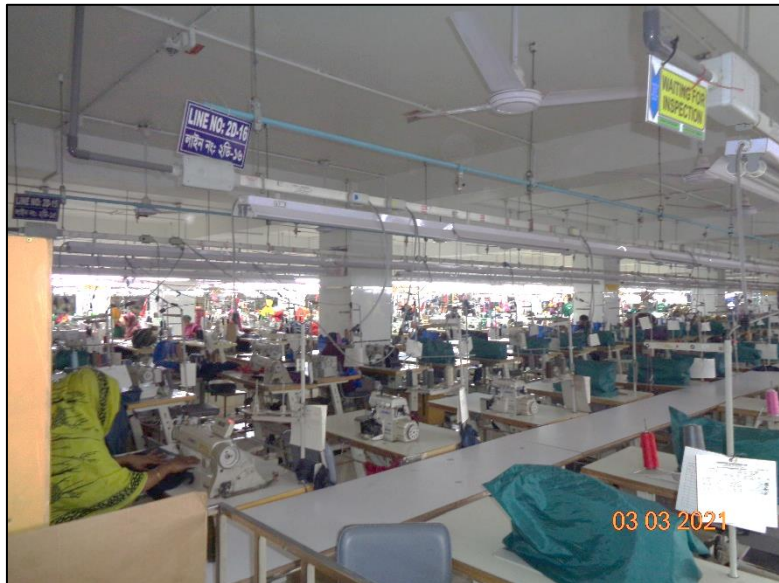
Storage Floor loading

As per BNBC every building or structure designed shall have its design documents prepared in accordance with the provision of Section 1.9.1. The design document shall include a design report, and a set of structural drawings, which shall be prepared in compliance with section 1.9.1.1 and section 1.9.1.2 as per BNBC. During the inspection, the design report was not found which is required to be prepared in compliance with section 1.9.1 (part-6, BNBC).
