UTAH Fashions Ltd. (Extension)

South Salna, Salna Bazar, Gazipur

10th February 2021

7 Observation: Building-2

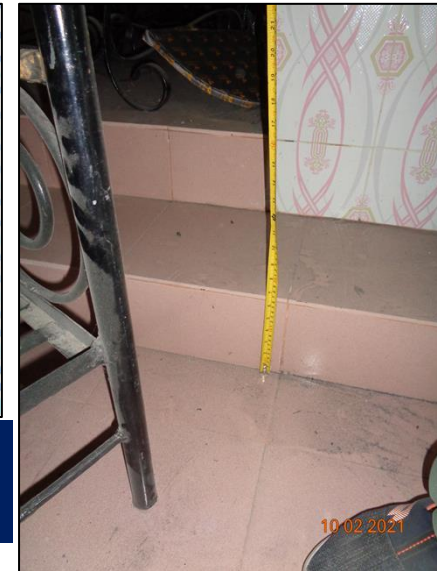
Toilet Zone area with built up at 1st floor.

This building is permitted for 8 storied (G+7) storied from local authority. Currently, the building is three storied (G+2). Extended portion of column rebar was found at roof level which indicates the possibility of vertical extension.

Cursory calculation indicates that the marked columns are stressed above normal design limit considering prepared live load plan and equivalent concrete strength from concrete core test value for the 8 storied building.

Item No.	Observation	Recommended Action Plan	Recommended Timeline
05	Column to be stressed above normal design limit considering possible vertical extension (Building-2)	Complete implementation of any remedial works deemed necessary by the Detail Engineering Assessment (DEA).	6-months
06	Column to be stressed above normal design limit considering possible vertical extension (Building-2)	Continue to implement loading plan.	6-months
07	Uncontrolled loading at 3 rd Floor (Existing Roof) (Building-2)	Factory is required to maintain the prepared floor live load plan.	6-weeks
08	Lack of lateral stability (Building-2: Roof Shed)	Building Engineer is required to check the lateral stability of the steel shed.	6-weeks
