# Universal Jeans-3

Plot # 69, Sector # 7, Export Processing Zone, Chattogram -4223  
(22.300516, 91.776743)  
17<sup>th</sup> February 2021

# Observations

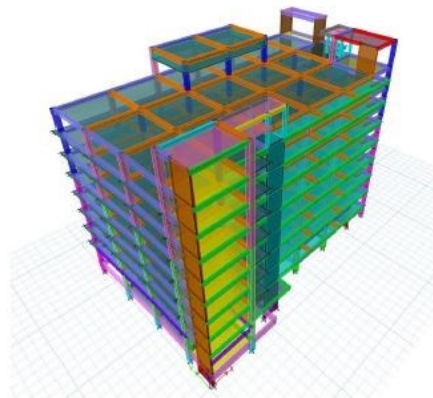
Figure 2.1.2: 3D View of Analytical Model

The building is classified as **intermediate moment resisting frame**. General 3D view of the building has been presented in **Figure 2.1**.
