Next Export Zone Ltd.

105/4, Adaboi, Peara Bagan, Joydebpur, Gazipur, Bangladesh
(23.970740, 90.425149)

24th Feb 2020

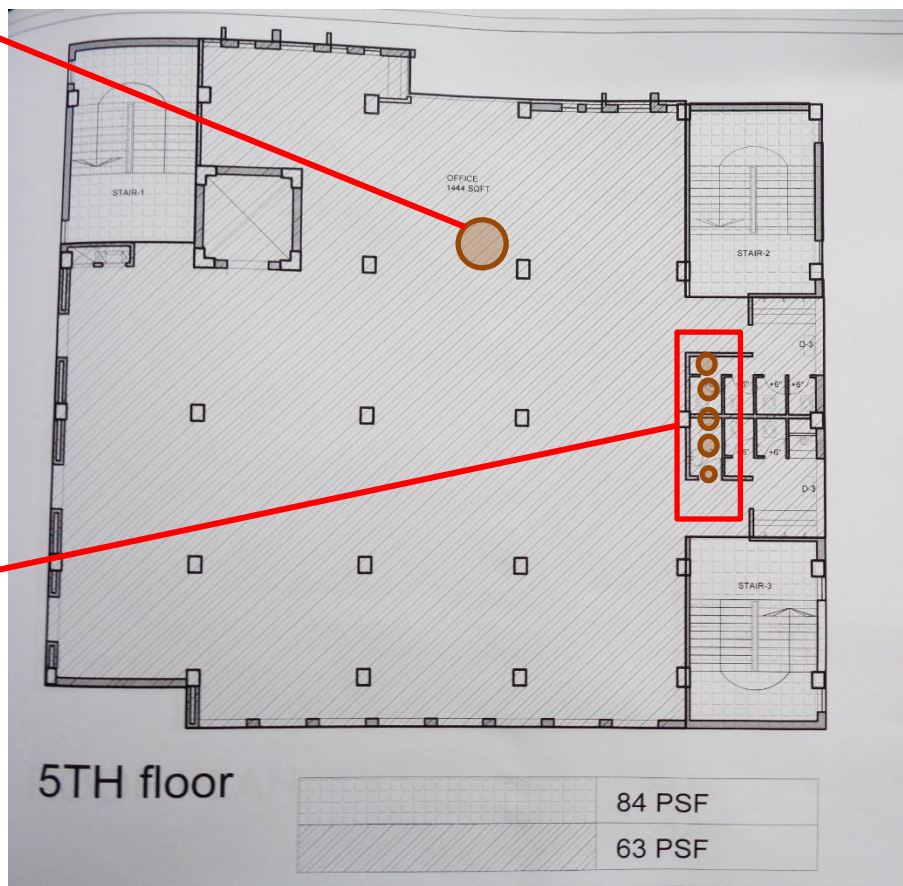
5TH floor
Floor loading plan

Undocumented water tanks were found on existing roof. Also a non-engineered supporting structure was found at roof level. Factory engineer is required to survey and update the as-built condition.

Item No.	Observation	Recommended Action Plan	Recommended Timeline
01	Undocumented water tanks and apparently non-engineered supporting structure on the roof. (Main Building)	Building Engineer is required to relocate the existing water tanks as per accepted load plan. Also, survey the supporting structure and take necessary remedial actions.	6-weeks
02	Mismatches in the design report and software analysis file. (Main Building)	The building engineer to update the engineering assessment (structural design) report including the software analysis file and submit to Accord for further review.	6-weeks
03	Mismatches in the design report and software analysis file. (Main Building)	Update and active manage the floor loading plans based on the column and floor capacity of the building.	6-weeks
04	Mismatches in the design report and software analysis file. (Main Building)	Complete remedial works arising from engineering assessment.	6-months
