Manel Fashion Ltd.

79/1, Bason, Viti Para, Gazipur.
(23.962769N, 90.357361E)
26th January 2021

Buildings Information

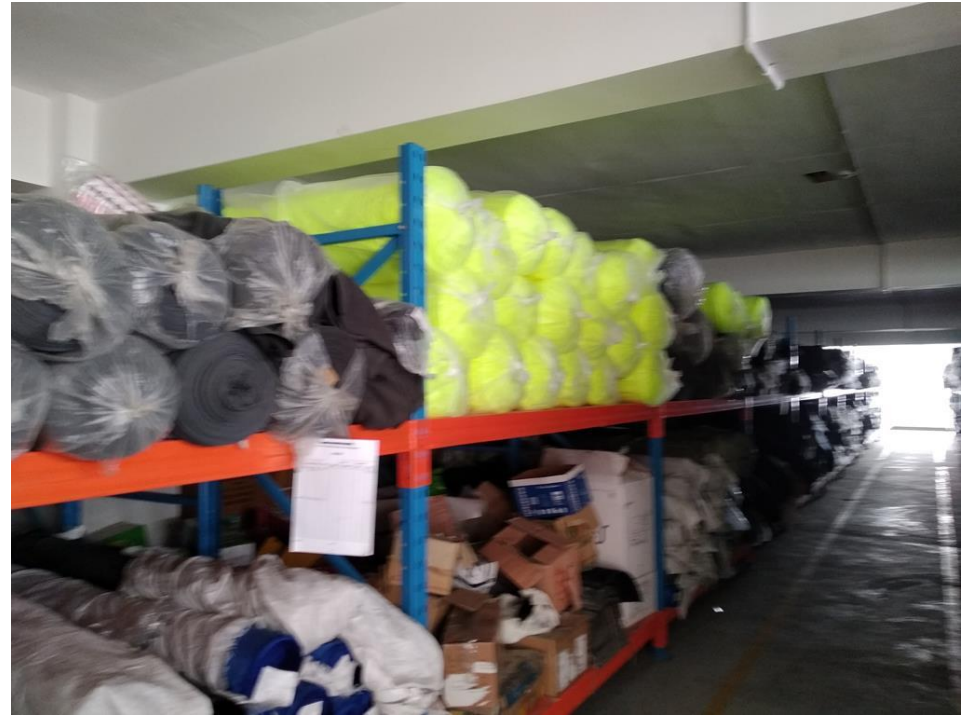
Typical floor loading

Column to be stressed above normal design limit

Cursory calculation indicates that the working stress of ground floor column exceeds the design limits and that requires immediate design review. 6 kPa live load (As per provided load plan) on typical floor & 2 kPa live load on roof top and minimum concrete strength for stone chips are considered. Factory engineer is required to review design, load & column stress in the area identified above.
