# Scandex (Bd) Ltd.

6<sup>th</sup> January 2021

# Buildings Information

1. Production Building (G+4)
2. Utility building (G+1)

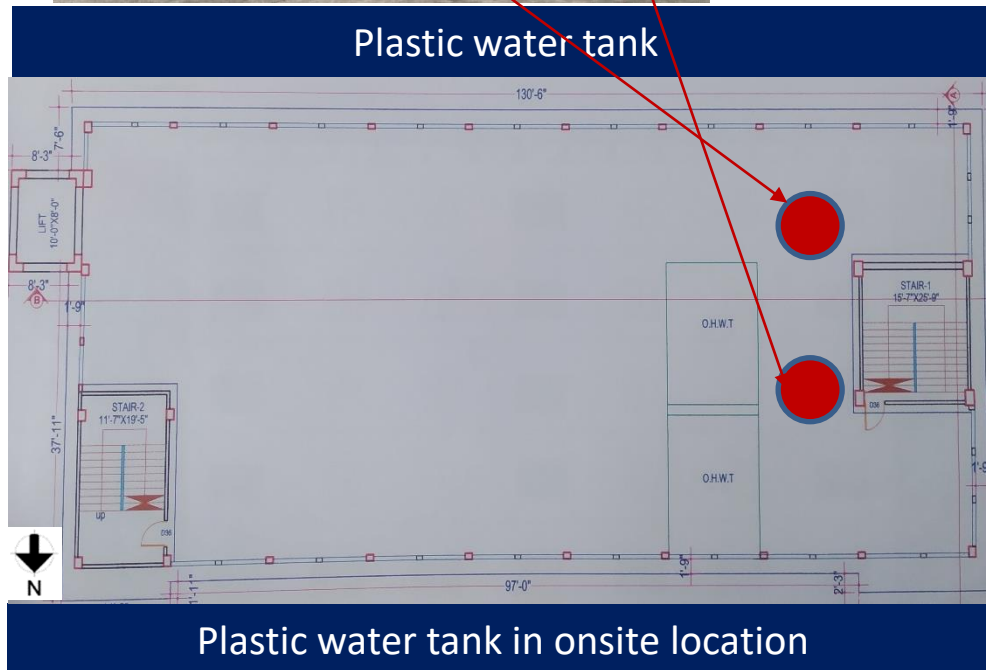
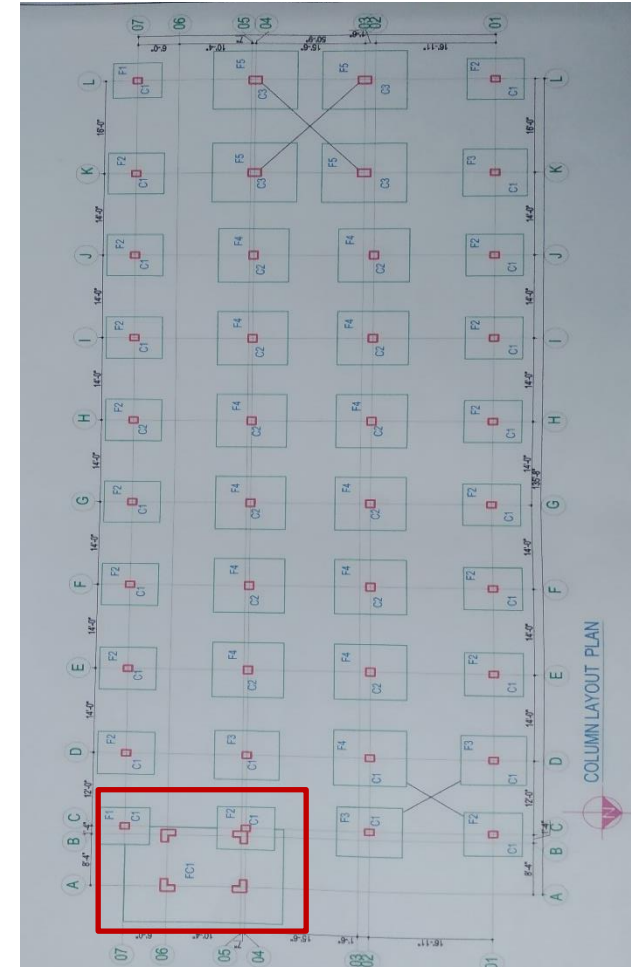
Plastic water tank

Two RCC O.H.W.T is shown in architectural drawing however 2 nos P.V.C water tanks are present at different locations.

In foundation drawing, lift core foundation has been merged with other footings. No details have been provided in drawings regarding this issue.

| Item No. | Observation | Recommended Action Plan | Recommended Timeline |
|---|---|---|---|
| 02 | Discrepancy in as-built drawing. (Production Building) | Mention plastic water tank’s size and locations on load plan and architectural drawings. Building engineer is required to check the lift core foundation and incorporate details in the as-built drawing. | 6-weeks |

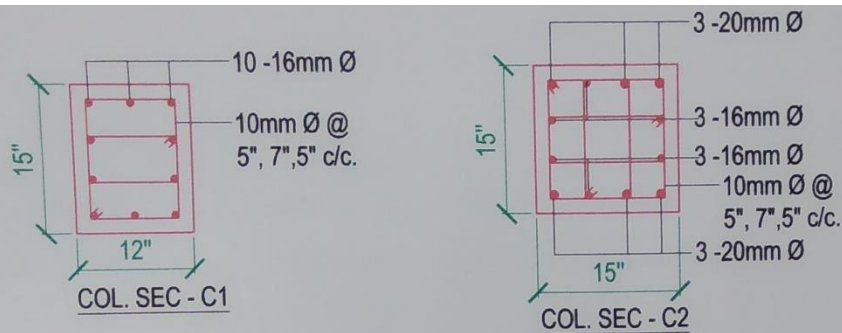
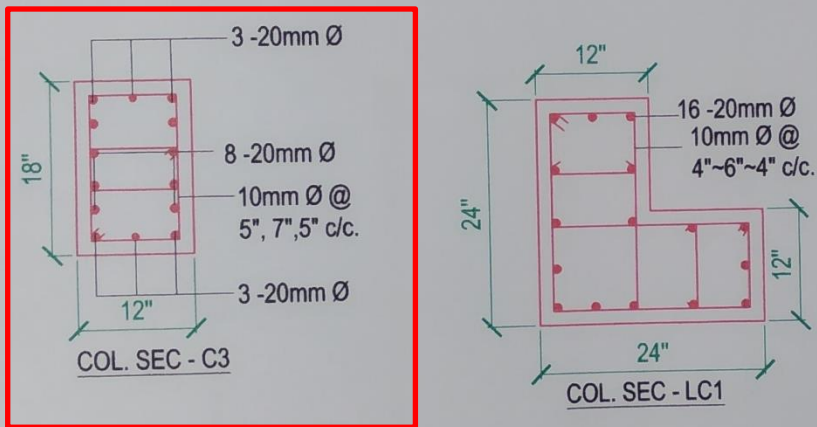
Rebar numbers of C3 column did not match with structural drawing. On long face (450 mm) 6 numbers of rebars were shown in column section, whereas 4 numbers of rebars were found by ferro scanning. Moreover, the size of the column was found different in column schedule.

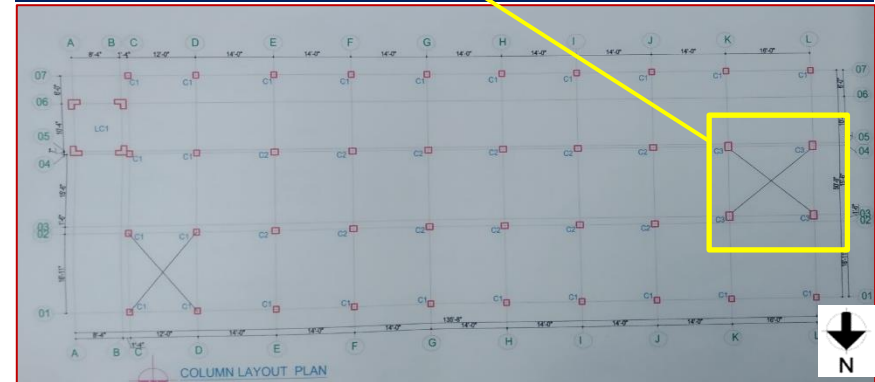
Column Layout

There is an inverted beam on ground floor roof level of grid 1/K-L which is not mentioned in as built drawing.

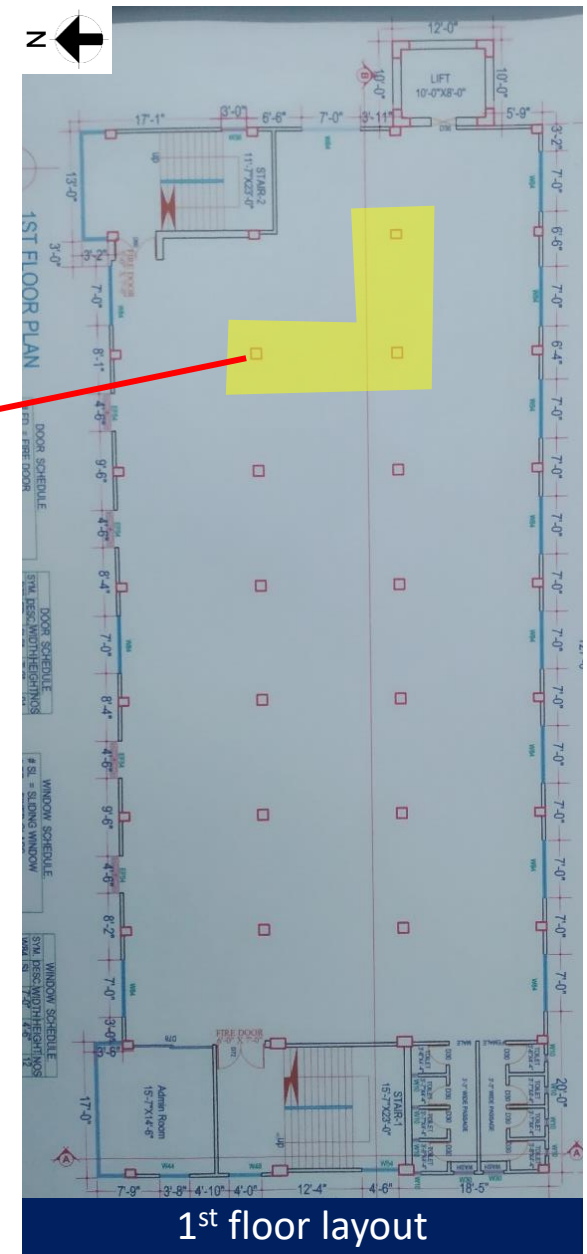
1<sup>st</sup> floor layout

No load plan has been prepared for the production building, besides localized high loading surrounding the column was observed in 1<sup>st</sup> floor. Moreover, in sufficient concrete test report was found for 2<sup>nd</sup> phase of construction. No test report found for 1<sup>st</sup> phase of construction.

Localized high loading

As per BNBC every building or structure designed shall have its design documents prepared in accordance with the provision of Section 1.9.1. The design document shall include a design report, and a set of structural drawings, which shall be prepared in compliance with section 1.9.1.1 and section 1.9.1.2 as per BNBC. During the inspection, the design report has not been found which is required to be prepared in compliance with section 1.9.1 (part-6, BNBC).

| Item No. | Observation | Recommended Action Plan | Recommended Timeline |
|---|---|---|---|
| 04 | Lack of Design report and localized high loading surrounding the column. (Production Building) | Verify in-situ concrete strength by taken 100 mm diameter cores (minimum 4 nos.) from lower tier columns or existing cylinder test reports from ground floor columns & foundation. | 6-weeks |

| Item No. | Observation | Recommended Action Plan | Recommended Timeline |
|---|---|---|---|
| 05 | Lack of Design report and localized high loading surrounding the column. (Production Building) | Produce and actively manage a loading plan for all floor plates within the factory, considering floor, column and foundation capacity. | 6-weeks |

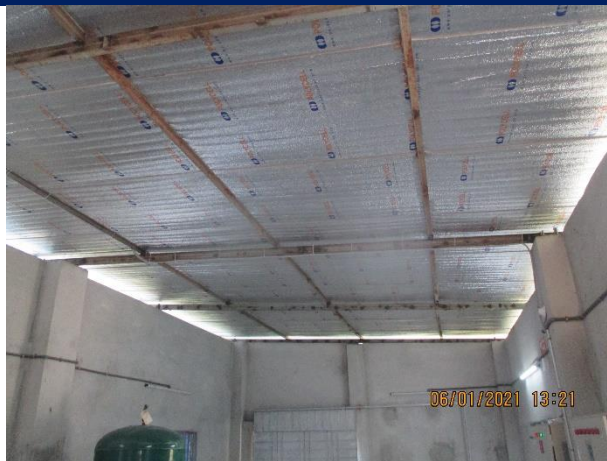
Interior of Utility Building

There was no credible approved drawing from concerned authority and DIFE. In addition, no as-built drawings were available. Factory engineer is required to survey the structure and prepare as-built drawings that are in compliance with section 1.9.1.2 as per BNBC.

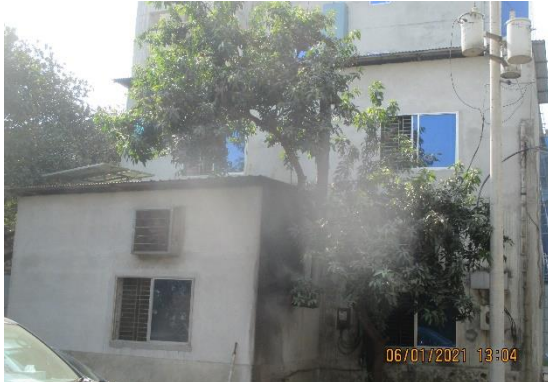
Utility Building

Non engineered connections were observed at light weight roof. Factory engineer is required to check the connection of the roof for the up-lift pressure of wind.
