# Oxford Knit Composite Ltd.

19 August 2021

# Buildings Information

# Observations

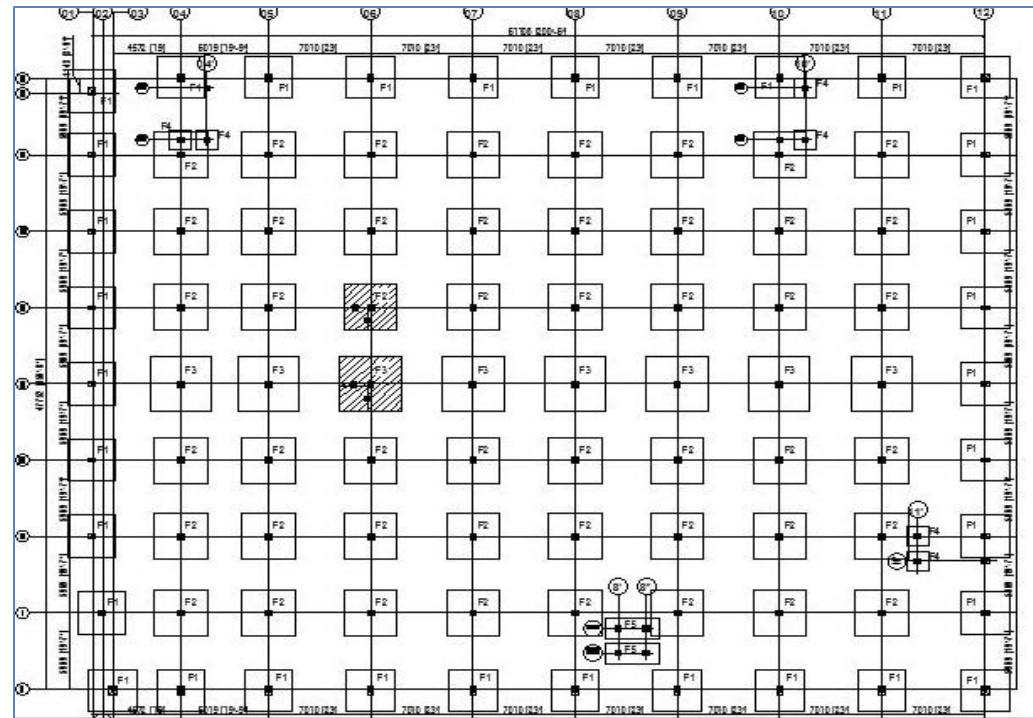
Isolated footing layout

**Footings are stressed above normal design limit**

As per geotechnical investigation report, the allowable bearing capacity is 0.46 tsf (49.33 KN/m<sup>2</sup>) at depth 5 ft (1.5 m) considering F.S 2.5.

Cursory calculation indicates that footing appears to be stressed above normal design limits considering the recommended soil bearing capacity in geotechnical report and footing sizes in drawing. Factory engineer is required to review the adequacy of footings and comply with BNBC.

| Item No. | Observation | Recommended Action Plan | Recommended Timeline |
|---|---|---|---|
| 03 | Footings are stressed above normal design limit (Building 1) | Produce and actively manage a loading plan for all floor plates within the factory Building considering floor, column and foundation capacity. | 6-weeks |
| 04 | Footings are stressed above normal design limit (Building 1) | Produce and actively manage a loading plan for all floor plates within the factory Building considering floor, column and foundation capacity. | 6-months |

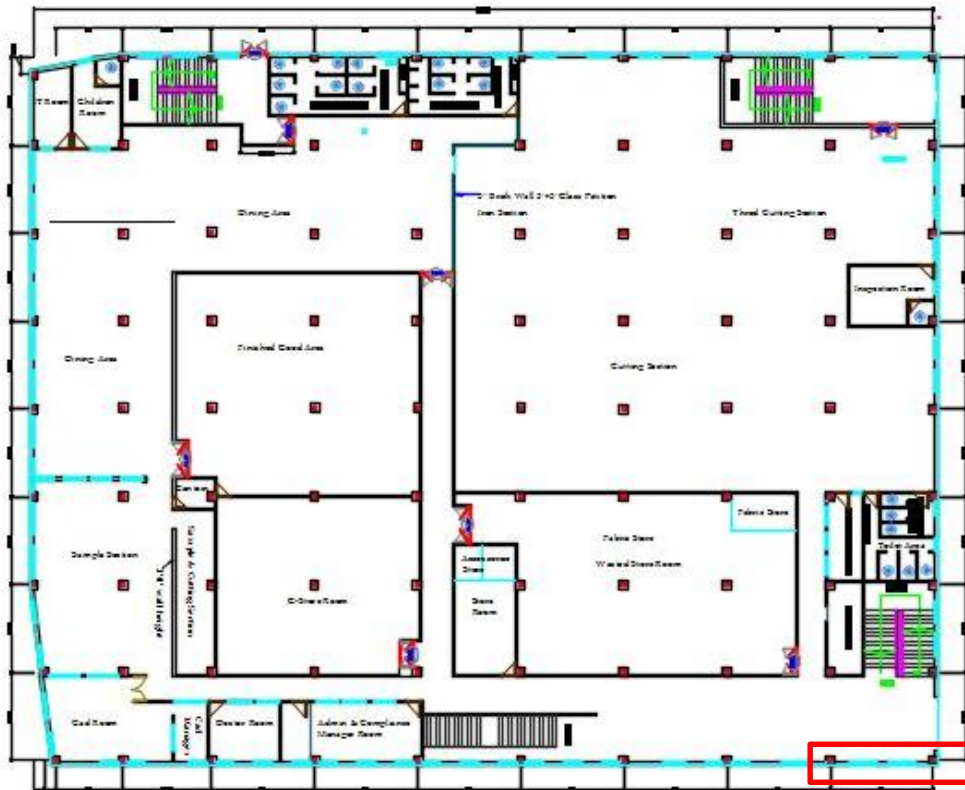
Ground floor layout plan

# **Vertical bracing missing in North-South direction**

Vertical bracing found missing in long direction.  
Building engineer is required to re-install all the missing bracing as per the design specifications.

| Item No. | Observation | Recommended Action Plan | Recommended Timeline |
|---|---|---|---|
| 11 | Vertical bracing missing. (Building 1) | Building engineer is required to re-install all the missing bracing as per the design specifications. Or check whether the existing bracing system are adequate for lateral stability. | 6-weeks |
| 12 | Vertical bracing missing. (Building 1) | Complete implementation of any remedial works deemed necessary by the Design Report. | 6-months |
