J K Knit Composite Ltd. (Extension)

10/1, South Dariapur, Savar, Dhaka-1340,
(23.8348N, 90.2547E)
9th June & 26th August 2021

Buildings Information

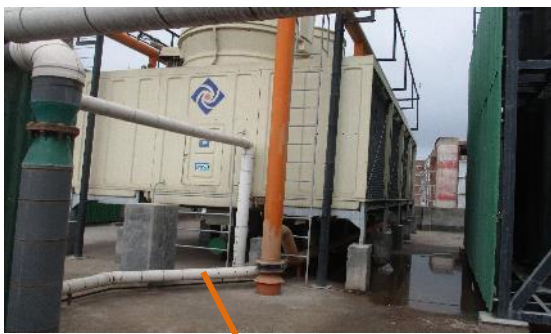
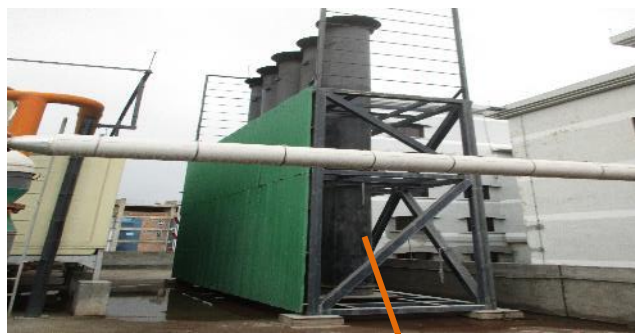
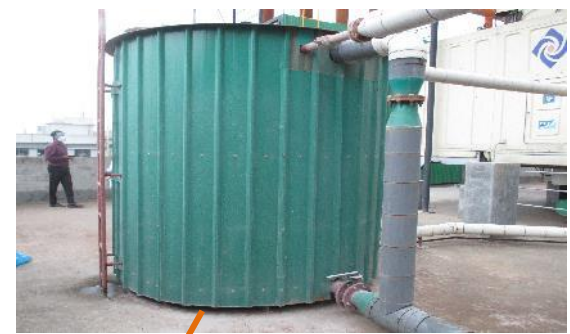
Undocumented horizontal expansion

Cooling tower, steam pipe and water tank were not mentioned in the roof layout plan. Undocumented horizontal expansion at east side of the building with steel framing was observed.
