# Fatullah Apparels

B-68/1 Wapda Road (Samad Member Dyeing Road), Jalkuri, Narayanganj.

31<sup>st</sup> May & 25<sup>th</sup> August 2021

# Building Information

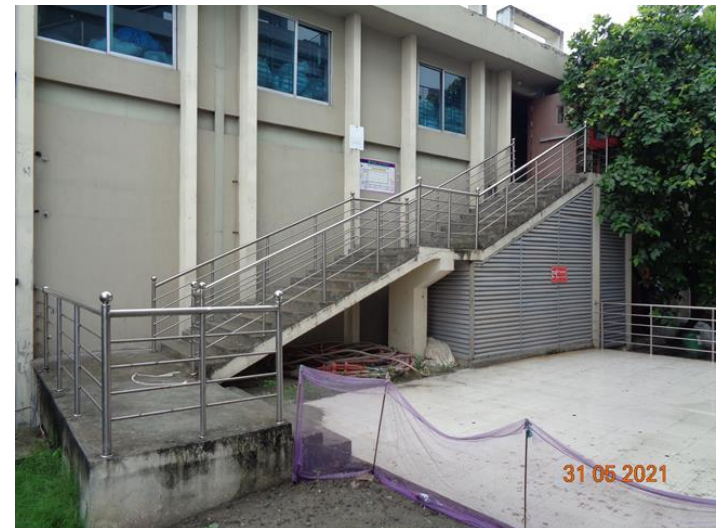
Crack found in external RC stair

Crack was found in several locations of RC stair. Factory engineer is required to investigate the cause of crack and repair the crack as per recommendation from investigation report.
