# Motex Fashion

802/1, Jajor, National University, Gazipur-1704

5 September 2021

# Observations

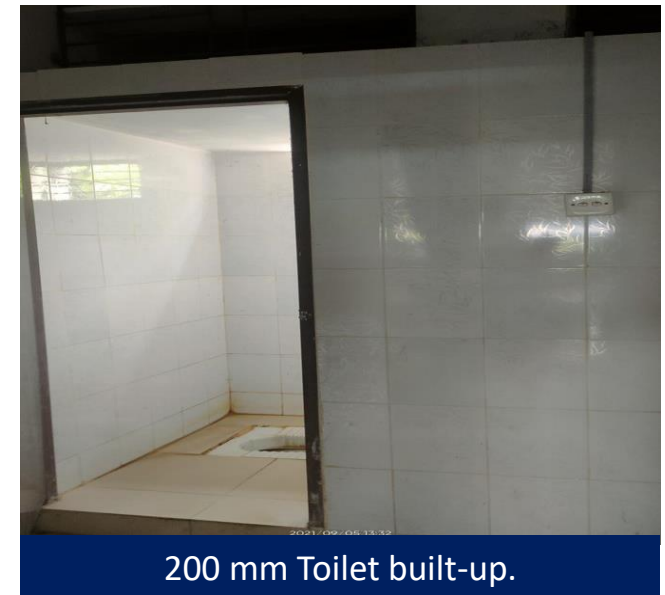
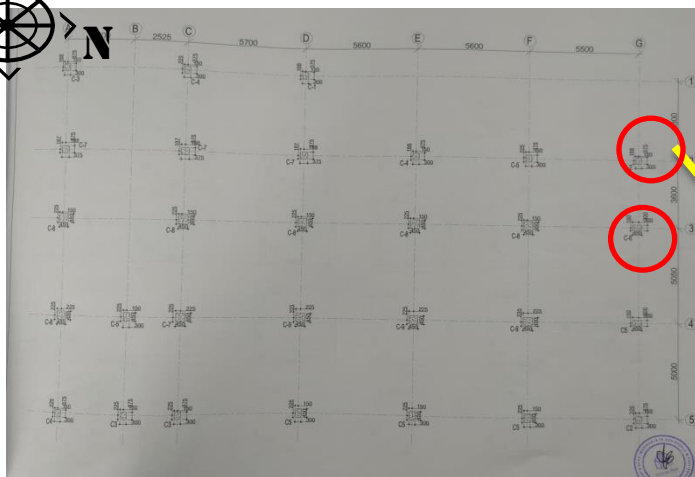
Column layout plan.

Toilet layout did not match with as-built drawings. Toilet build up was not shown in drawings.

Some stair beams were missing on-site but shown in the provided drawings. Grid distance between 1 and 2 was measured 3300mm instead of 4300mm. Update as-built drawings as per actual as-built condition.
