# Euro Jeans Ltd (New Shed)

Vogra, Chowdhury Bari, Gazipur  
(23.978714, 90.379255)

07 September 2021

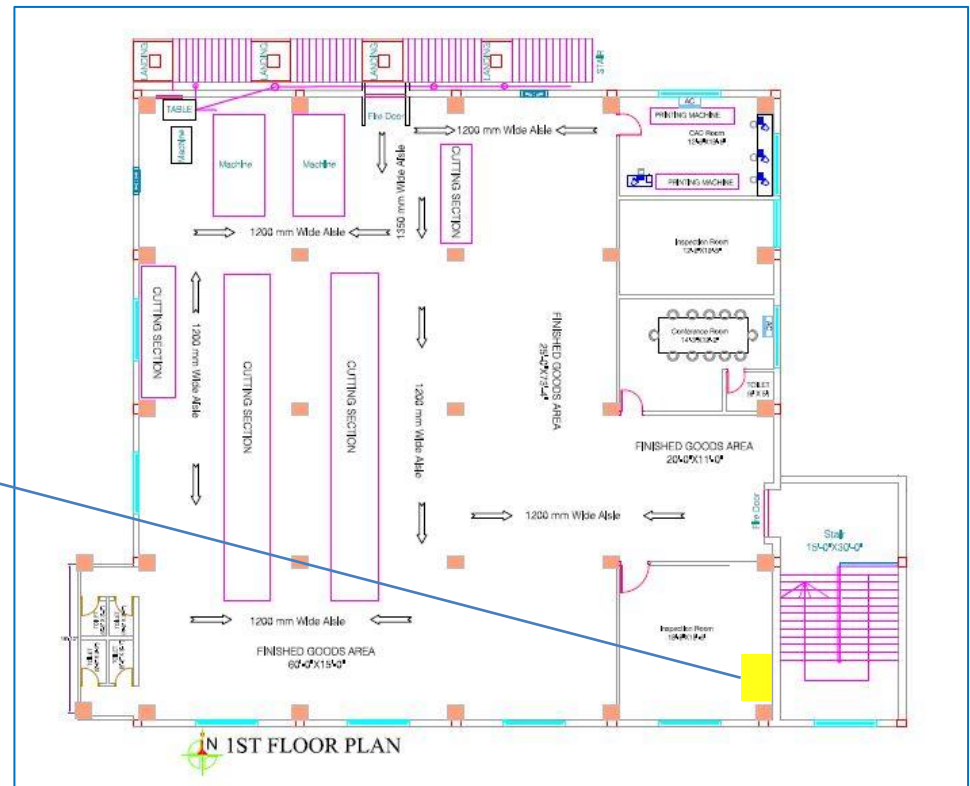
Plastic water tanks on stair top not shown in drawing. Also, toilet zone was found different with drawings.

Water tanks

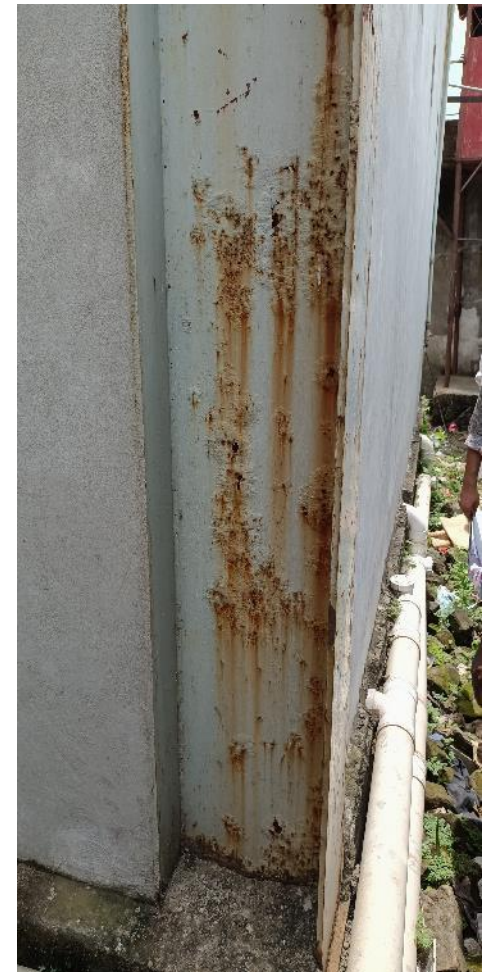
Corrosion in steel member was observed in several locations. The building engineer to investigate the reason of corrosion and suggest proper remedial measure accordingly.

Corrosion in steel column

| Item No. | Observation | Recommended Action Plan | Recommended Timeline |
|---|---|---|---|
| 06 | Corrosion in steel member. (Shed-3) | The building engineer to investigate the reason of corrosion and suggest proper remedial measure accordingly. | 6-weeks |
| 07 | Corrosion in steel member. (Shed-3) | Take necessary measures to prevent further corrosion and repair the corroded steel members as per engineer's suggestion. | 6-months |
