# Refat Garments Ltd (Extended Building)

144, 147-148 East Narashingapur, Ashulia, Savar, Dhaka, Bangladesh.

1<sup>st</sup> June & 5<sup>th</sup> September 2021

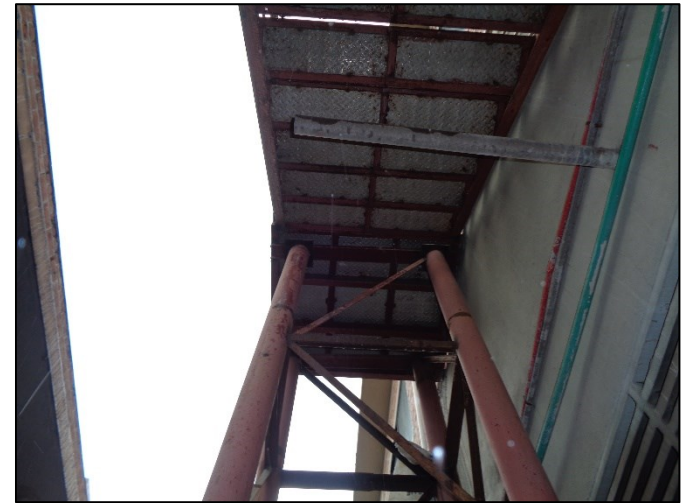
Undocumented Steel Stair found at East corner of the compressor building. No as-built drawing was found. The factory engineer is required to prepare as-built drawing and check the structural integrity for the steel stair.
