# AKH ECO APPARELS LTD.

## - Extended Buildings

07 September 2021

# Observations

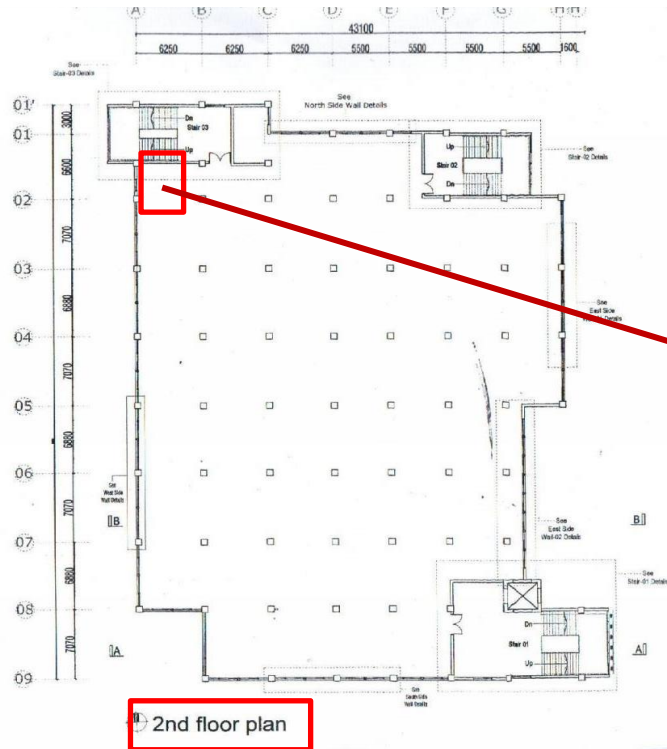
Architectural plan of second floor

# **Mismatch between architectural and as-built condition**

| Item No. | Observation | Recommended Action Plan | Recommended Timeline |
|---|---|---|---|
| 03 | Mismatch between architectural and as-built condition (Building- 03) | Building engineer is required to update the architectural drawing. | 6-weeks |

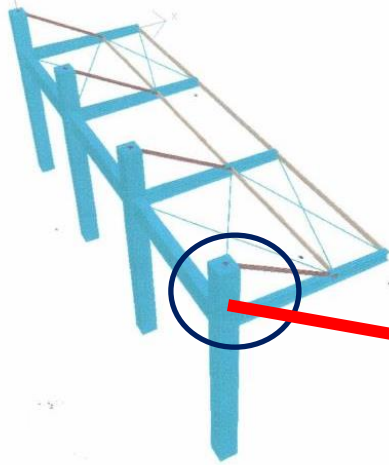
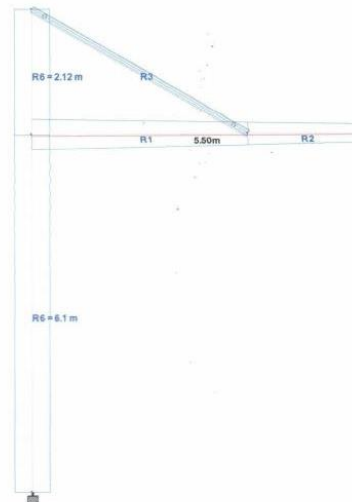
Canopy For (A.K.H GROUP)

## **Irregular load path of the Canopy**

Two end beams are shown connect to column in the design report but, they were connected to brick wall in as-built condition. Hence, the load path is not regular. Building engineer is required to check the adequacy of the connection of canopy.
