IRIS FABRICS LIMITED (Extension Building)

Zirani Bazar, Kashimpur, Gazipur
(23.999028, 90.251593)

20 September 2021

5 Observation: Printing and Dyeing Building

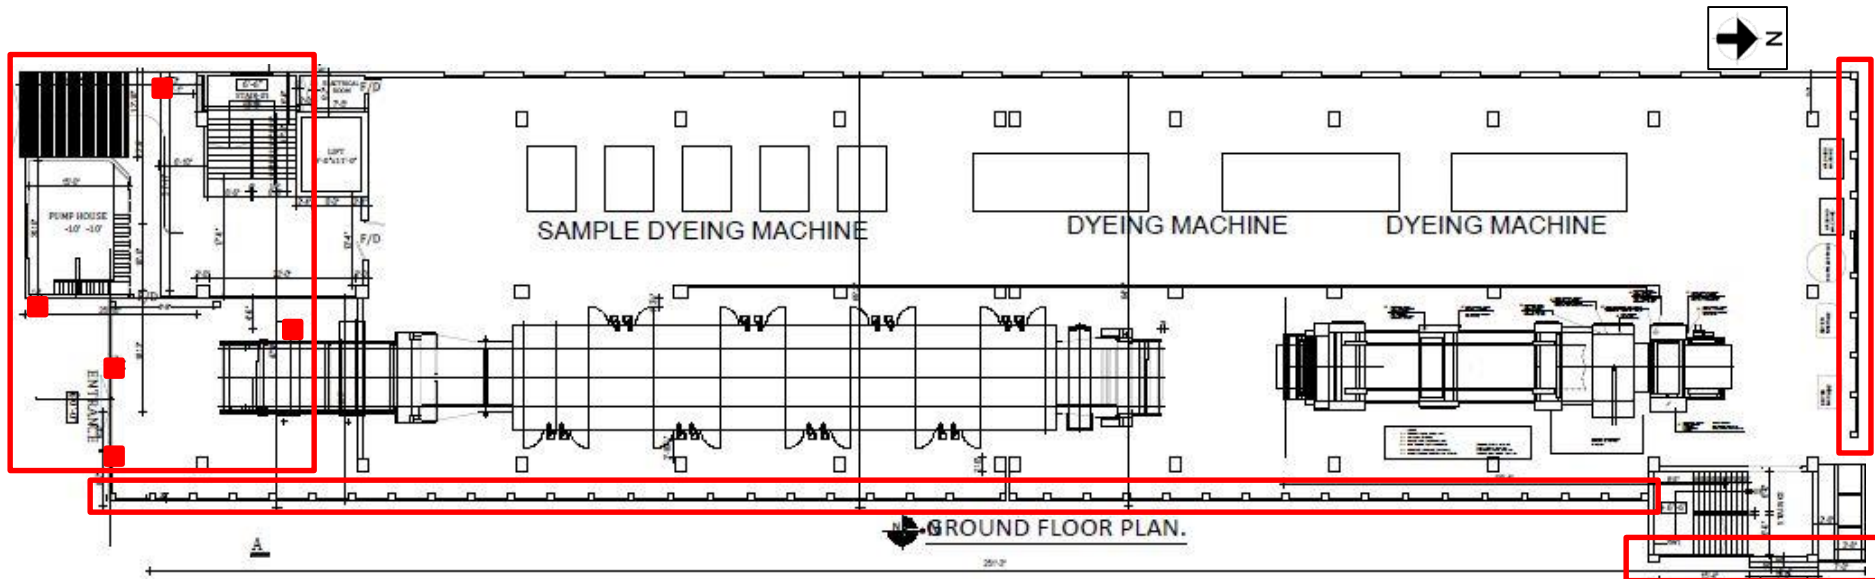
In the architectural drawing, few RC columns in ground floor was shown but no structural information was found for that RC columns and foundation system. Also, pump room was structurally connected with the mezzanine floor slab, which was not shown in drawing.

Item No.	Observation	Recommended Action Plan	Recommended Timeline
05	Design report not fully comply with BNBC	Building Engineer to prepare design report as per BNBC (part-6; Article 1.9.1) by reviewing design, loads and capacity of structural members.	6-weeks
06	Design report not fully comply with BNBC	Implement the recommendation of design report.	6-months
07	Inconsistencies in as-built drawing	The factory engineer is required to survey the structure and update the as-built drawings.	6-weeks
08	Mismatch in drawing (Rooftop connecting bridge)	The building engineer to survey the structure and update the as-built drawings with connection details.	6-weeks
