# BIG BOSS WASHING LTD

Aptech Industrial Park, 30, Sarabo, Kashimpur, Gazipur

21st September 2021

# Observations

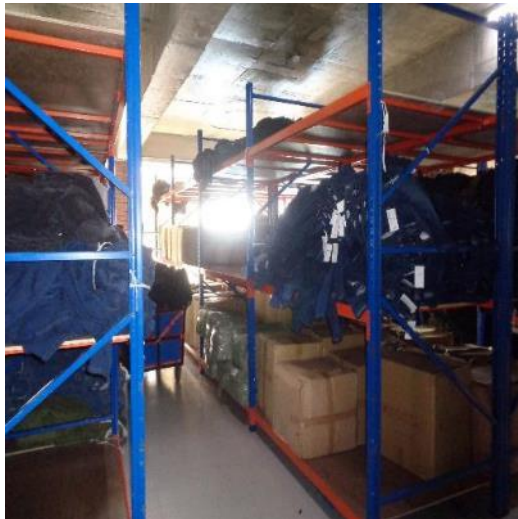
Live load on typical floor is considered as 4 kPa in prepared load plan. As per BNBC- Part 6, live load for light storage areas is required to be considered minimum 6 kPa. Also, value of R is mentioned as 6 which should be 5 or 8 based on the rebar detail. However, the factory engineer is required to revise the load plan as per BNBC requirement and check the design accordingly.

| Item No. | Observation | Recommended Action Plan | Recommended Timeline |
|---|---|---|---|
| 06 | Prepared load plan to be revised (Washing Building) | <ul style="list-style-type: none"> <li>Produce and actively manage a set of floor live loading plan following BNBC minimum live load requirement and considering foundation &amp; column capacity of the building.</li> </ul> | 6-weeks |
