# GMS Composite Knitting Ind. Ltd. (New Building)

Sardaganj, Kashimpur, Gazipur-1346, Bangladesh,  
(23.96859, 90.29699)

24<sup>th</sup> & 31<sup>st</sup> May & 06<sup>th</sup> September 2021

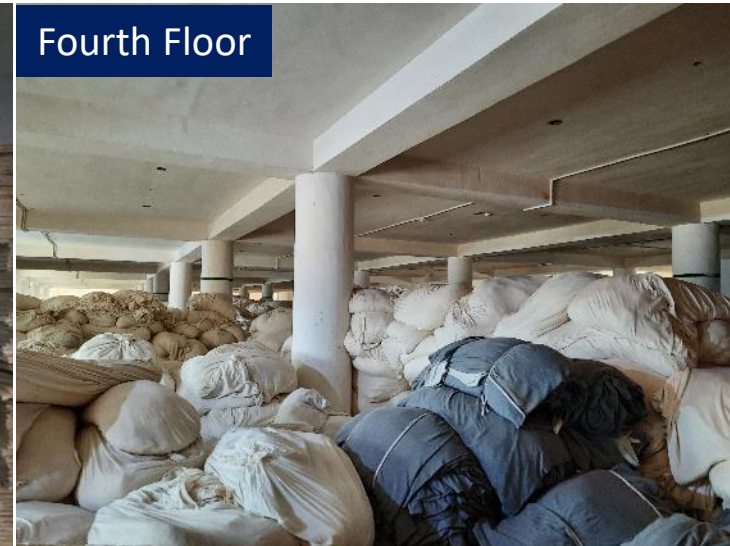
Fourth Floor

Heavy loading observed throughout the building which exceeds the prepared live load of 3 kPa (3<sup>rd</sup>, 4<sup>th</sup>, 5<sup>th</sup> floor), 5kPa (2<sup>nd</sup>, 1<sup>st</sup>, Ground floor). Building engineer is required to actively manage the floor load plan also maintain floor loading below 3 kPa.

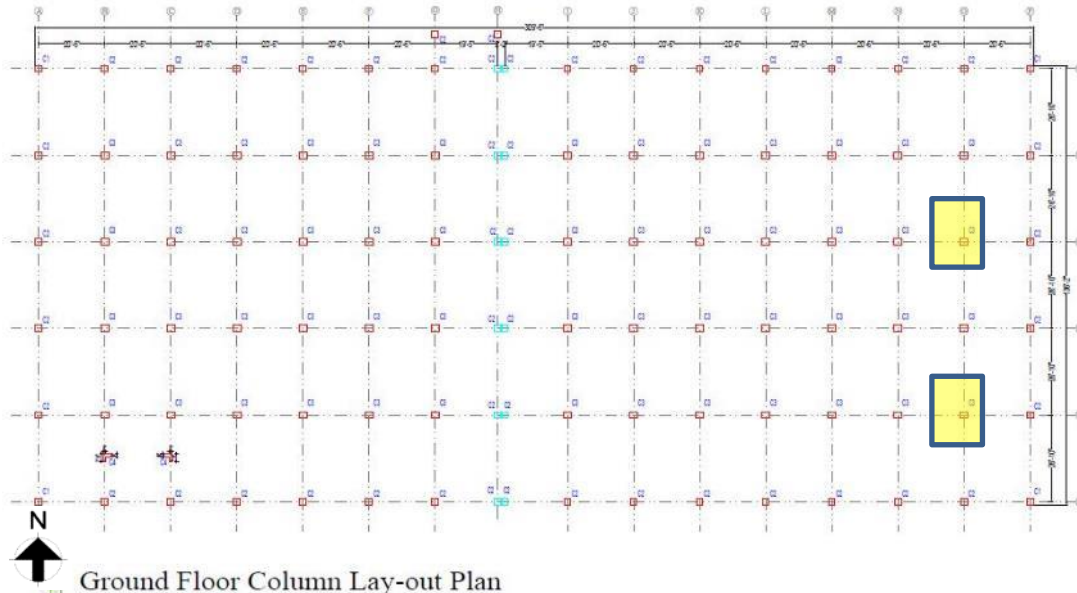
Ground Floor Column Lay-out Plan

Cursory calculation indicates that columns are stresses above normal design limits at the marked locations considering 3 kPa live load on typical floor. Building engineer to review design, loads and columns stresses.

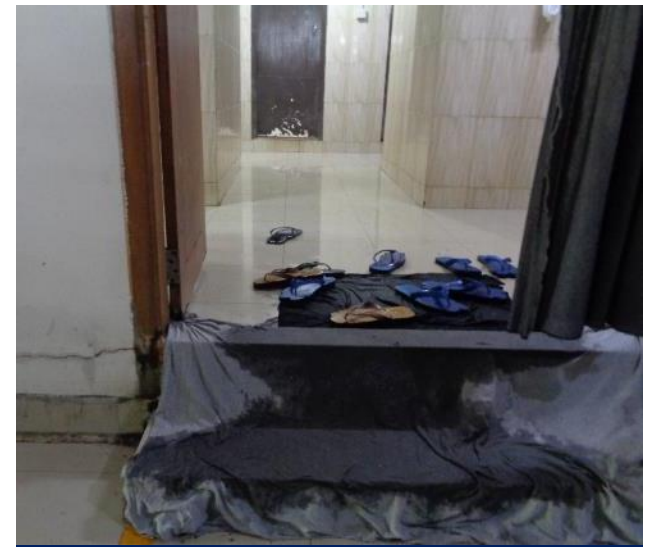
250mm Build up at toilet area

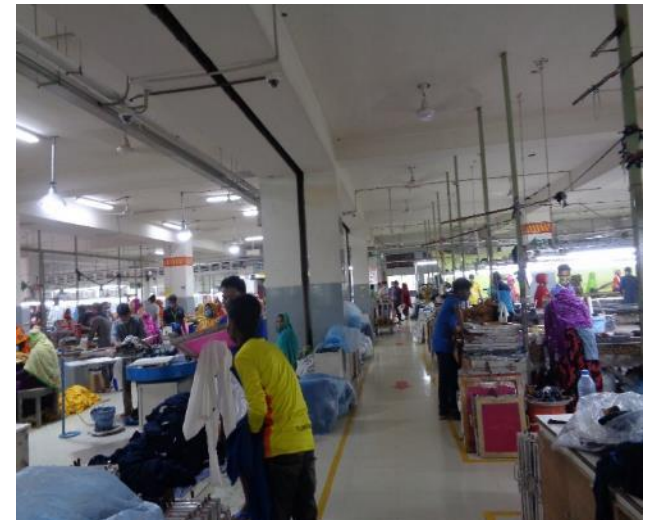
Typical floor loading

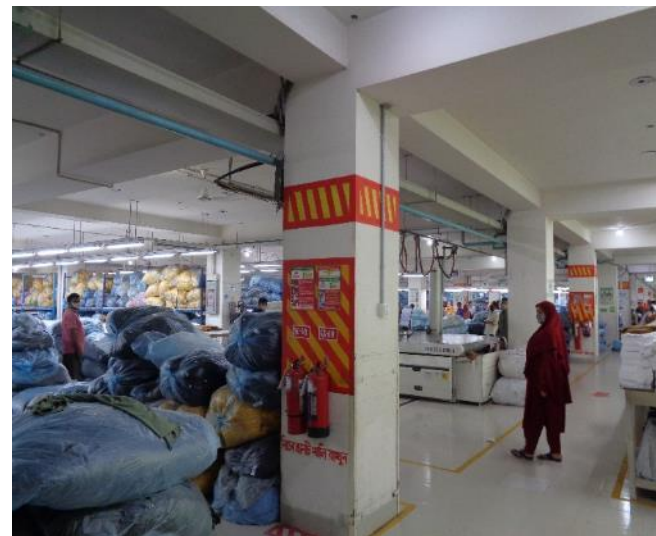
Cursory calculation indicates that foundation is stressed above normal design limits at the marked locations considering 3 kPa live load on typical floor. Building engineer to review design, loads and foundation stresses.

Typical floor loading

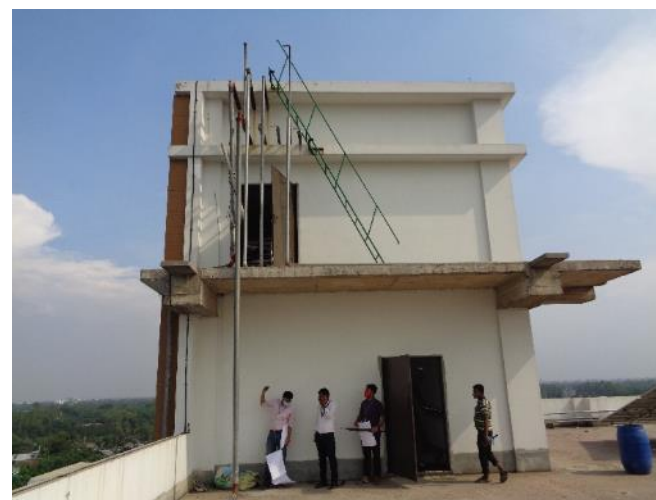
Loading from extended floor and RC water tank

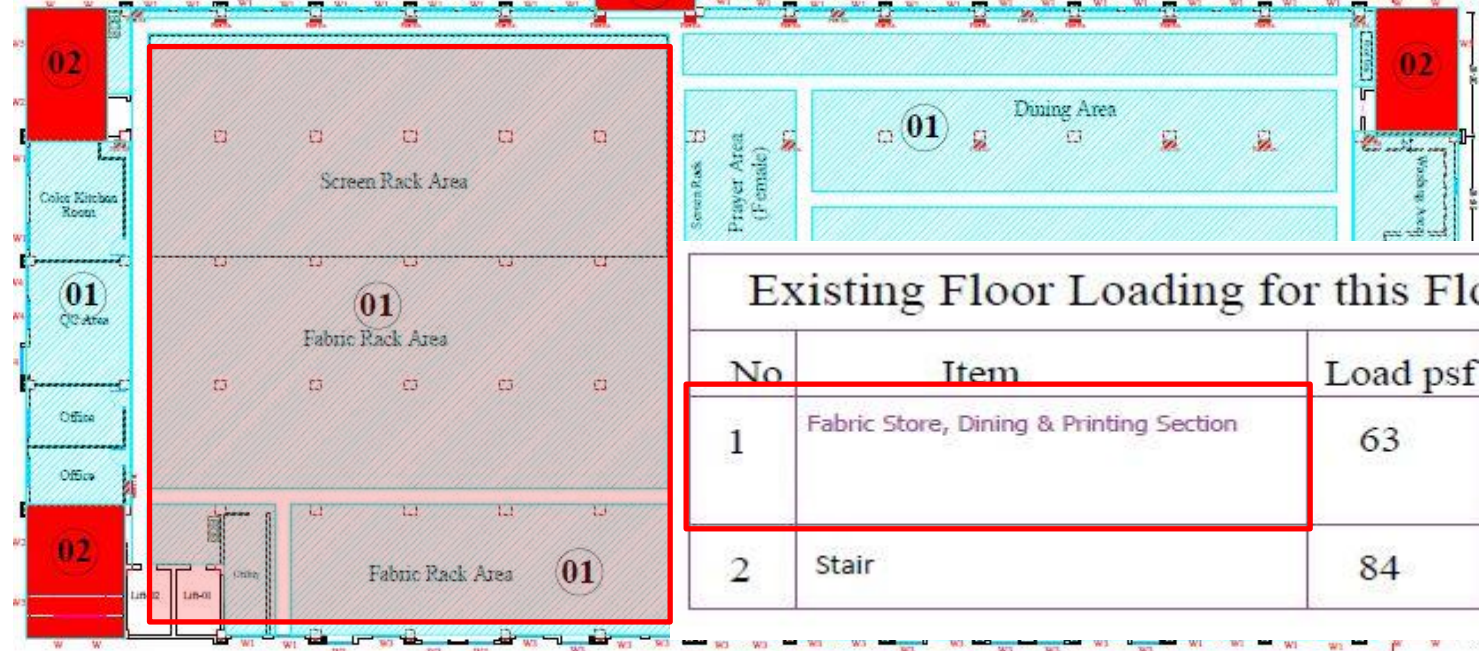
Load plan for 4<sup>th</sup> floor

Live load at storage areas are considered as 3 KPa in prepared load plan. However, as per BNBC-Part 6 live load for light storage areas is required to be considered as 6 KPa. Building engineer is required to revise the load plan as per BNBC part-6.

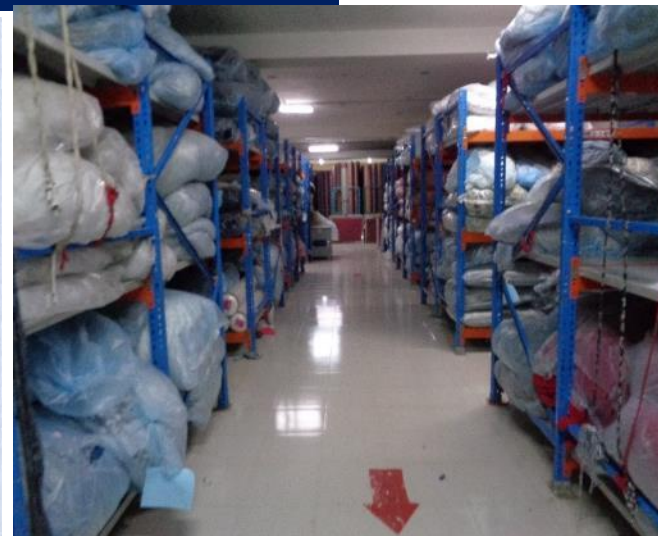
Typical storage area

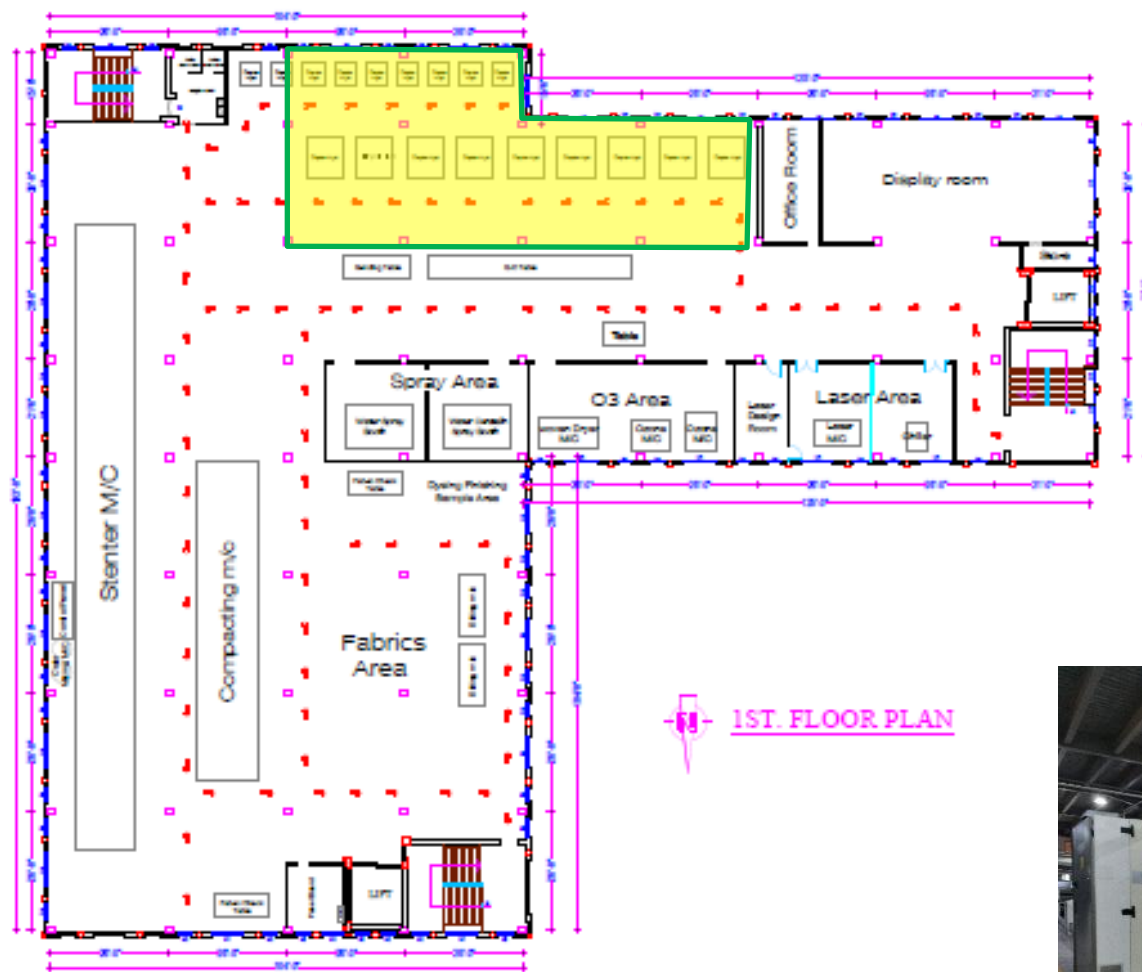
First floor layout plan

Significant vibration was felt on the first floor due to operation of heavy machineries. Building engineer is required to investigate the long-term effect of the vibration and suggest remediation.

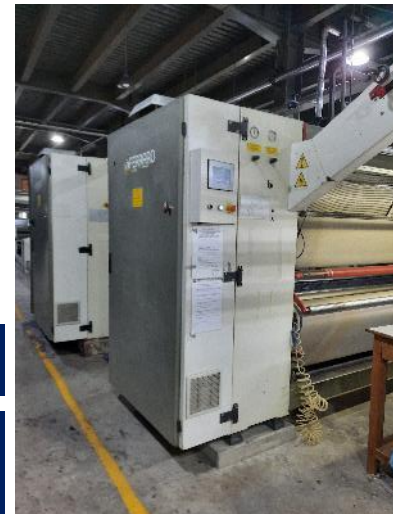
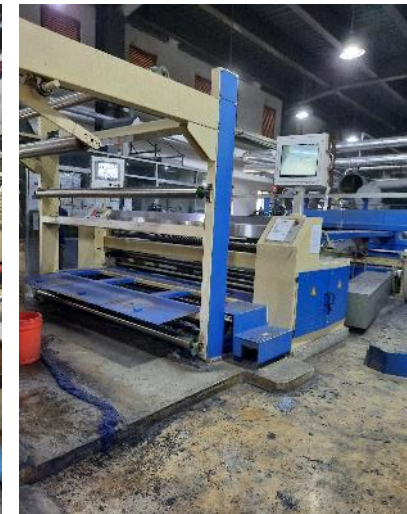
Heavy machineries

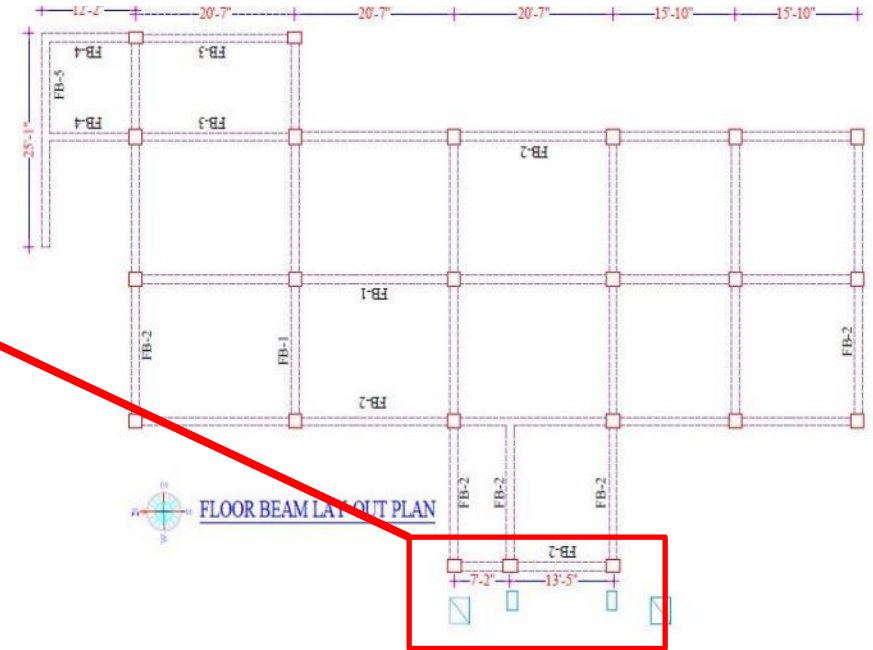
Cantilever beam at south side

Cantilever beams at south side extended area are not shown in drawing.  
Building engineer is required to update the as-built drawing.

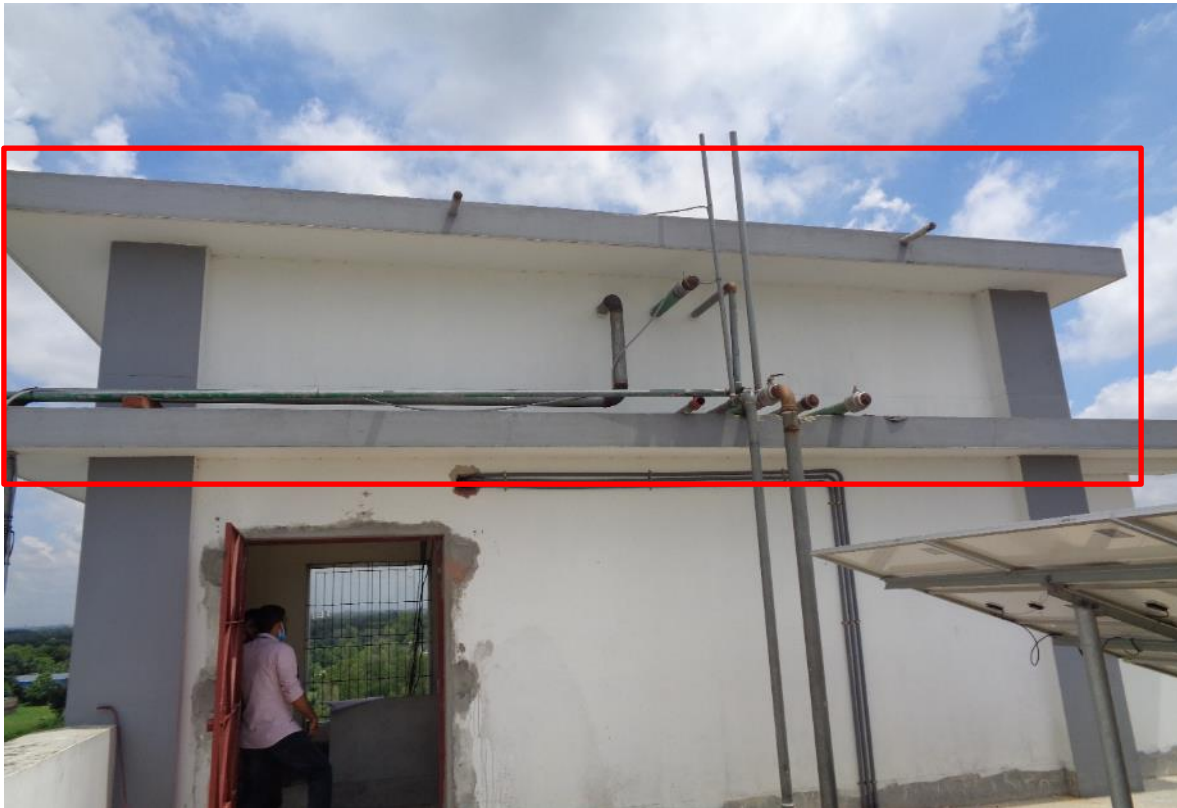
Sectional detail of overhead water tank not shown in layout

Dimension of overhead water tank was not shown in as-built drawing.  
Building engineer is required to update the as-built drawing.

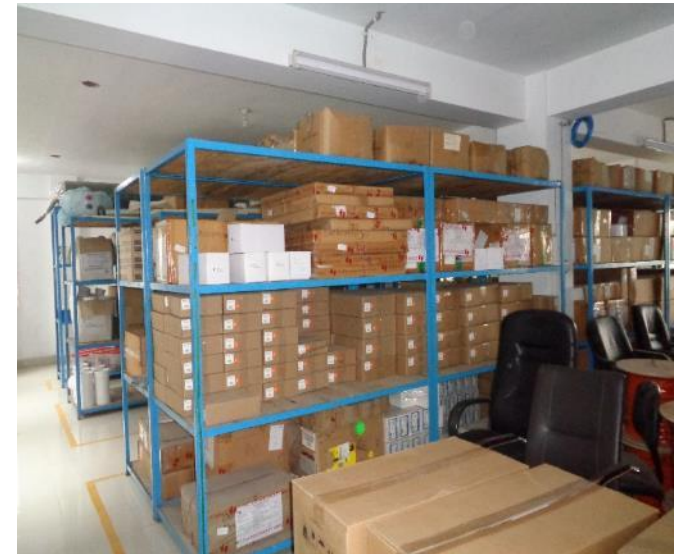
Cursory calculation indicates that foundation is stressed above normal design limits at the marked locations considering 3 kPa live load on typical floor as per prepared live load plan. Building engineer to review design, loads and foundation stresses.

Typical floor loading

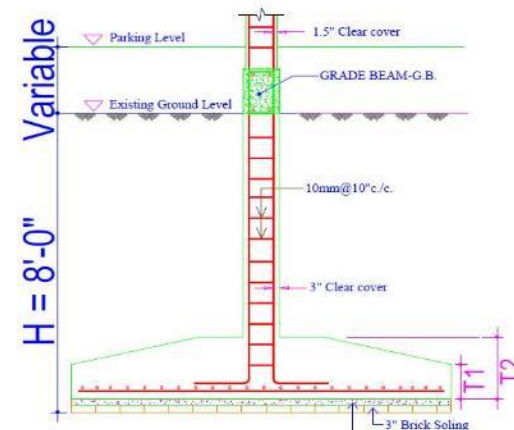
In geotechnical investigation report, factor of safety of soil capacity considered as 2.50 and foundation depth mentioned at 2.44 m depth in provided drawing. However, in prepared DEA report soil bearing capacity used for 3.04m depth and factory of safety used as 3.0 which may result in significant change in foundation capacity calculation. Building engineer is required to revised the foundation capacity calculation.

Foundation depth mentioned as 2.44 m

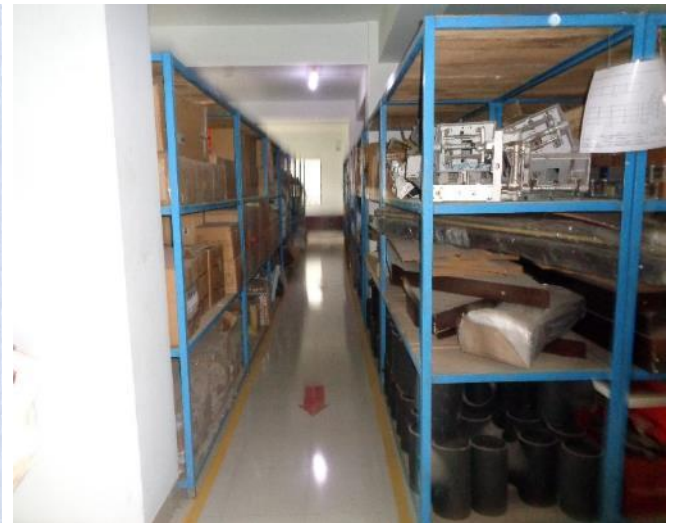
Typical storage area

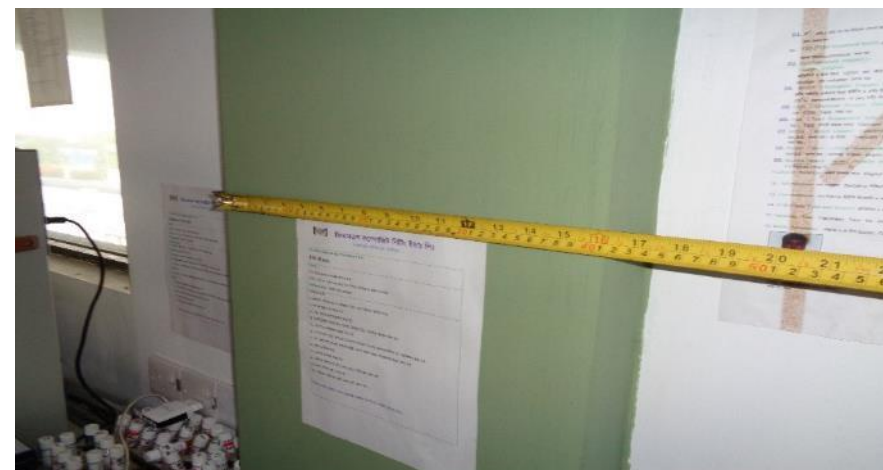
Column dimension measured as 300mmX375mm

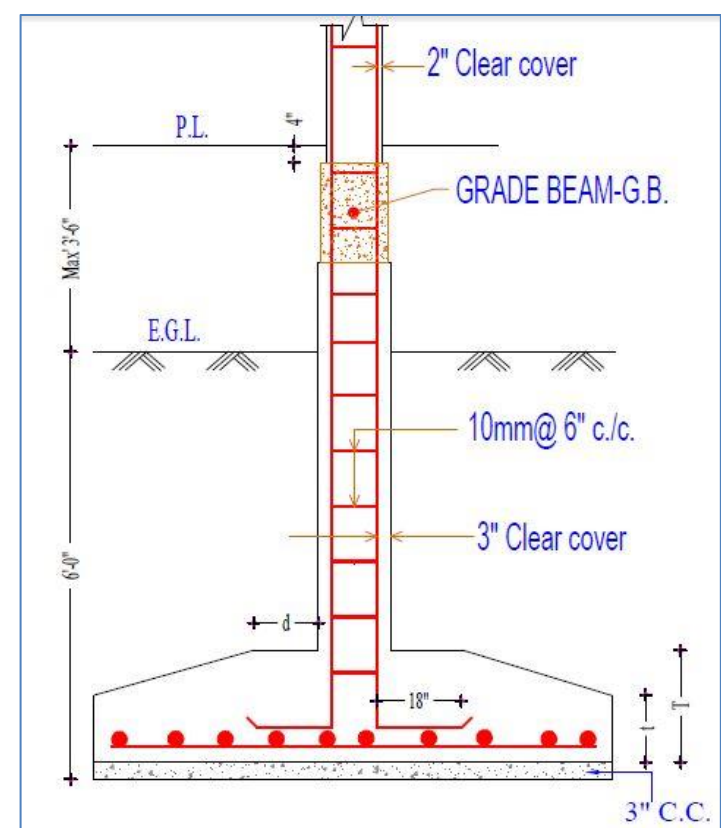
As per provided structural drawing footings are in 6 feet below from the EGL

Cursory calculation indicates that internal footings of the building are stressed above design limit considering the bearing capacity from soil test report. A Detail Engineering Assessment is required carryout by Building Engineer.

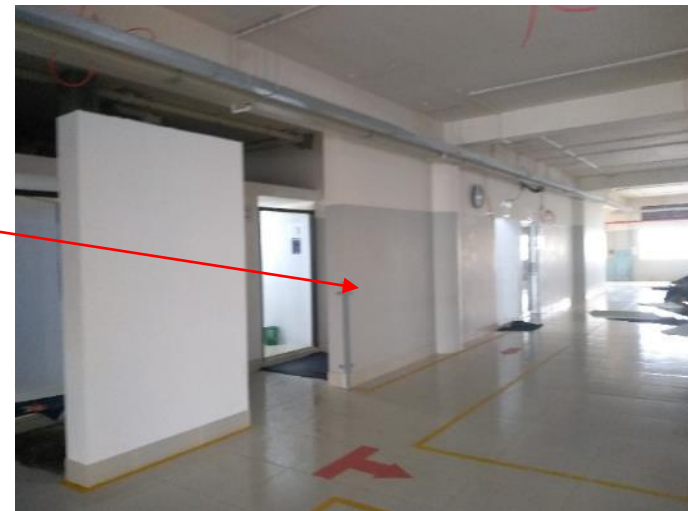
Partition walls at 3<sup>rd</sup> floor

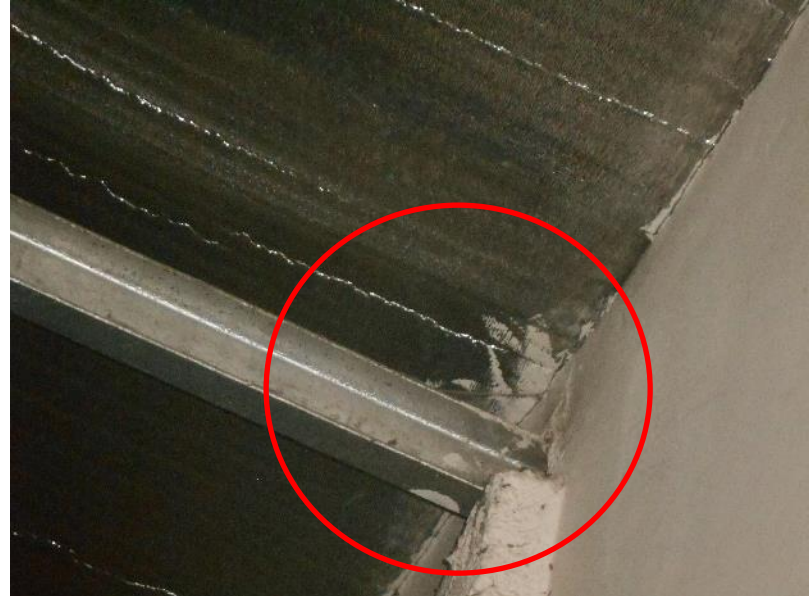
Poor connection details

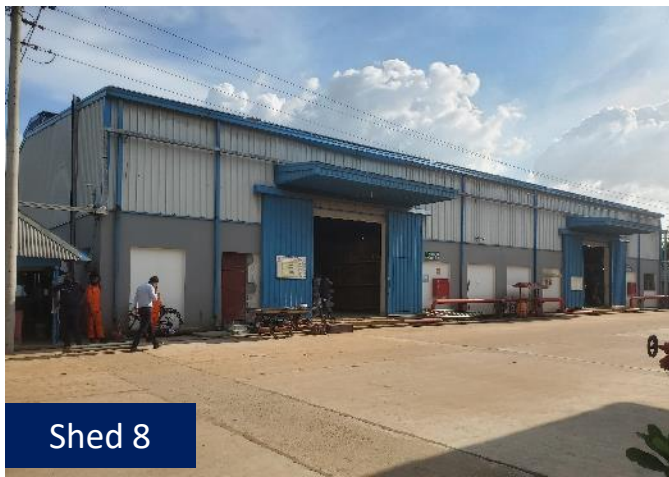
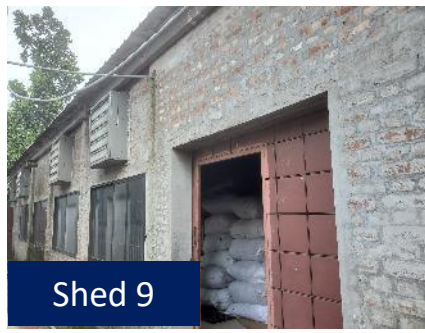
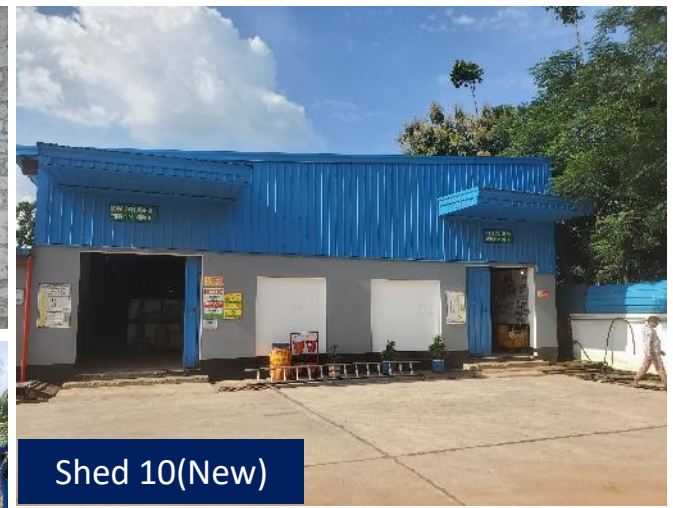
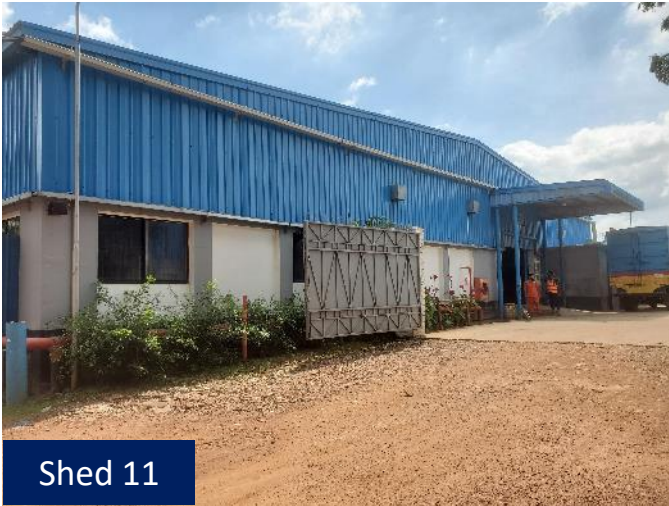
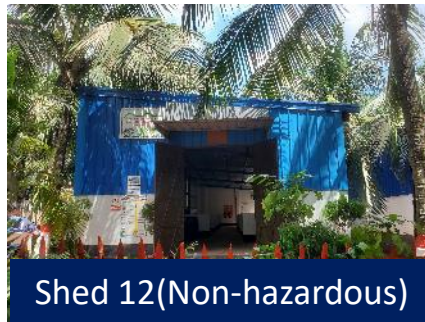
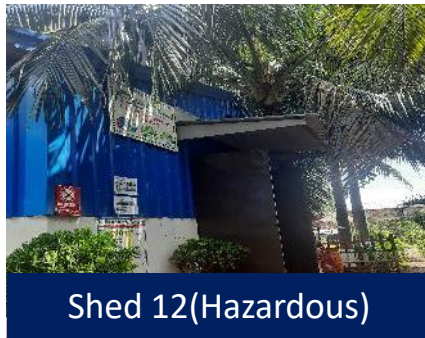
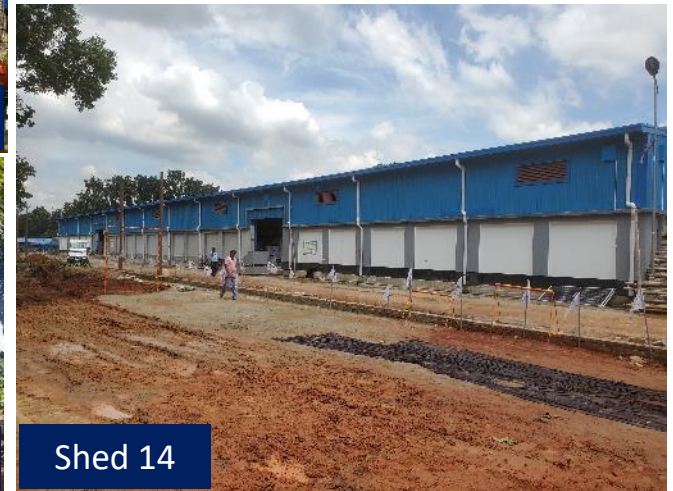
As per BNBC every building or structure designed shall have its design documents prepared in accordance with the provision of Section 1.9.1. The design document shall include a design report, and a set of structural drawings, which shall be prepared in compliance with section 1.9.1.1 and section 1.9.1.2 as per BNBC. During the inspection, design report was not available which is required to be prepared in compliance with section 1.9.1 (part-6, BNBC).

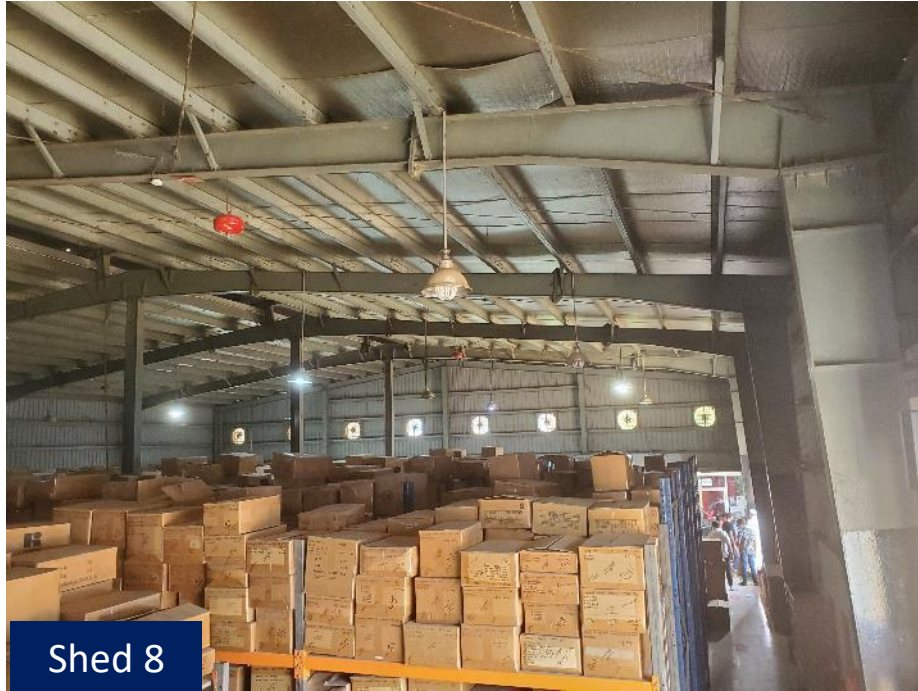
Shed 8

# **Apparently lack of lateral load resisting system**

No compression strut/Load transfer media has been provided in the long direction. Building engineer is required to check the requirement of the any load transfer media in the long direction.

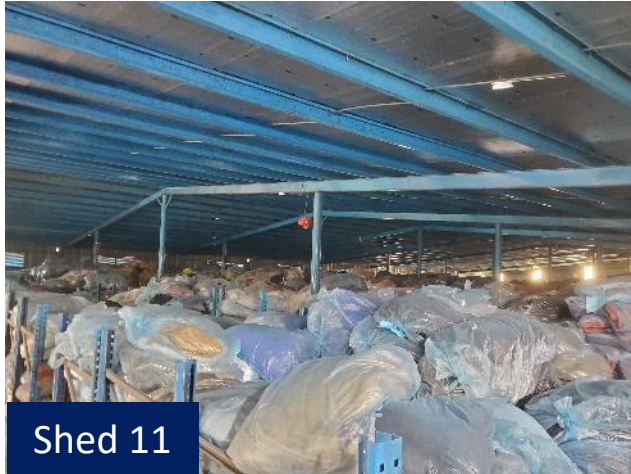
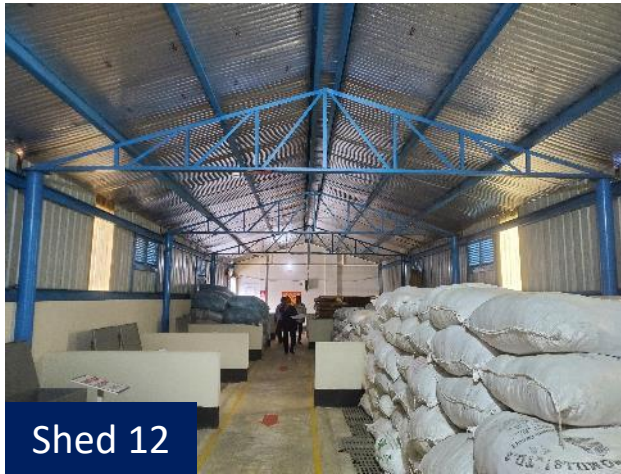
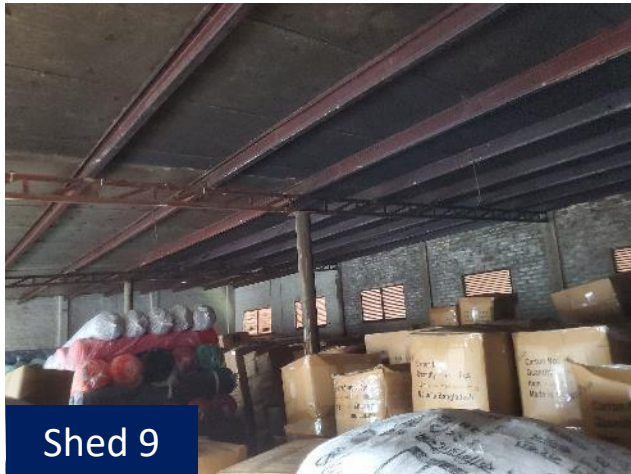
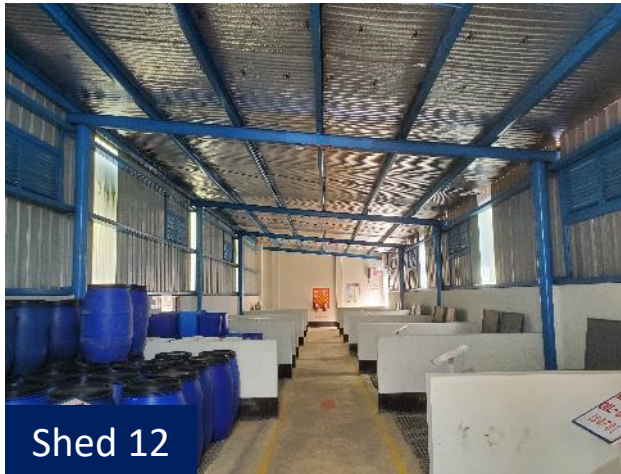
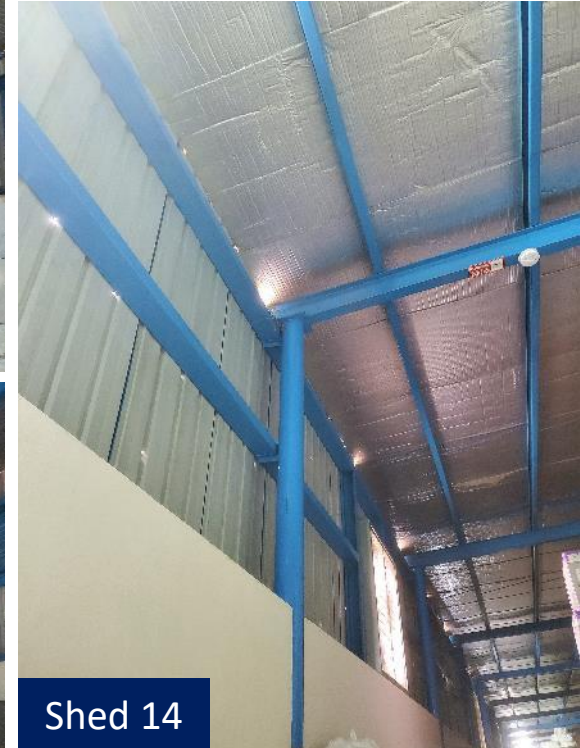
Wall & roof bracings are not provided. Building engineer is required to check the lateral load resisting system of the shed.

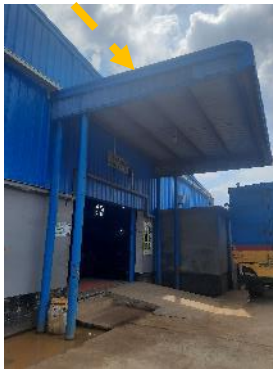
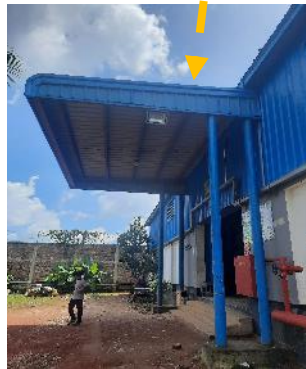
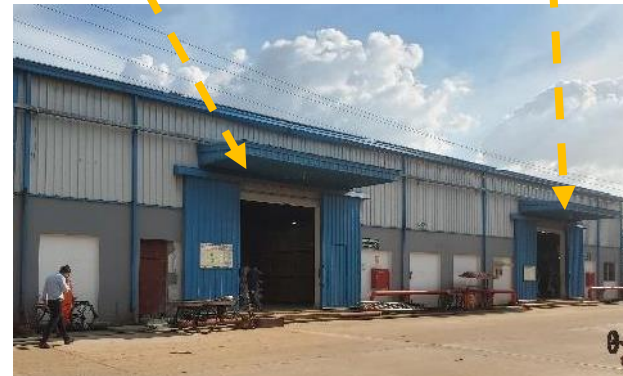
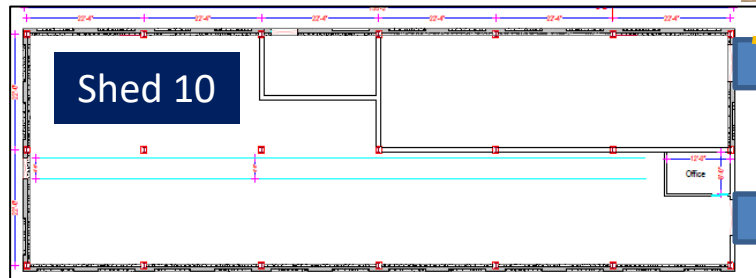
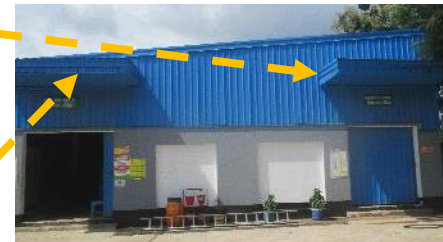
Undocumented canopy at shed 8, 10, 11 & 12.

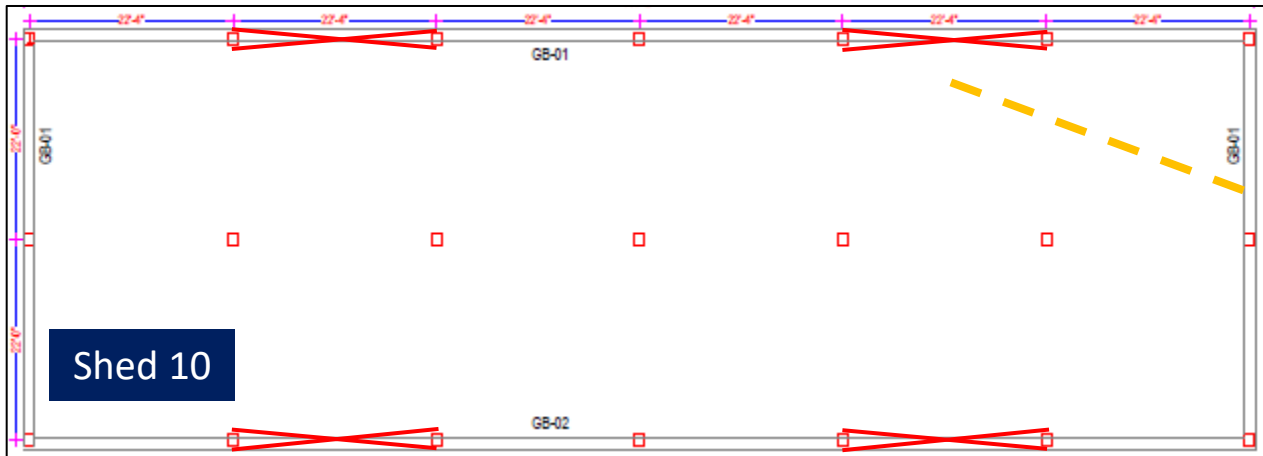
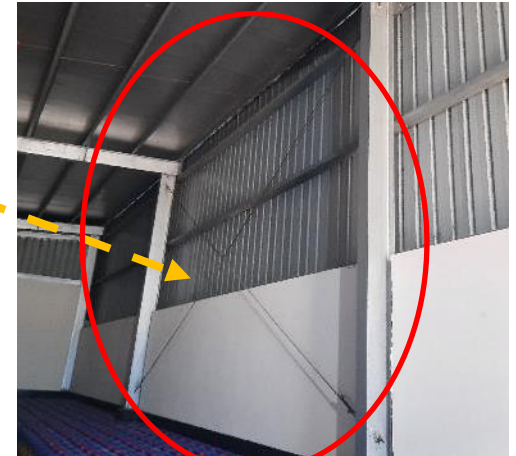
Undocumented wire bracings

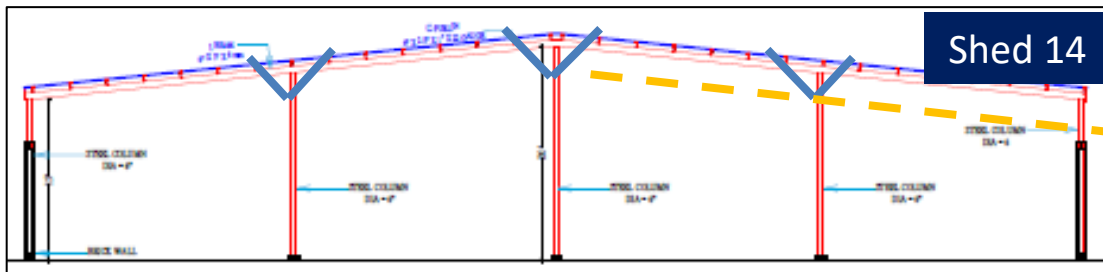
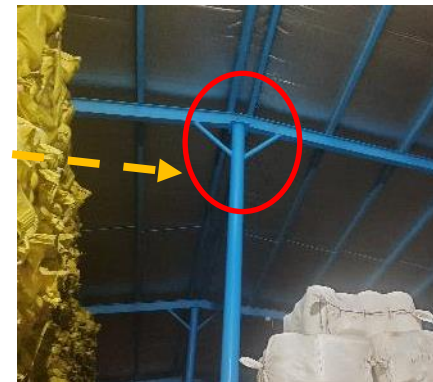
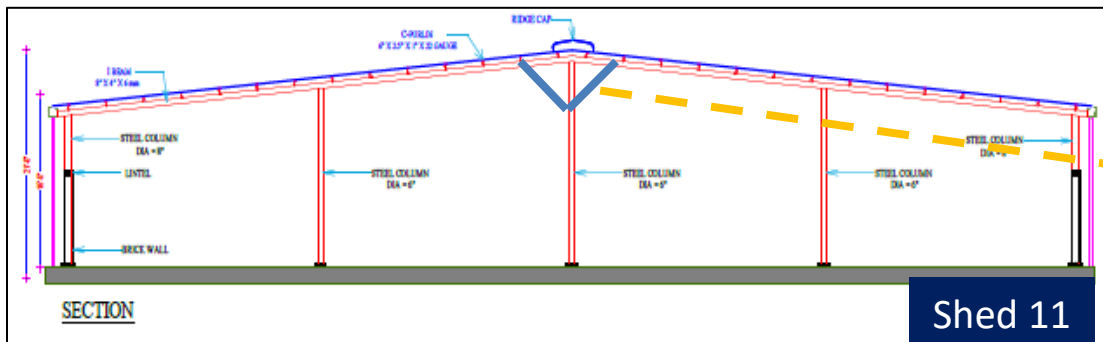
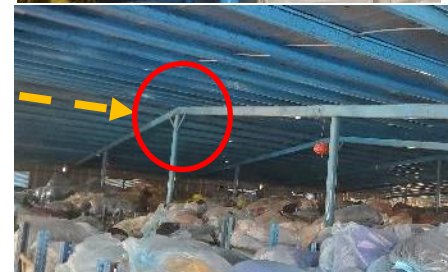
Undocumented knee bracings.

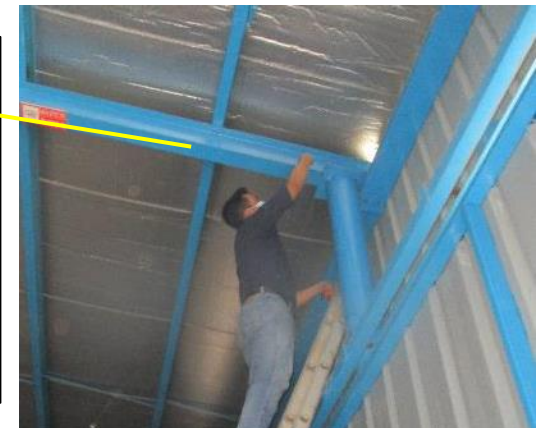
Rafter size found F-100 (5) x W-195(4) instead of F-100 (6) x W-200(6) at shed 11

Similarly, Rafter size found F-100 (6) x W-200(4) instead of F-75 (6) x W-150(6) at shed 14

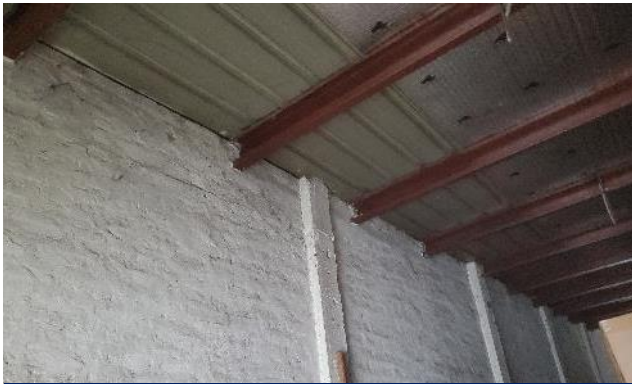
Shed 9

Angle truss and C purlin is embedded in peripheral brick wall

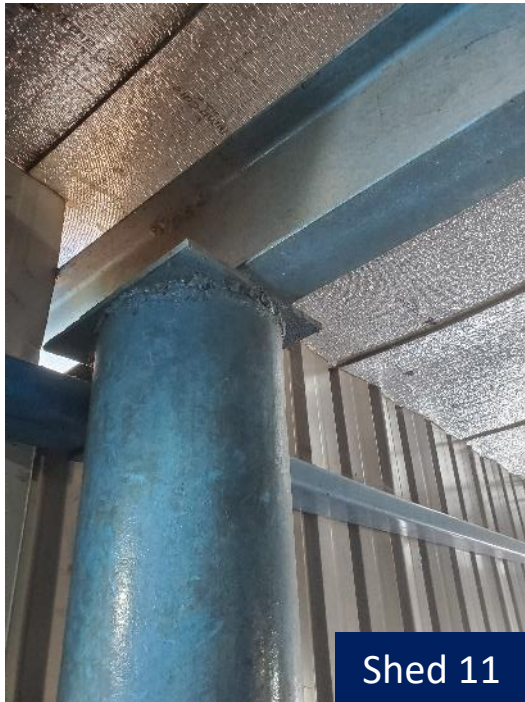
Shed 11

Apparently poor connection details between steel pipe column and roof truss/rafter

The steel roof angle truss and rafter is poorly connected to the steel pipe column (shed 9, 11, 12, 14). Steel pipe column is embedded to RCC short column (shed 9, 11, 12, 14) and there is no visible connection found between steel rack and ground floor slab (shed 8 & 11). As there is no as-built connection drawing found on site, building engineer is required to prepare accurate as-built drawings. Also, it is required to check the connection adequacy as part of Engineering Assessment (EA) Report in compliance with section 1.9.1 as per BNBC.

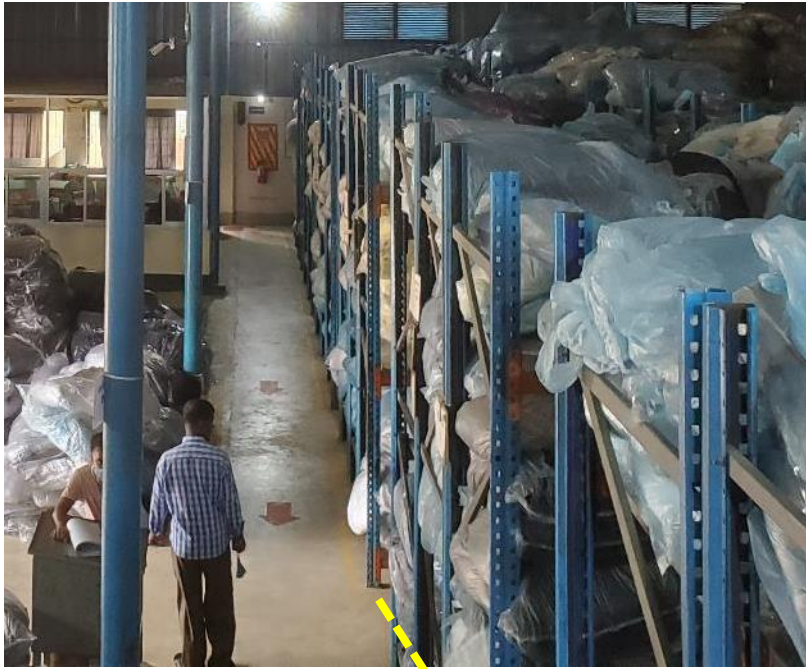
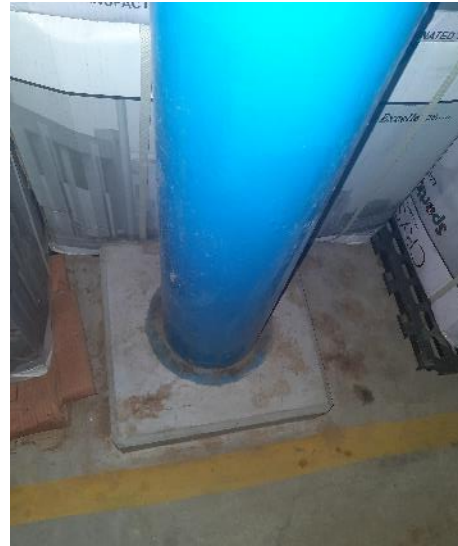
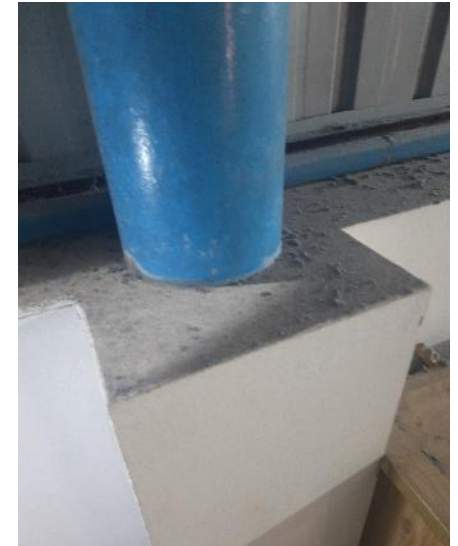
Steel pipe column is embedded to RCC short column at shed 9, 11, 12 & 14

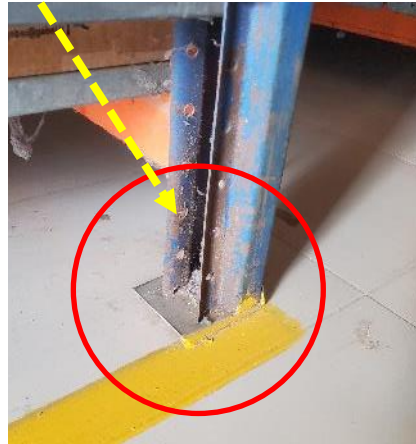
No anchorage found between steel rack and ground floor slab at shed 8 & 11.

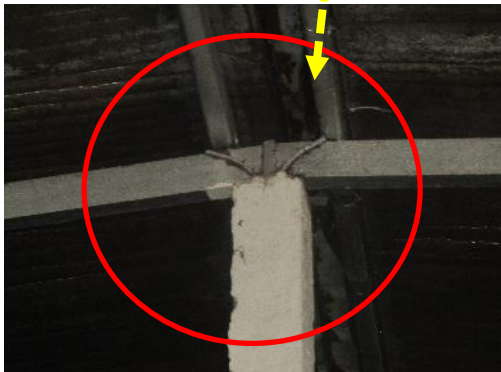
Poor Connection

Apparently inadequate steel members,  
Poor connection details and no clear/defined load path observed.  
Seemingly non-engineered shed.  
Building engineer is required to check  
the stability of the shed or replace by an  
engineered structure.
