# Denim Asia Limited (Extension Building)

Ratanpur Road, Taltola Shafipur, Kaliakair, Gazipur, Bangladesh  
(24.0341, 90.2792)

21<sup>st</sup> September 2021

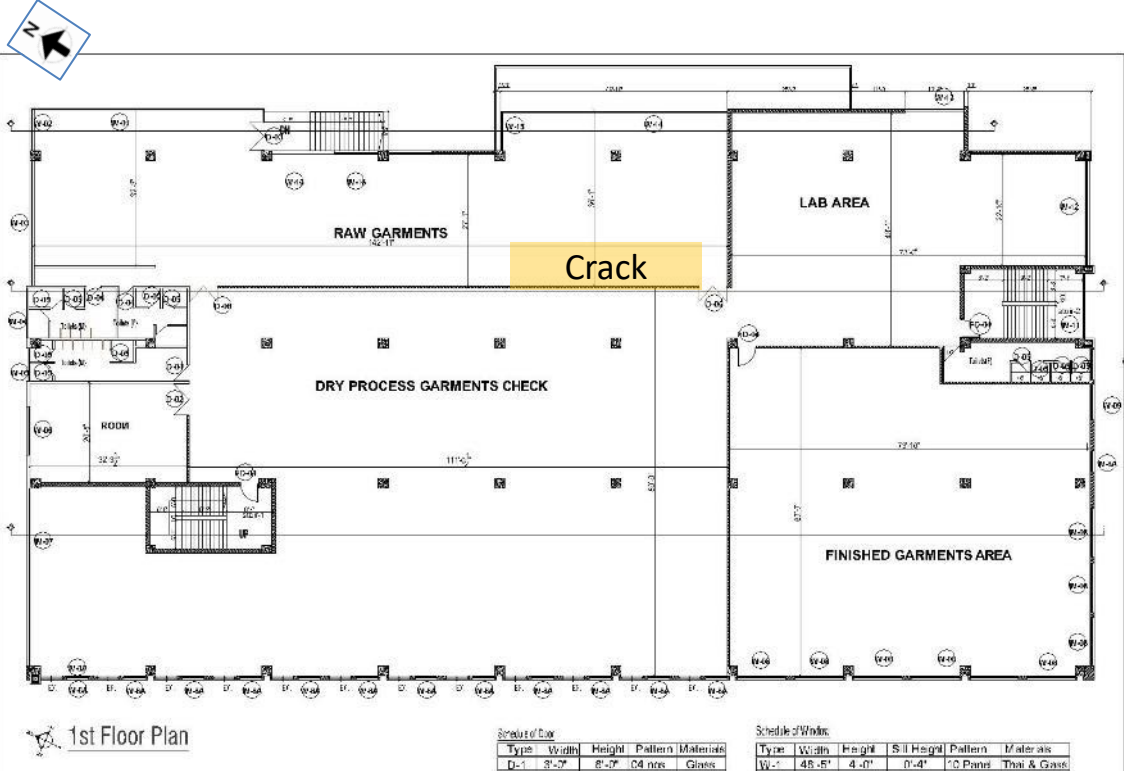
1<sup>st</sup> floor layout plan

# Cracks on 1<sup>st</sup> floor slab soffit

**Observation: Building 1**

Crack observed on 1<sup>st</sup> floor slab soffit. Building engineer is required to check the reason, determine the extents of crack and prepare an investigation report with remedial actions.

| Item No. | Observation | Recommended Action Plan | Recommended Timeline |
|---|---|---|---|
| 01 | Cracks on 1st floor slab soffit. (Building 1) | Building engineer is required to check the reason, determine the extents of crack and prepare an investigation report with remedial actions. | 6-weeks |
| 02 | Cracks on 1st floor slab soffit. (Building 1) | Check whether any settlement issue arises. | 6-weeks |
| 03 | Cracks on 1st floor slab soffit. (Building 1) | Carryout remedial works where necessary | 6-weeks |

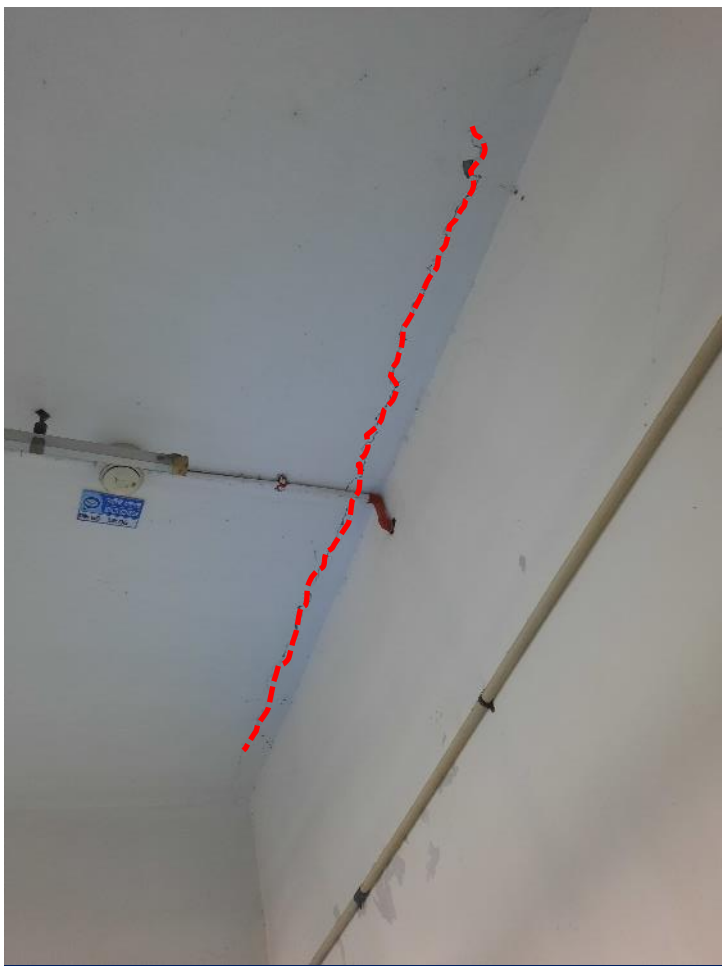
Crack on 1<sup>st</sup> floor Slab Soffit

Item 01: Cracks on 1<sup>st</sup> floor slab soffit.

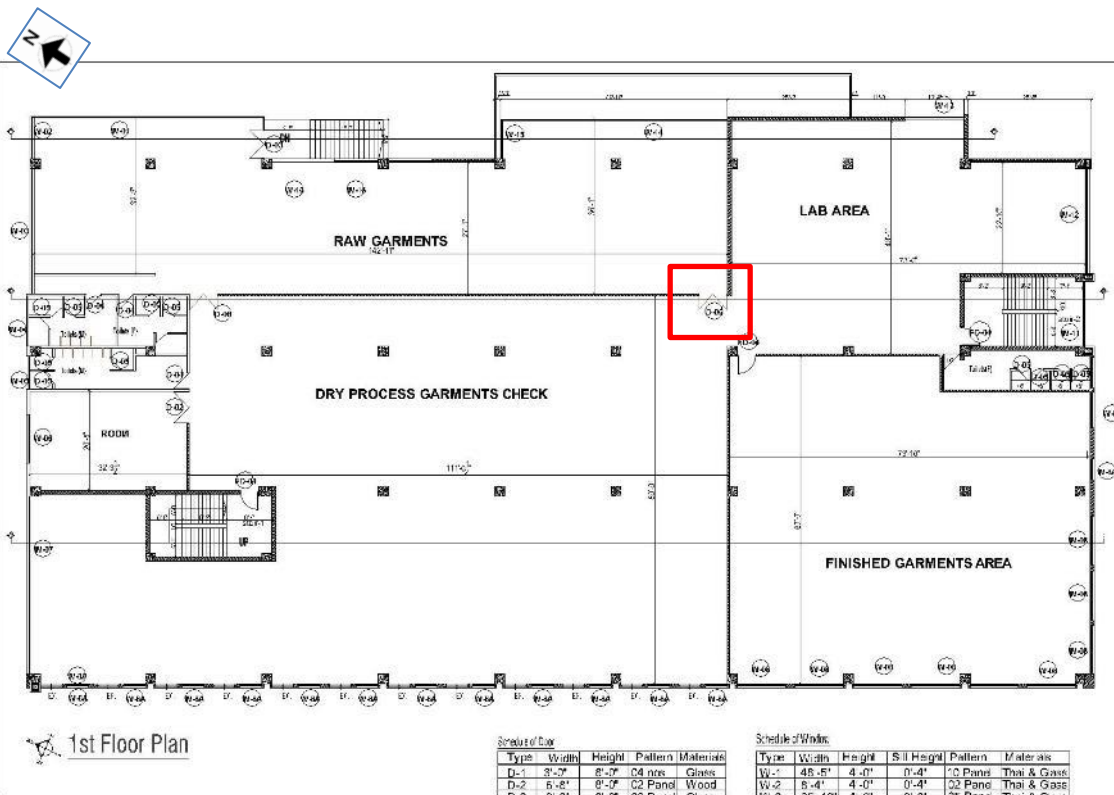
1<sup>st</sup> floor layout plan

# Unrestrained brick walls

Unrestrained brick wall observed on 1<sup>st</sup> floor. Building engineer is required to provide temporary support to the unrestrained walls and suggest appropriate remedial measures.
