Cotton Field (BD) Ltd (Relocated)

Plot- 42/3, Rajnagar, Sataish Road, Tongi, Gazipur
(23.920396N, 90.363708E)
28th September 2021

Observations

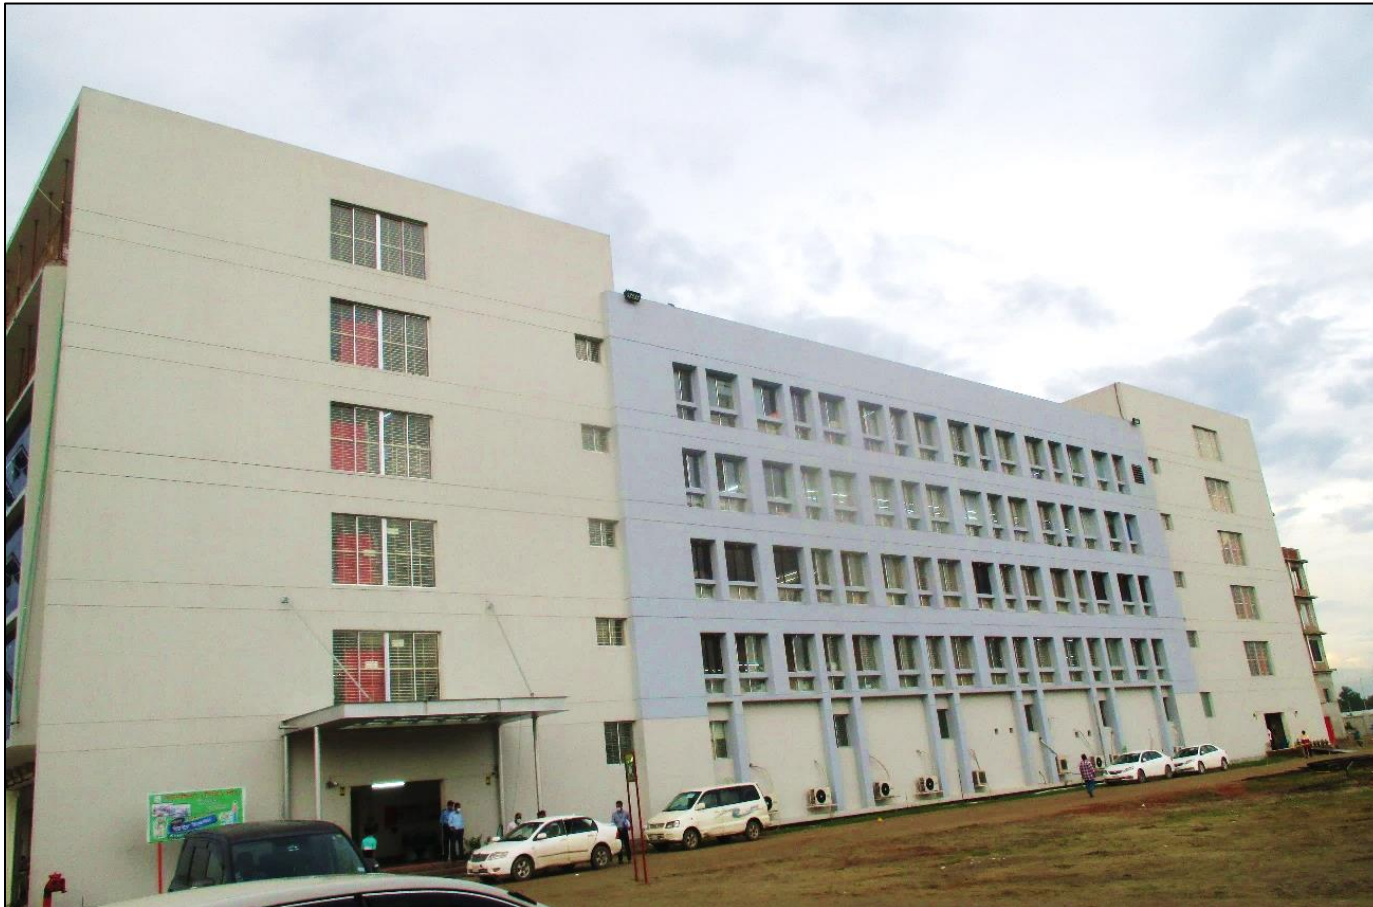
Lower Factor of safety of pile foundations

Factor of safety for Pile foundations at grid 1G, 1H, 2C, 2E, 2G were found below 2.50. In the DEA report their no recommendation for those pile foundations.

The factory engineer is required to check the foundation adequacy and suggest proper remedial actions accordingly.
