# MM Knit Wear (Extension Buildings)

Ambagh Road, Konabari, Nilnagar, Gazipur

8 June, 25 August & 6 September 2021

# Observations

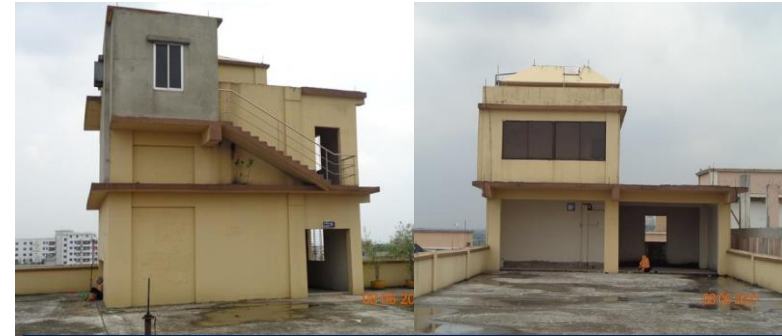
OHWT Loading

Cursory calculation indicates that columns are stressed above normal design limit considering observed 2 kPa live load and equivalent concrete strength (11.87 Mpa) based on core test results. Factory engineer is required to review design, load & column stresses of the building.

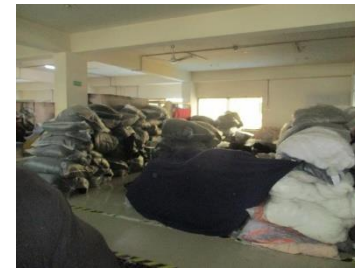
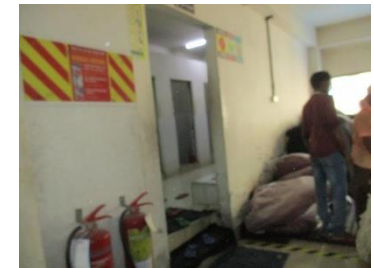
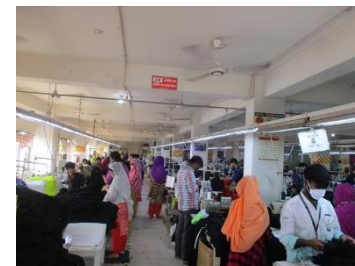
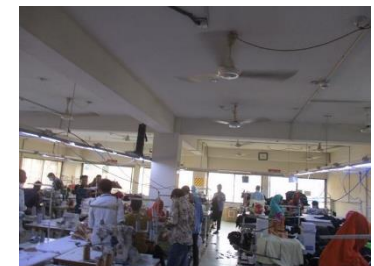
Floor Loading

Cursory calculation indicates that footings are stressed above normal design limit considering observed live load (2 kPa), equivalent concrete strength (17.17 MPa) based on core test results and ultimate soil bearing capacity 7.5 ksf (359.1 kN/m<sup>2</sup>). Factory engineer is required to review design, load & footing stresses of the building and suggest remedial actions accordingly.

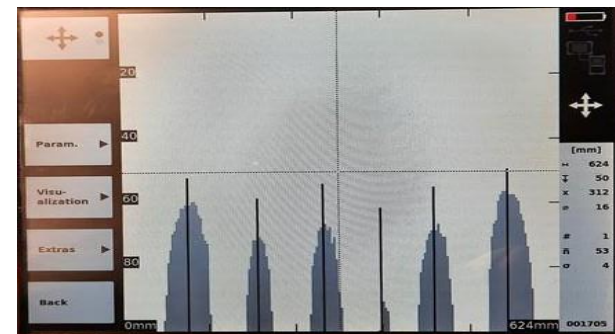
Rebar Scan Image (C4 column)

Rebar number of interior column, (C4 type) was found less than mentioned in column schedule. On long face, the number of rebar was found 6 instead of 7.

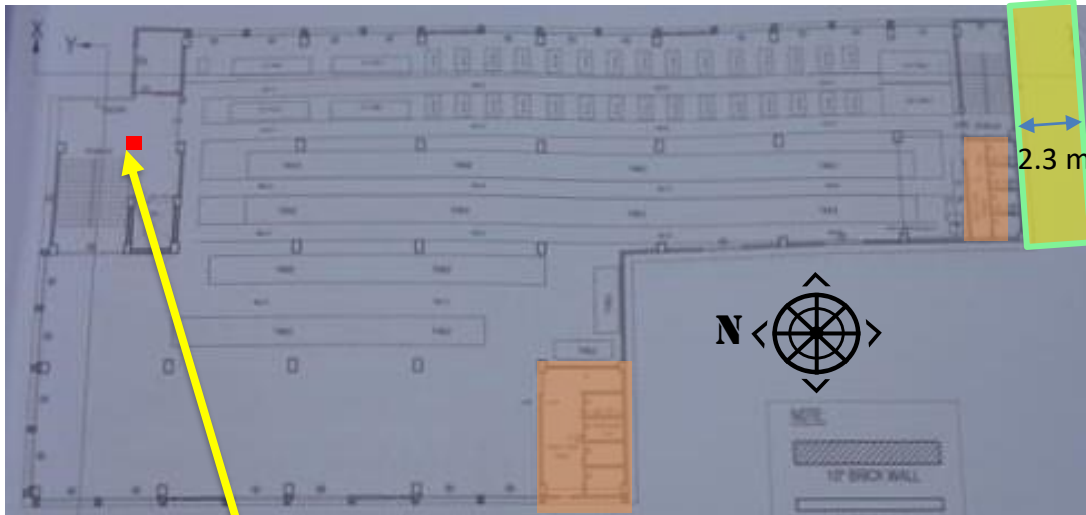
Cantilever portion at north side -Not shown in drawing

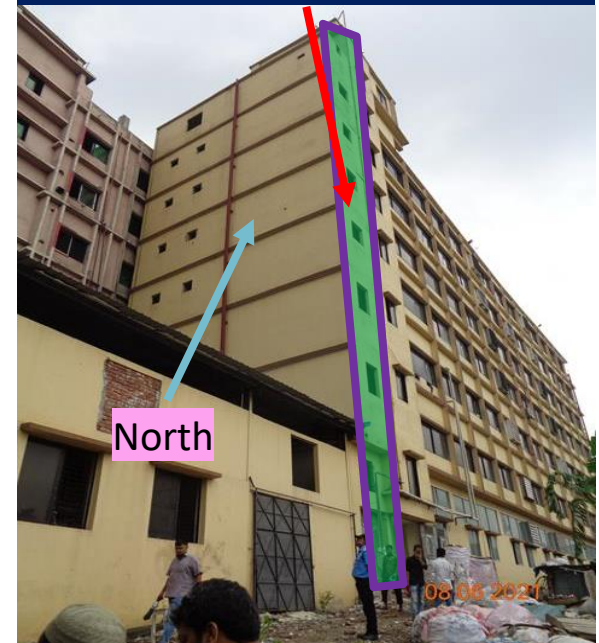
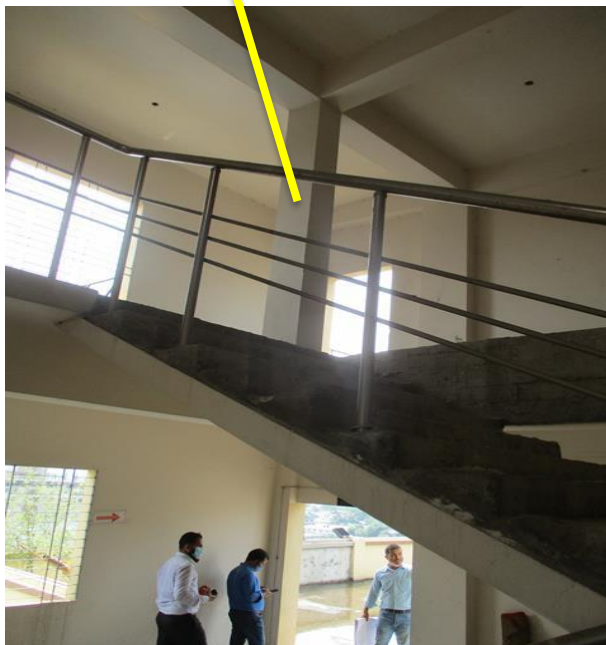
Discontinue column at stair roof

350 ~ 375 mm floor buildup not mentioned in drawing

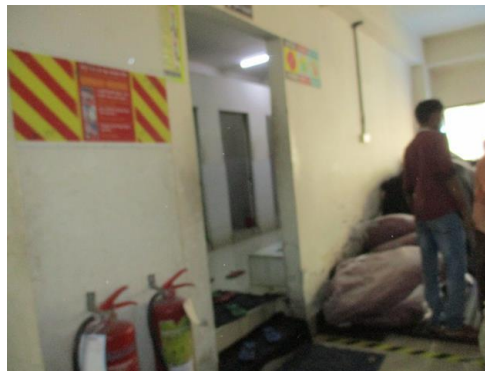
350 ~ 375 mm build-up on typical floor toilet block

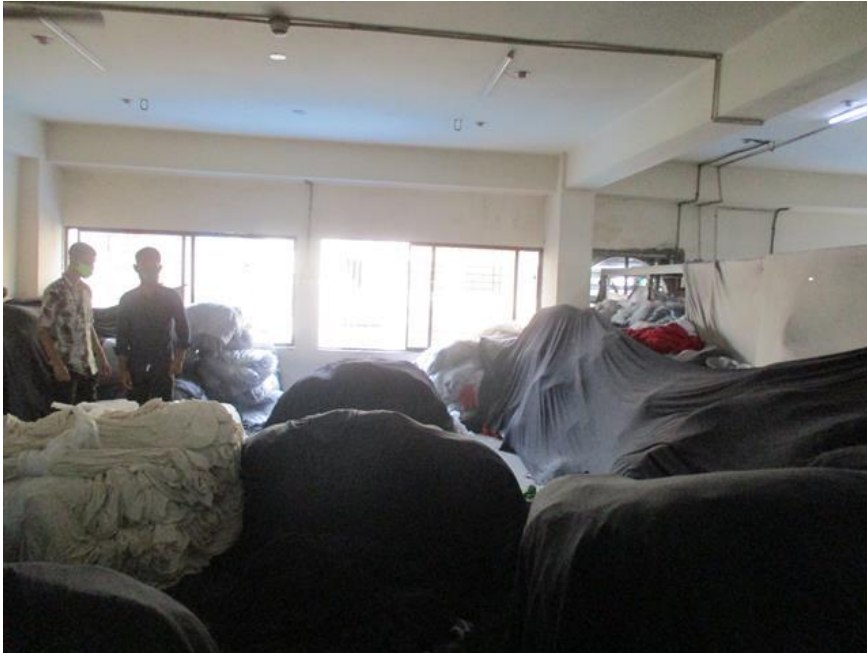
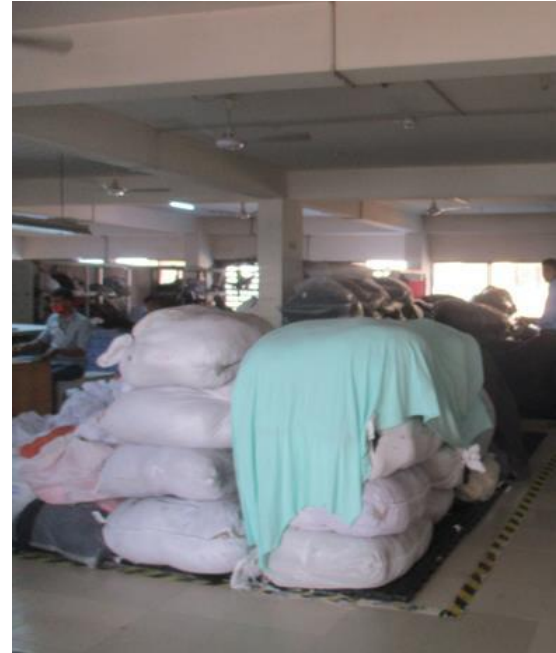
Uncontrolled loading on 5th floor storage areas

Load plan of the building was not produced. Also, load management program was not implemented. Produce and actively manage a loading plan for all floor plates within the factory considering the floor capacity and column capacity.

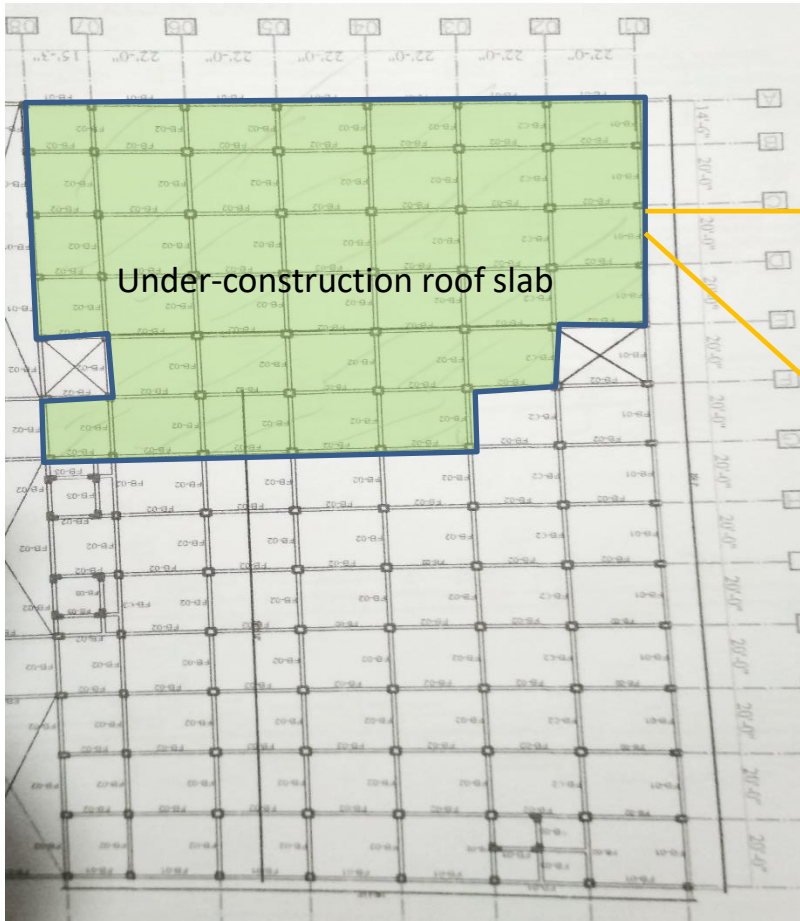
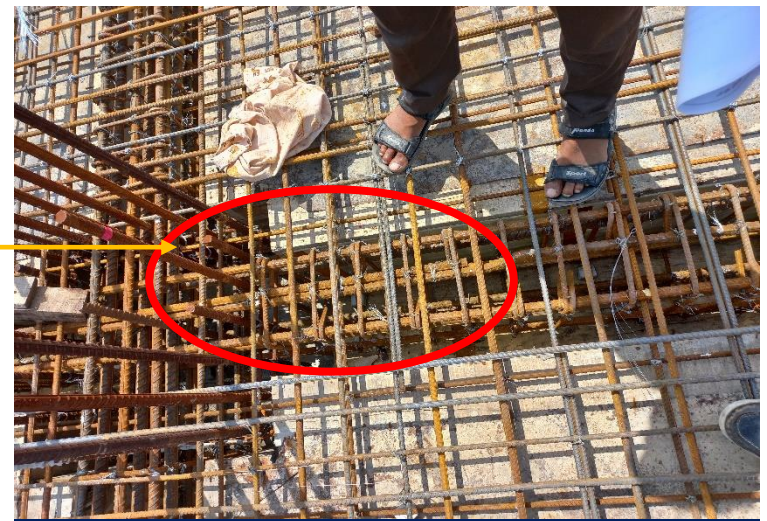
Top bar splice near support/column

Splice of rebar is places in tension zone of beams at several locations. That does not comply with the seismic detailing requirements. The factory engineer is required to check the seismic detailing in the design report.

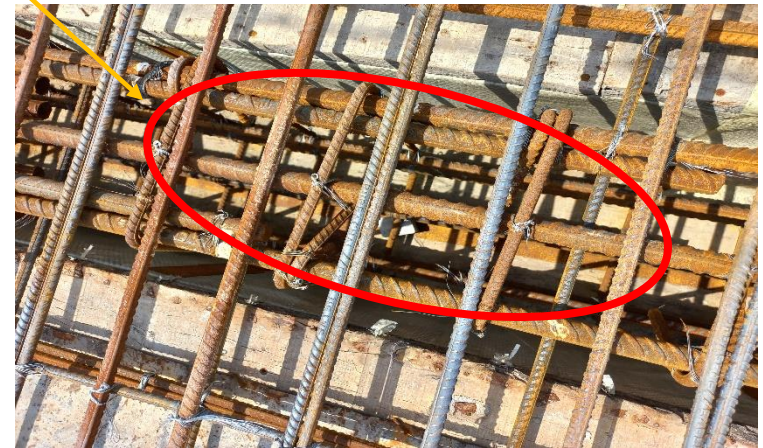
Bottom bar splice at mid span of beam

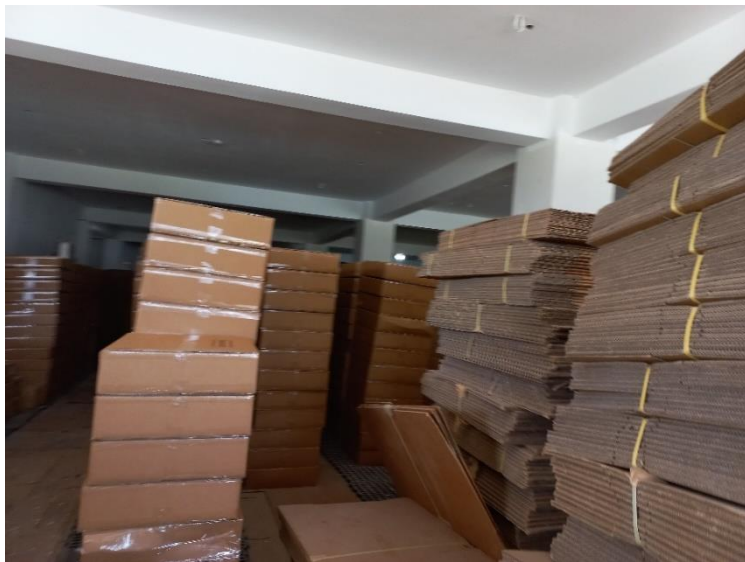
Uncontrol loading on floor

Load plan of the building was not produced. Also, load management program (load plan posting, stack height restriction and signage) was not implemented. Produce and actively manage a loading plan for all floor plates within the factory considering the floor, column and foundation capacity.

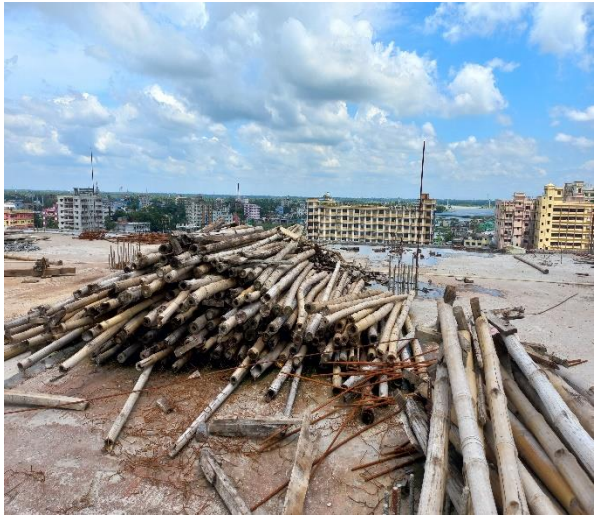
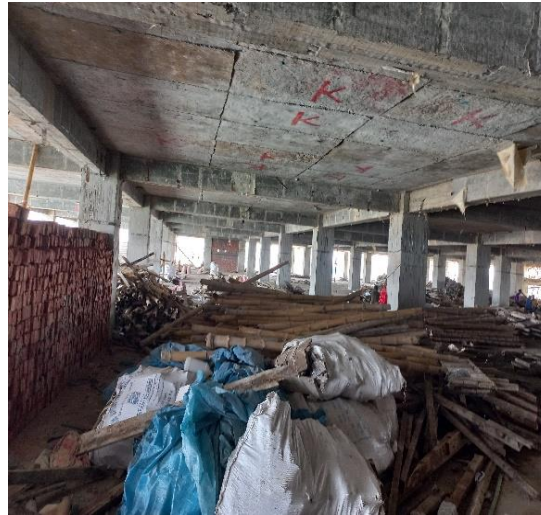
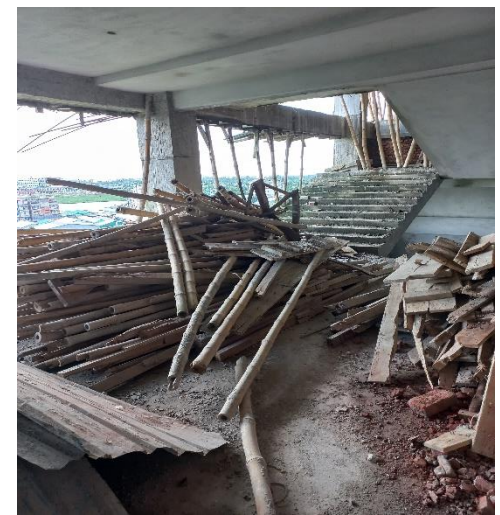
# **Construction debris and exposed rebar**

The construction debris at different floor should be removed.

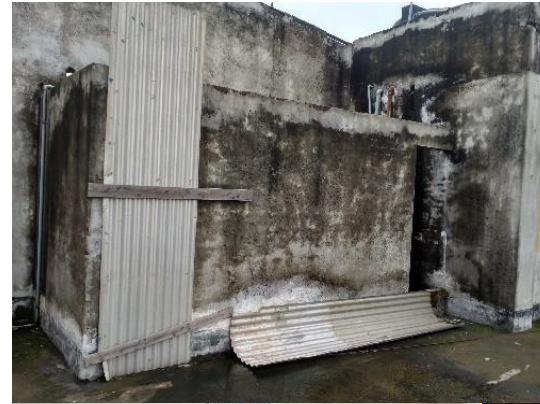
Toilet zone with 325 mm floor buildup

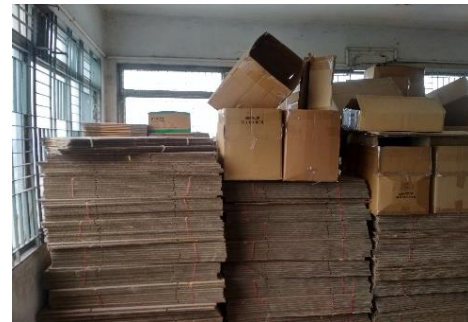
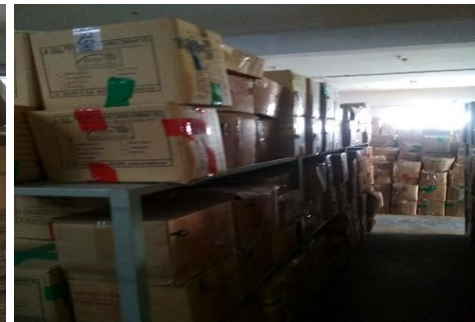
Uncontrolled floor Loading

The floor live load at marked zone at all floor level must not exceed 2 kPa until a Details Engineering Assessment is completed.

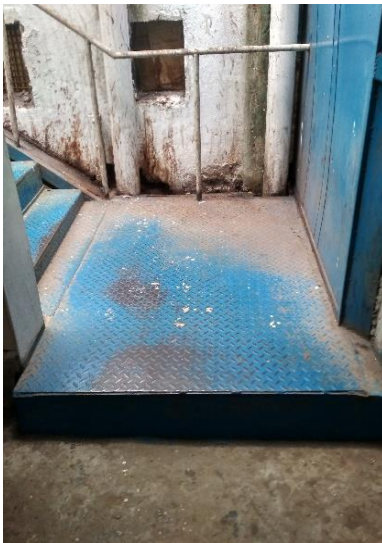
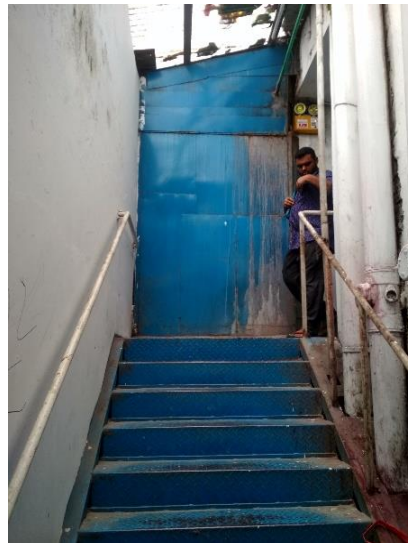
Steel stair

An undocumented steel stair was found at 6<sup>th</sup> Floor of building-6. This structure bridged the Building-2 and Building-6.

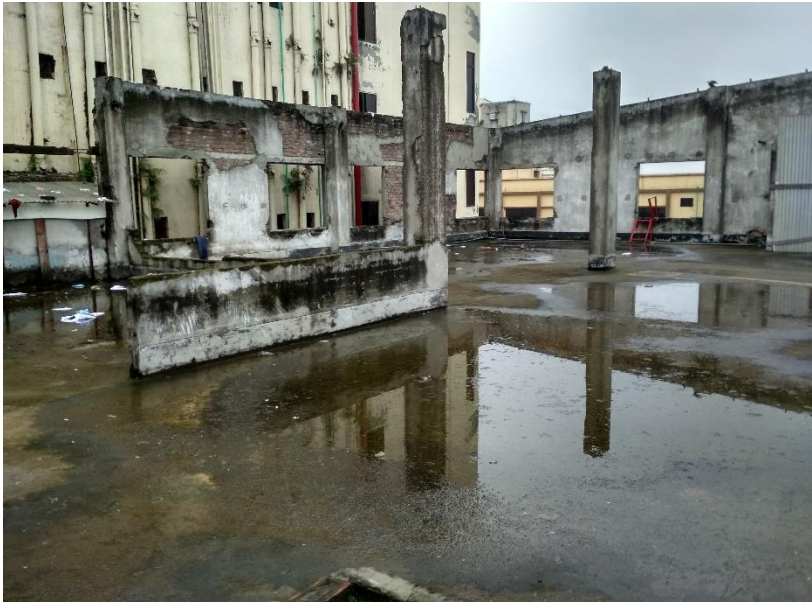
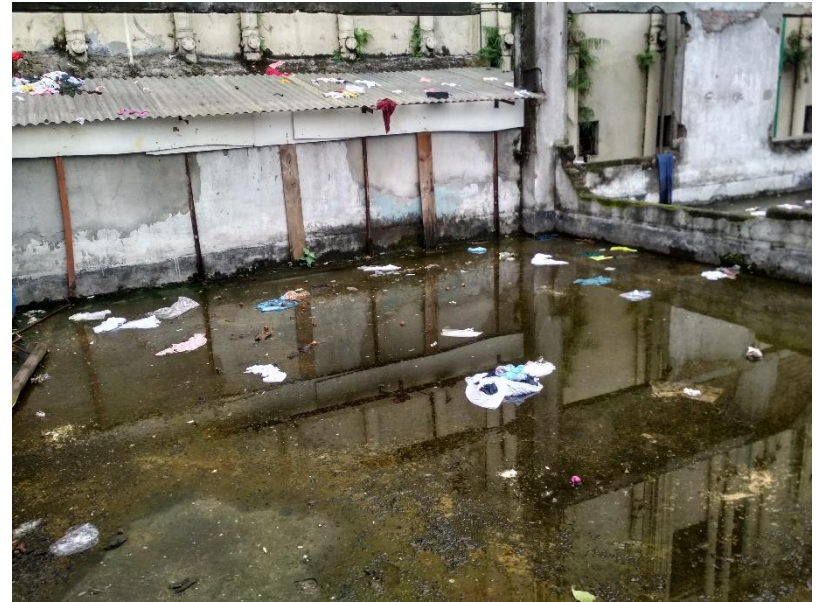
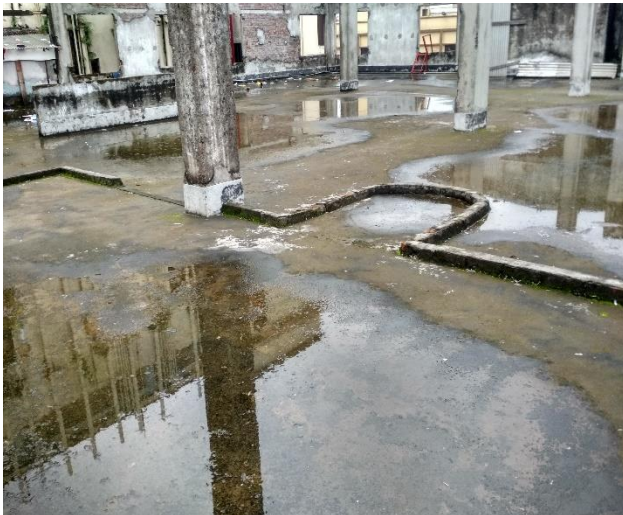
## Water ponding on roof

Stagnant of water

Factory is required to water proofing compound and develop proper drainage system on roof with adequate slope to resist water ingress to slab.

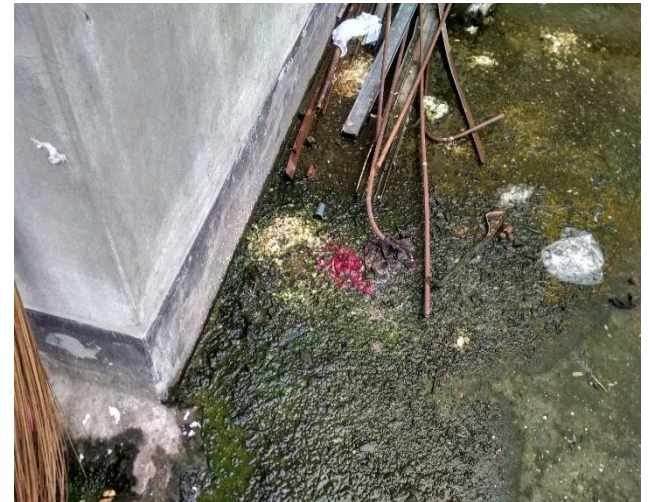
Vegetation

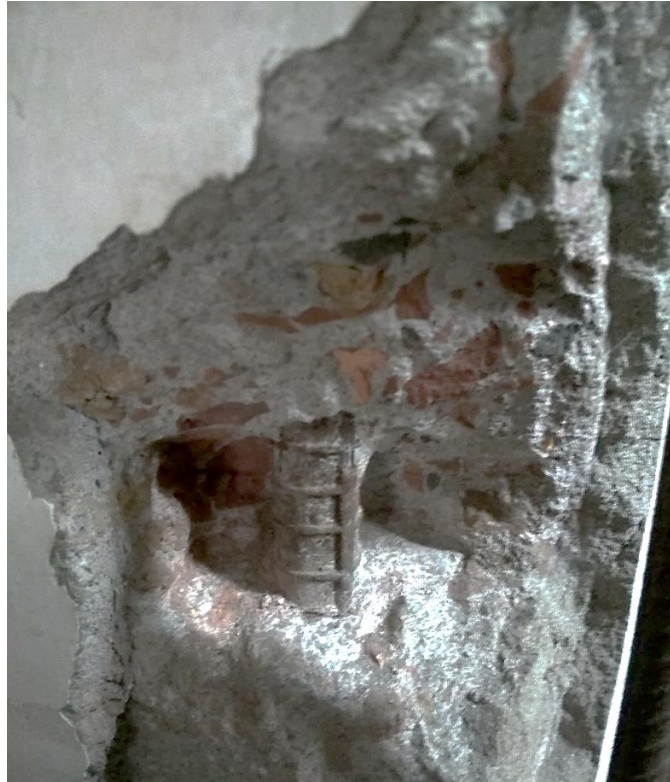
## **Exposed rebar of column**

Rebar exposed to check its diameter  
but not covered.

The factory is required to cover the rebar with proper concrete materials.

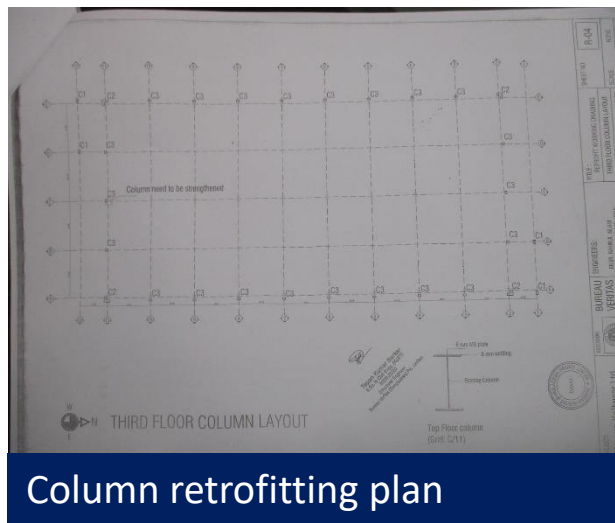
Column retrofitting plan

A set of retrofitting drawings & material test reports were available on site but there were no soil test report and design report available.

As per BNBC, every building designed shall have its design documents prepared in accordance with the provision of Section 1.9.1. The design document shall include a design report, and a set of structural drawings, which shall be prepared in compliance with section 1.9.1.1 and section 1.9.1.2 as per BNBC. However, before starting any remedial action, the factory is required to submit the design report and retrofitting scheme to RSC for review.

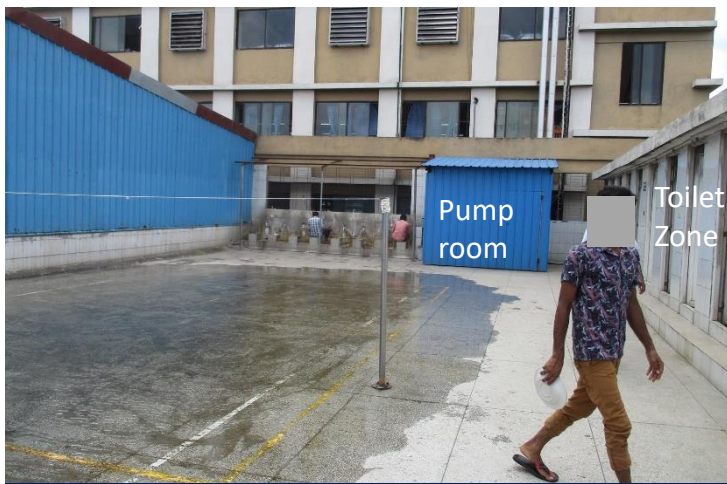
Roof extents

At open area of the roof, undocumented toilet zone & wash space with floor built-ups and pump room with lightweight steel shed was observed.

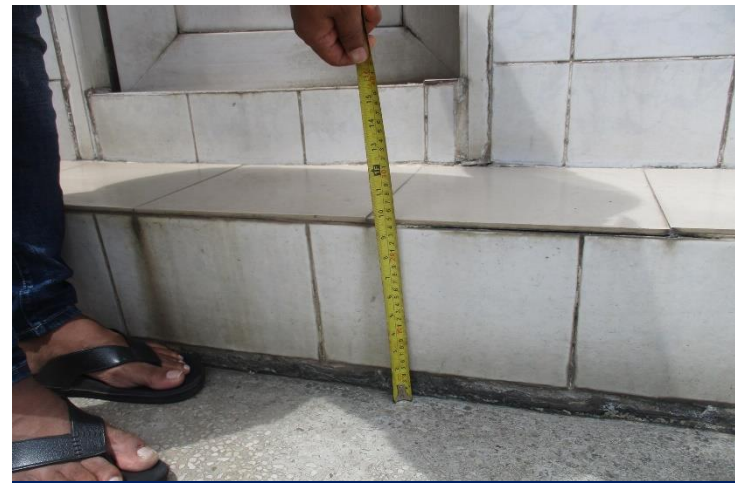
350 mm built-ups at rooftop toilet zone

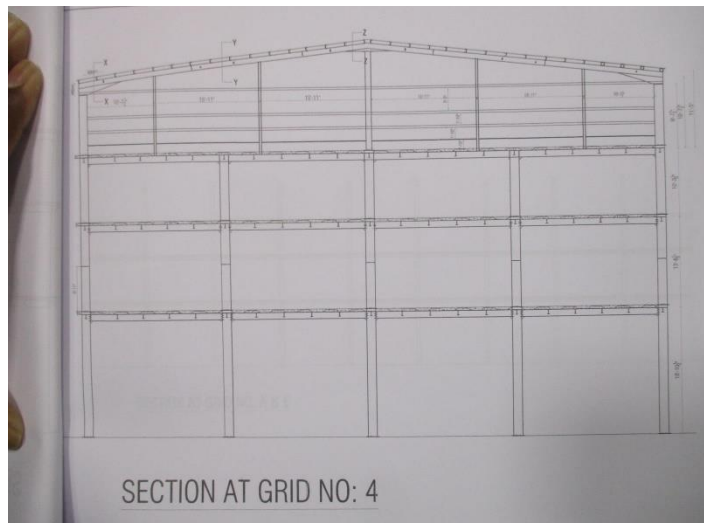
Steel pipe column in grid- 4

Size of steel pipe column in grid- 2, 3 & 4 has not mentioned in the drawings. The factory is required to survey the structure and update the as-built drawings accordingly.

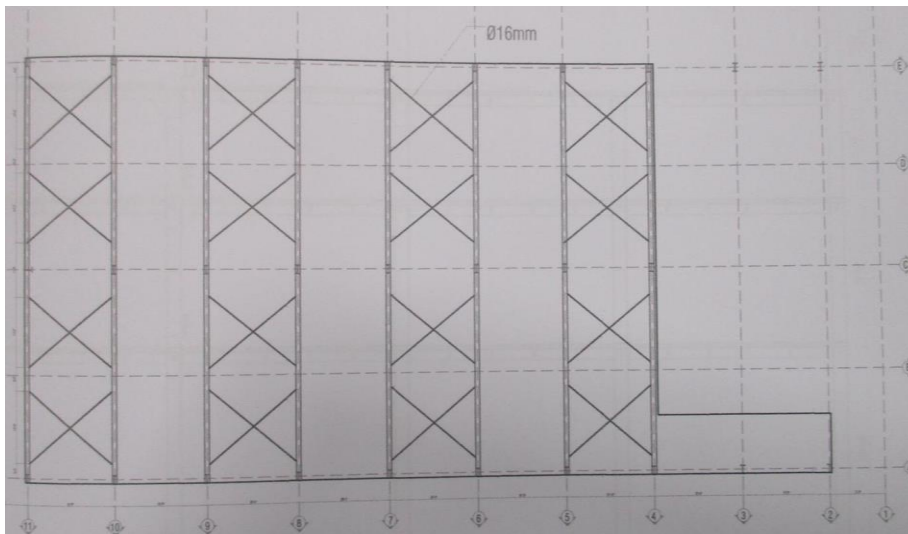
Bracing layout

No compression member at the roof and lateral load transfer media is absence. The factory is required to determine the size, position of load transfer media and install accordingly.

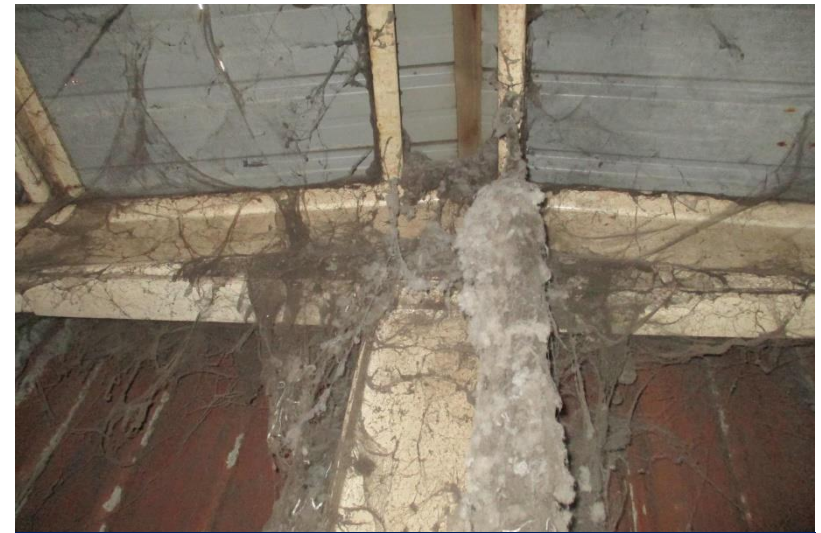
No compression member at ridge

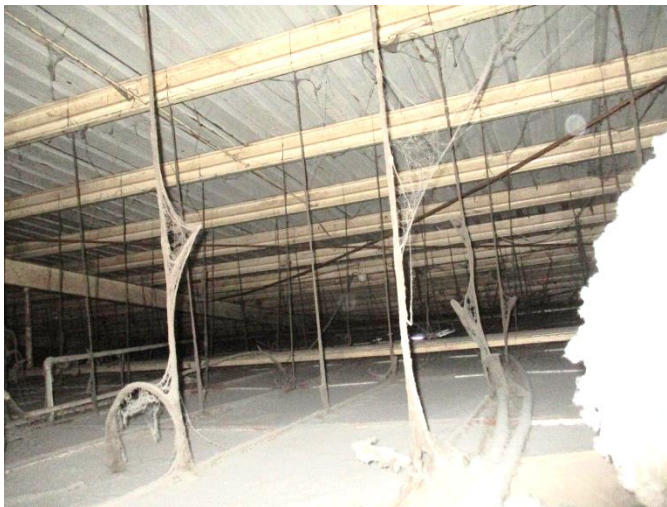
Cable bracing at roof

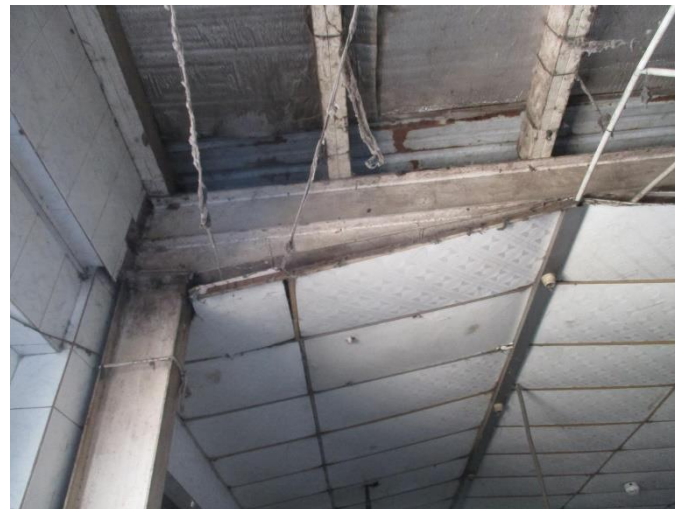
No compression member at eave

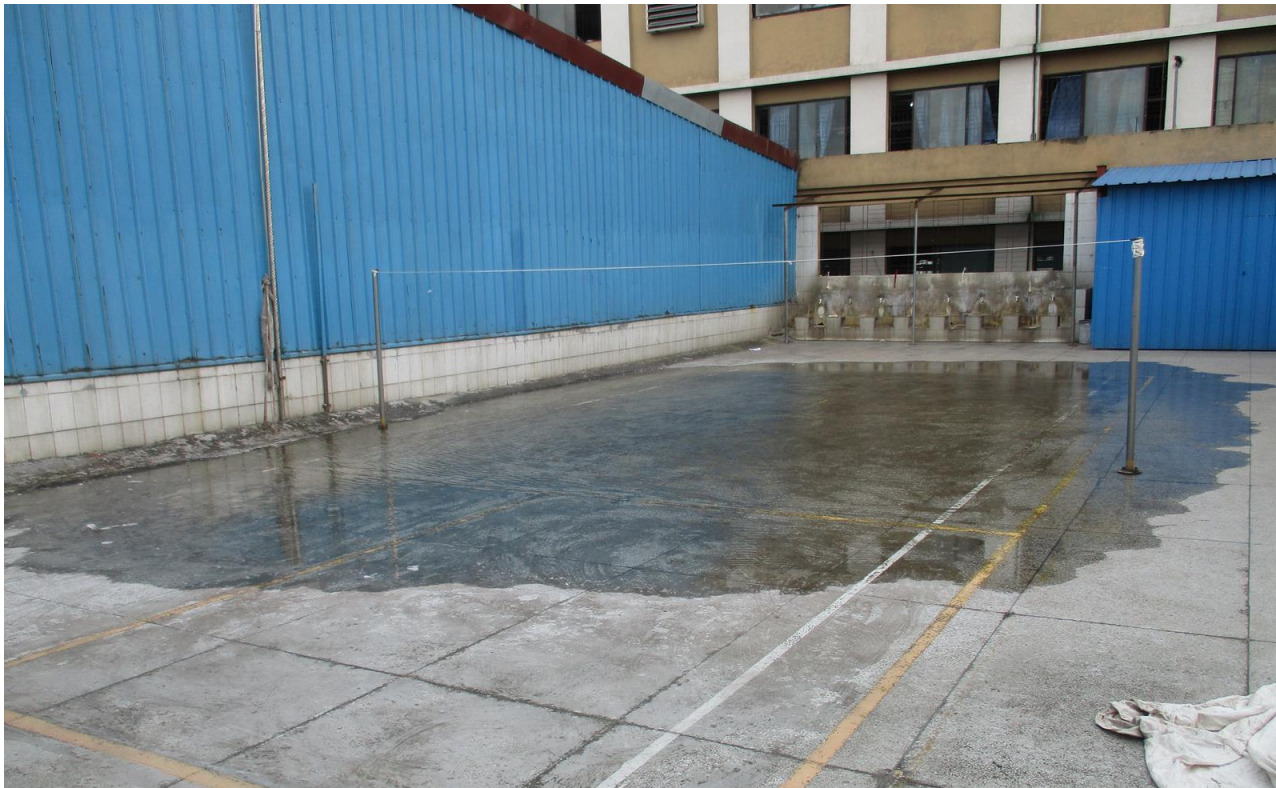
Stagnant water on the open roof area.

Factory is required to develop proper drainage system on the roof with adequate slope to resist water ingress into the concrete slab.

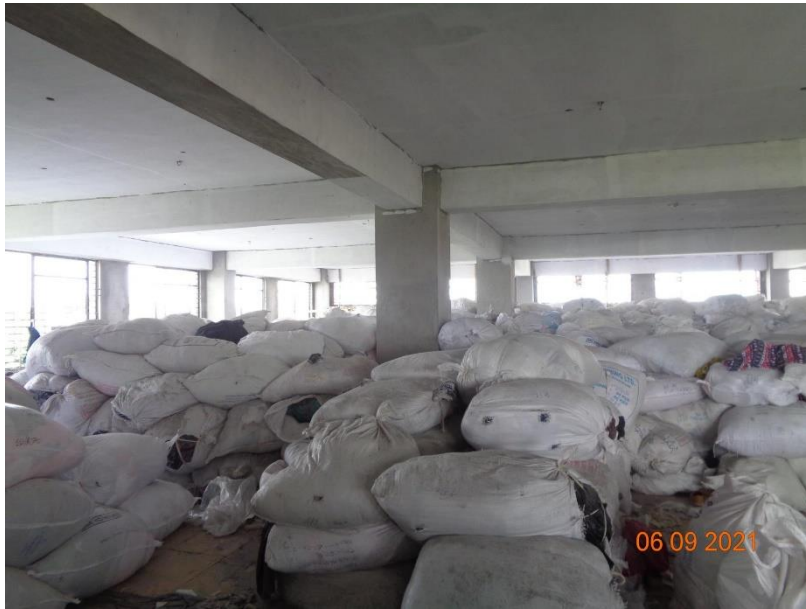
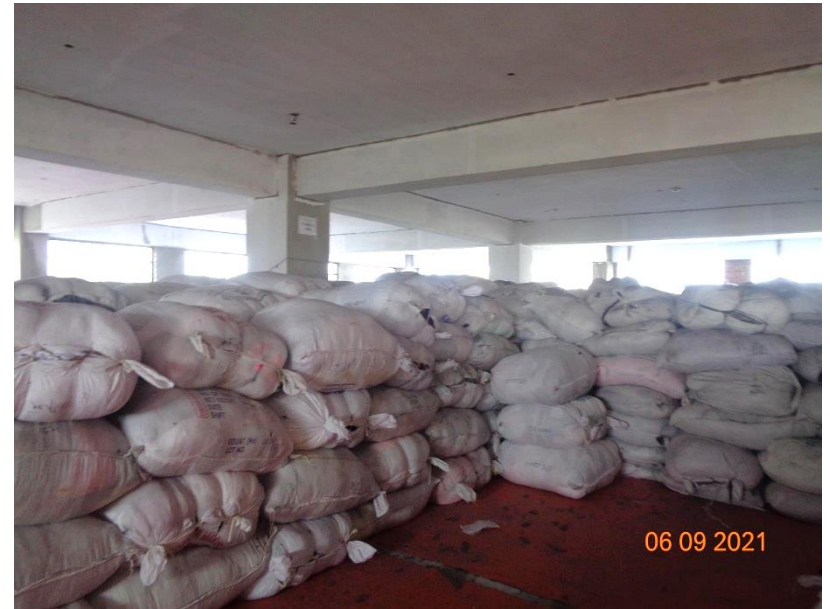
4 kPa floor live load on typical floor

Load plan of the building was not produced. Also, load management program (posting load plan, stack height marking and signage) was not implemented. Produce and actively manage a loading plan for all floor plates within the factory considering the floor and column capacity.

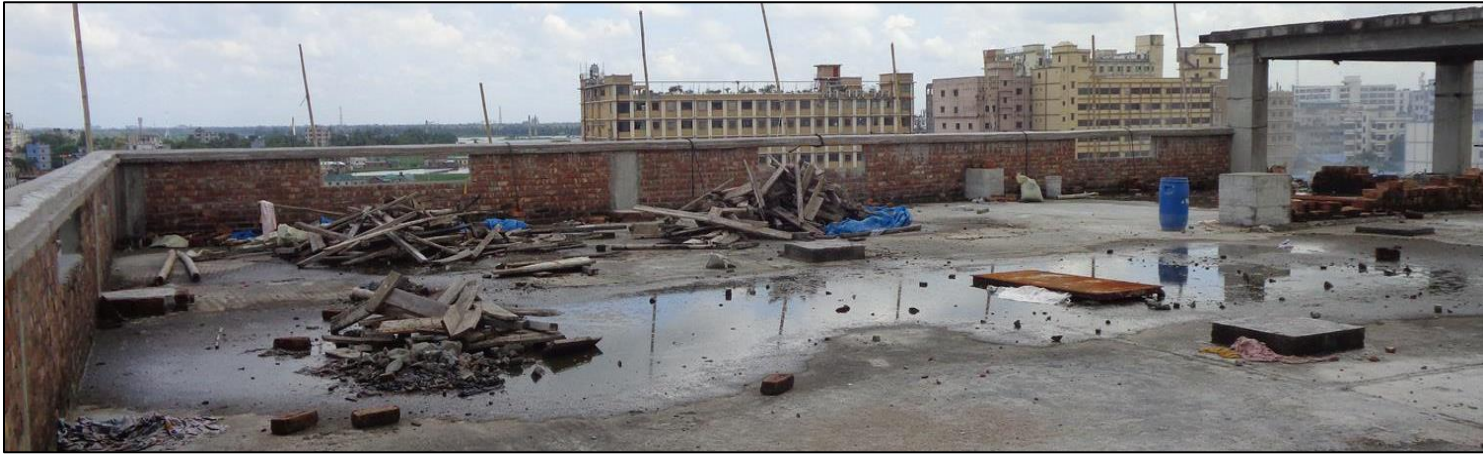
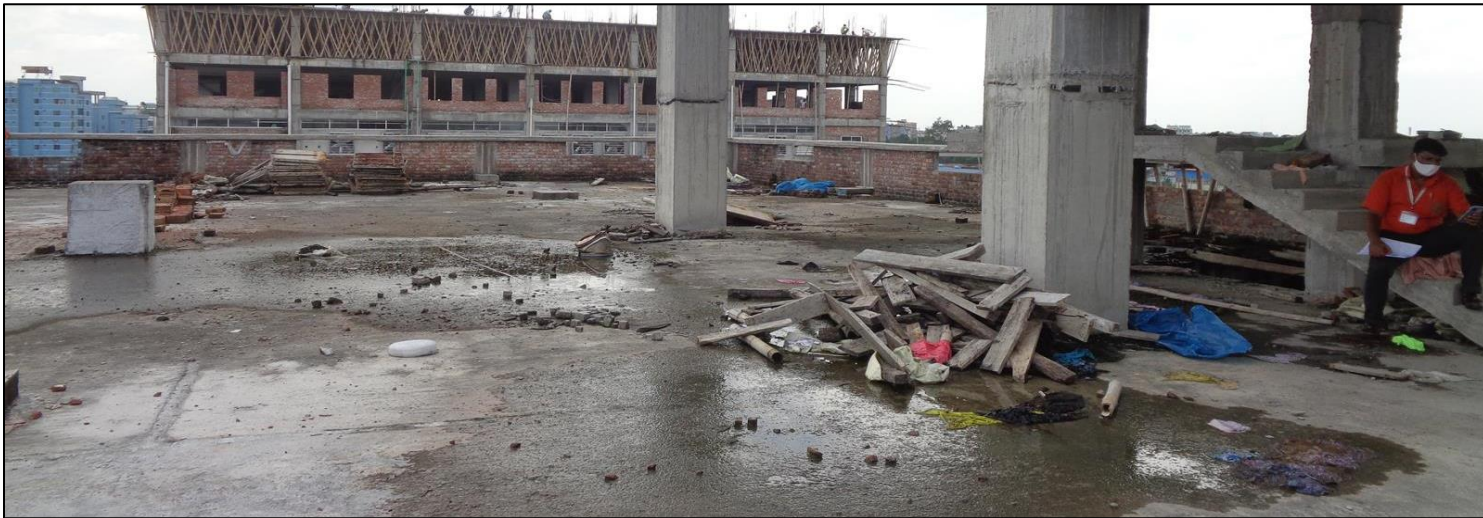
**Water ponding on roof**

Factory is required to develop proper drainage system on roof with adequate slope or apply water proofing compound on roof slab to resist water ingress.

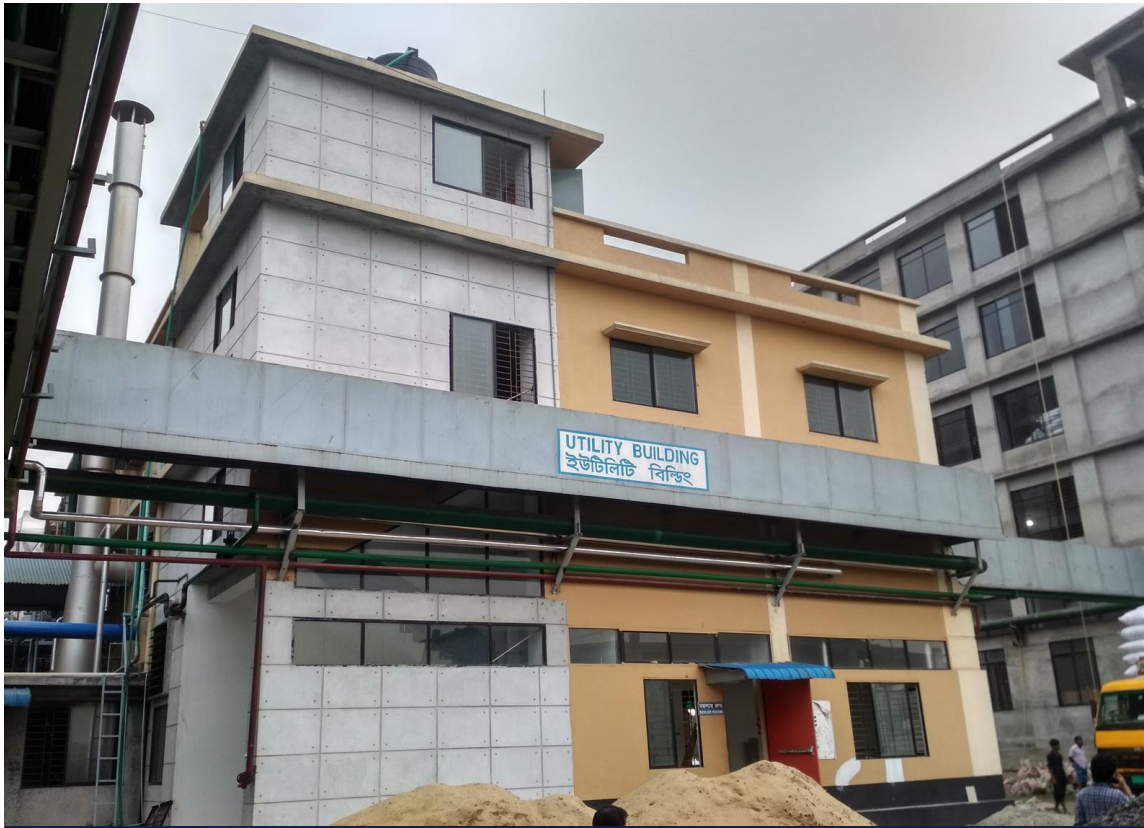
Front View

As per BNBC, every building or structure designed shall have its design documents prepared in accordance with the provision of Section 1.9.1. The design document shall include a design report, and a set of structural drawings, which shall be prepared in compliance with section 1.9.1.1 and section 1.9.1.2 as per BNBC. At the time of inspection, only as-built drawing was available, but no design report was available which is required to be prepared in compliance with section 1.9.1.1 (part-6, BNBC).

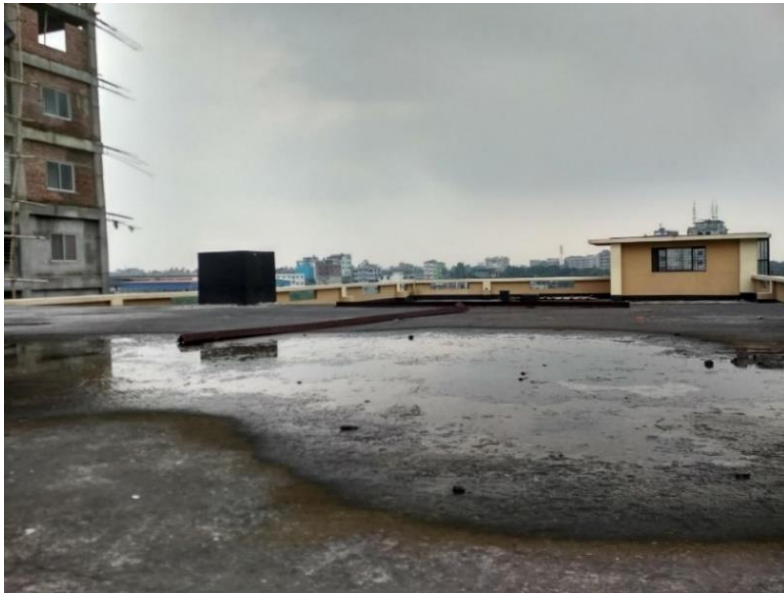
Water ponding on roof

Factory is required to develop proper drainage system on roof with adequate slope and apply water proofing compound on roof slab to resist water ingress.

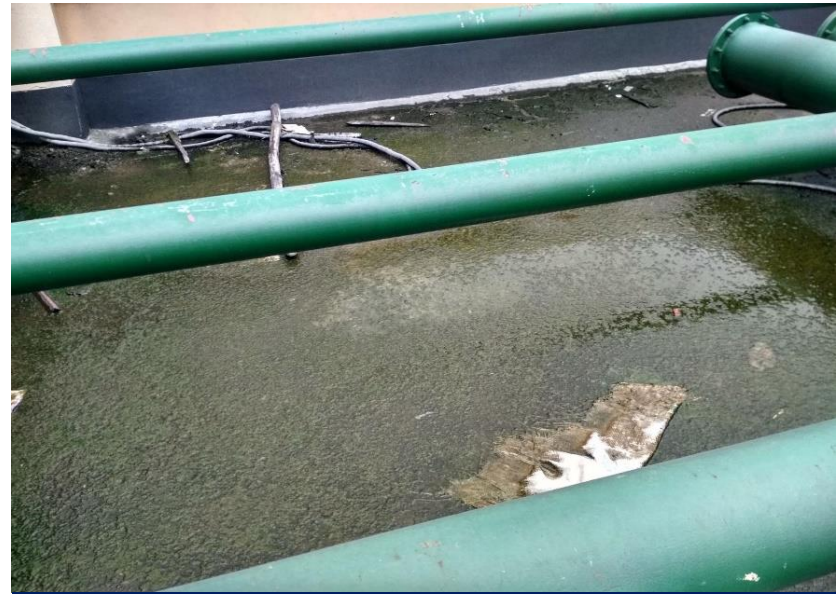
Vegetation

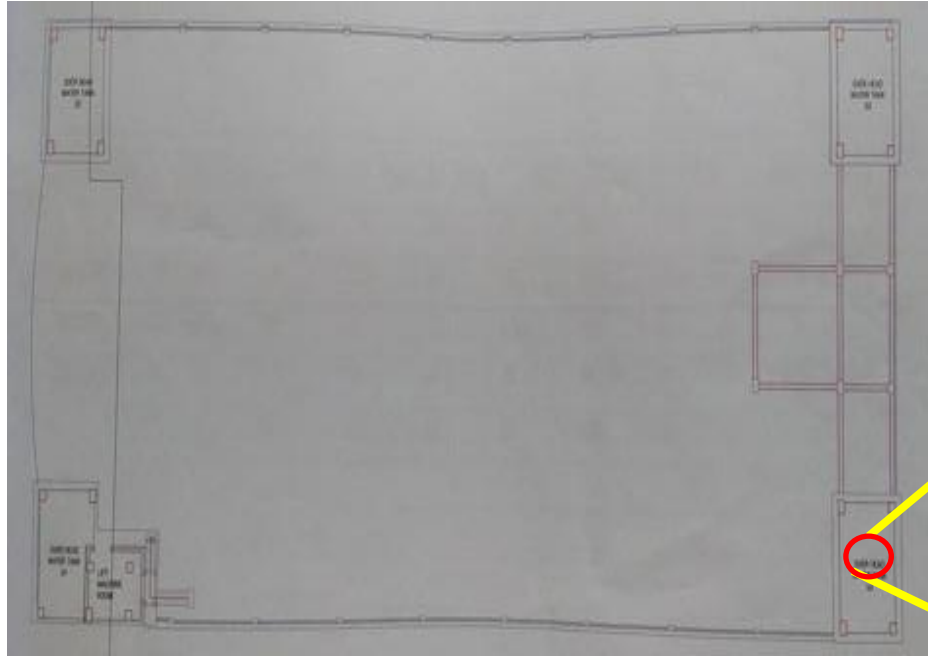
Roof Layout Plan

# **Discrepancies between as built condition and on-site observation**

Factory engineer is required to survey all the structural elements and produce correct as-built drawings accordingly.

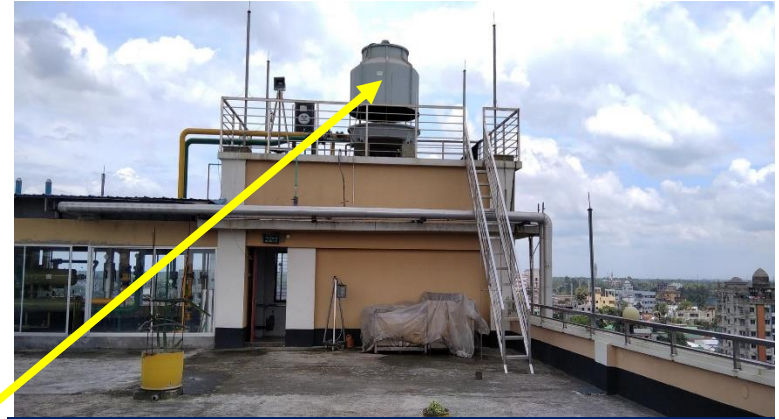
Chiller machine and stair not mentioned in the drawing

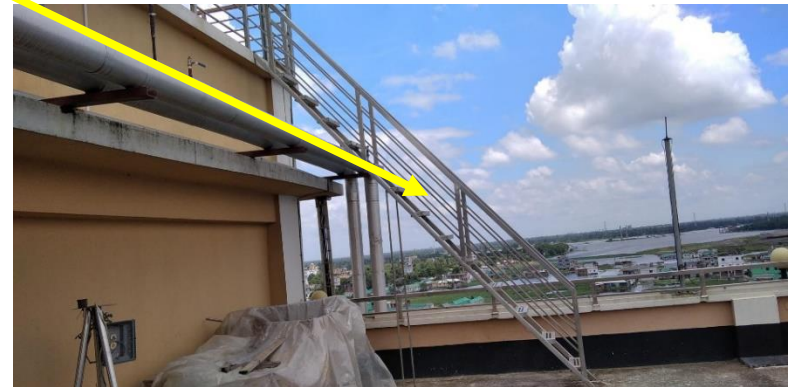
Undocumented steel stair

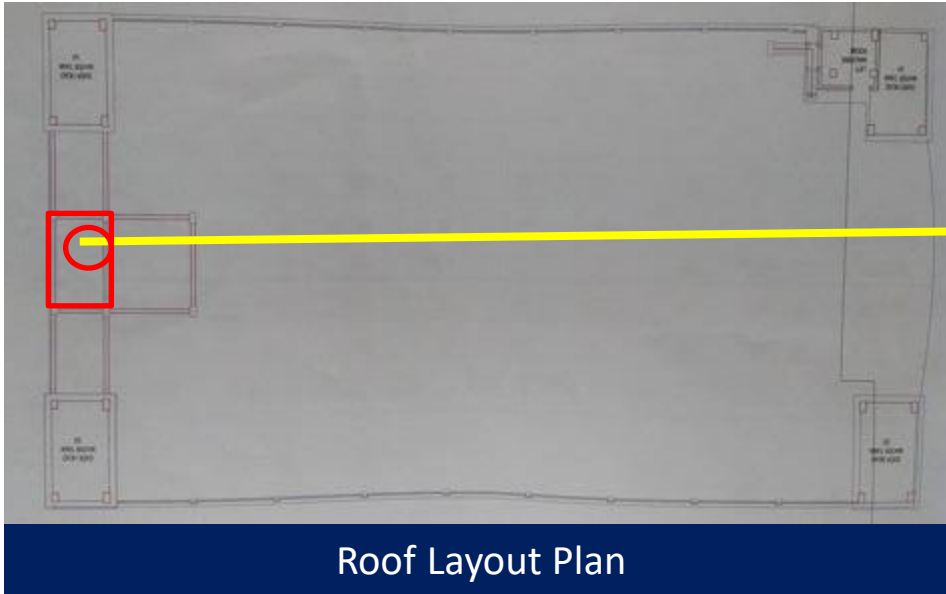
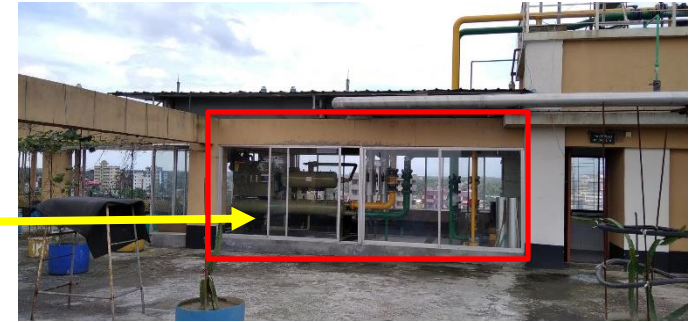
Chiller Machine and roof top shed not mentioned in the drawing

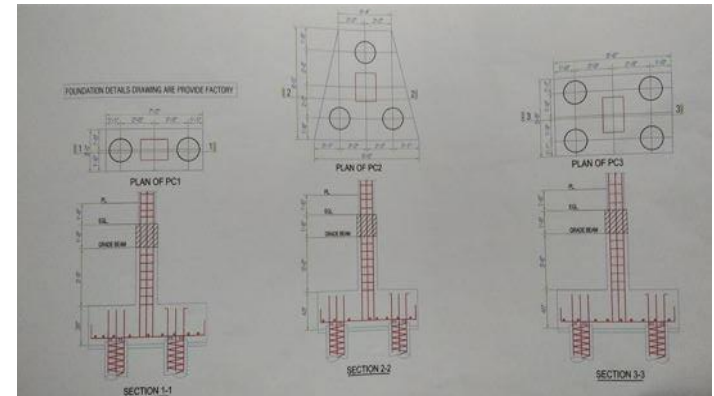
Rebar details are not mentioned in the pile cap drawing

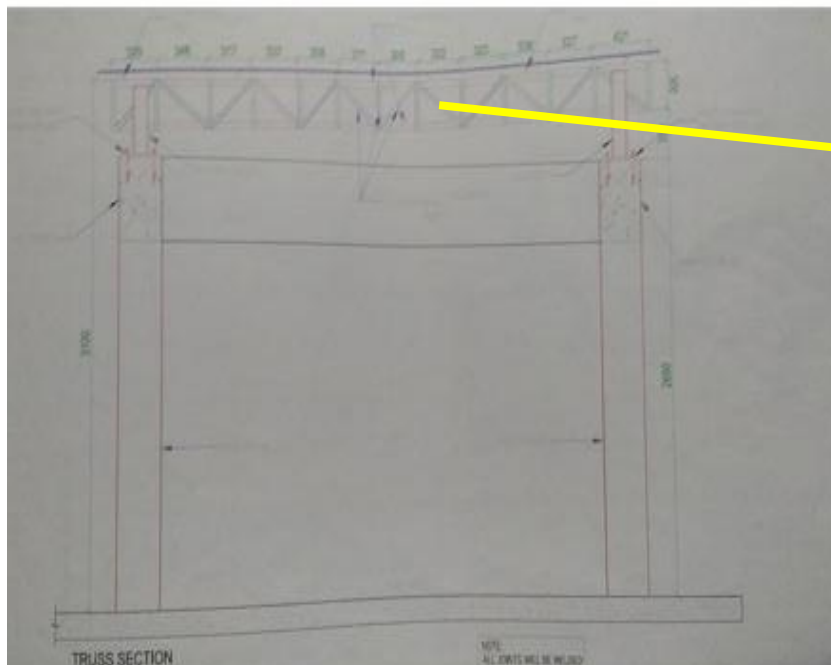
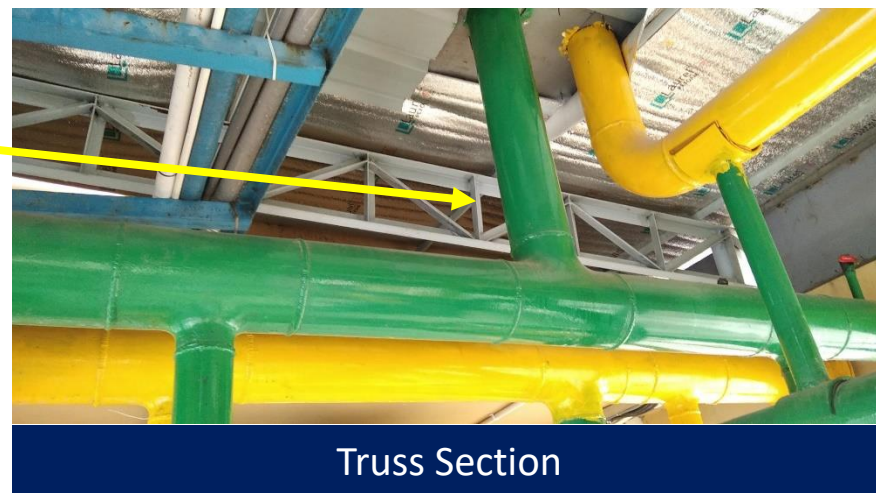
Truss Section

Connection details for truss sections not shown in the drawing

Factory engineer is required to install the missing bolts and carry out connection adequacy check for all the connections and implement remedial work accordingly. Moreover, no roof bracing or compression member was observed in the shed during inspection. Factory engineer is required to carry out lateral stability check for this steel shed.

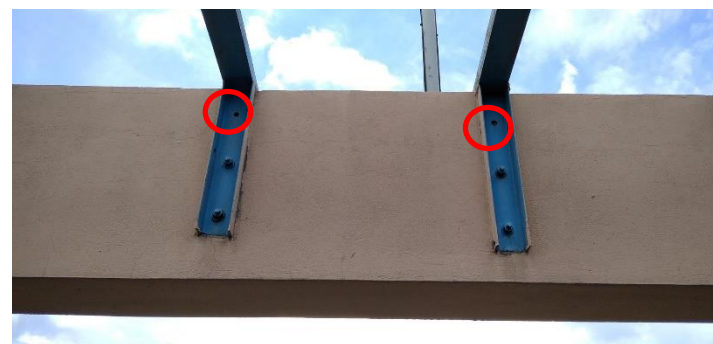
Missing Bolts
