# MM Knit Wear (Extension Buildings)

Ambagh Road, Konabari, Nilnagar, Gazipur

8 June, 25 August & 6 September 2021

# Observations

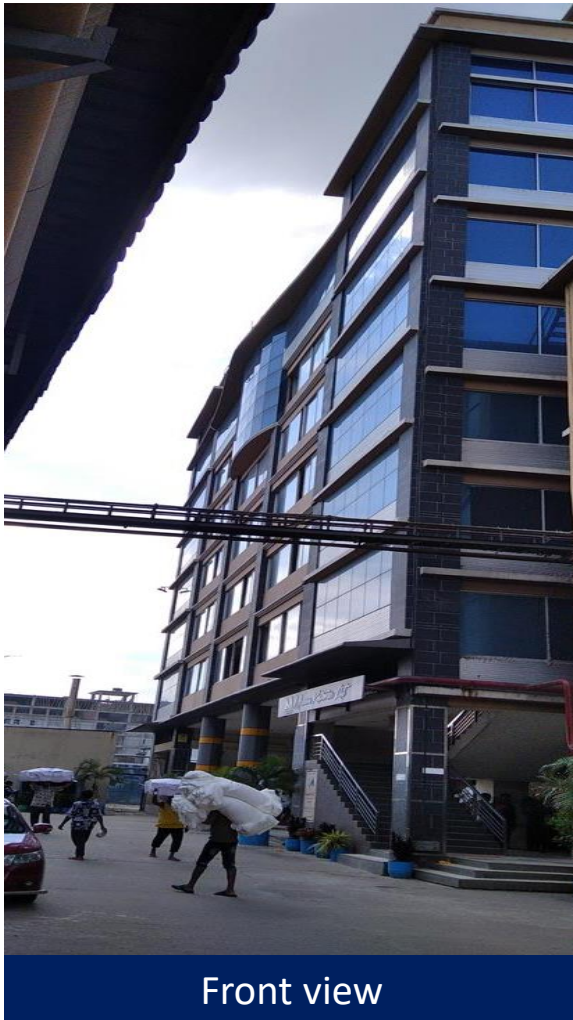
As per BNBC, every building or structure designed shall have its design documents prepared in accordance with the provision of Section 1.9.1. The design document shall include a design report, and a set of structural drawings, which shall be prepared in compliance with section 1.9.1.1 and section 1.9.1.2 as per BNBC. At the time of inspection, only as-built drawing was available, but no design report was available which is required to be prepared in compliance with section 1.9.1.1 (part-6, BNBC).

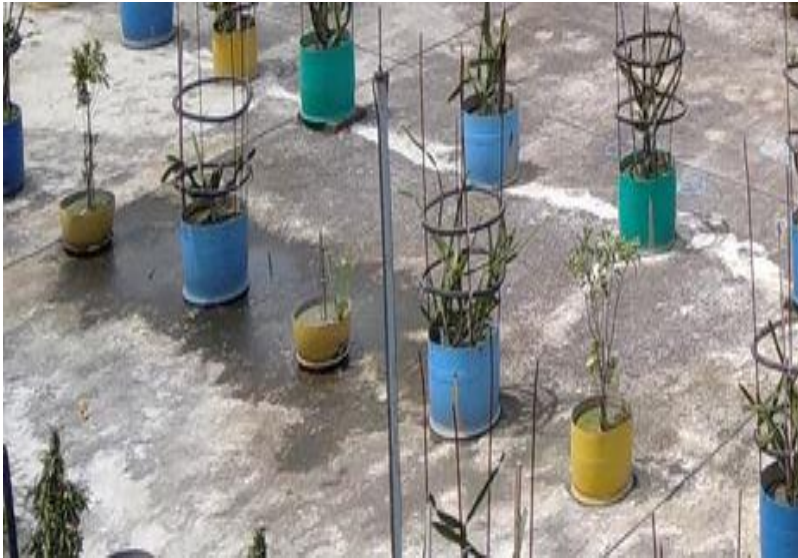
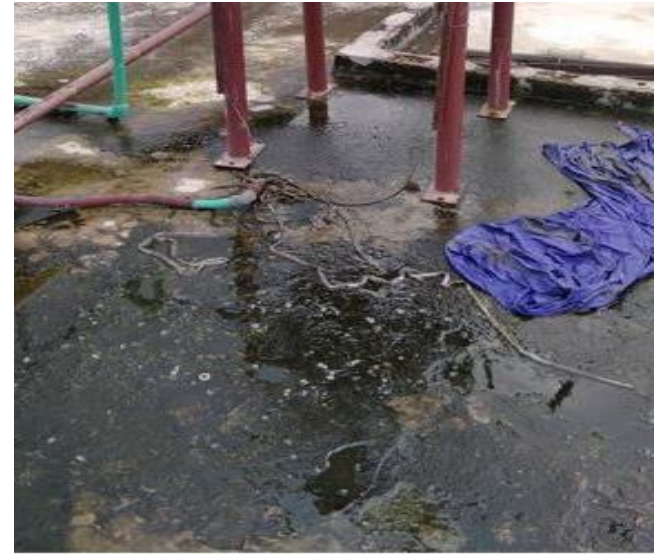
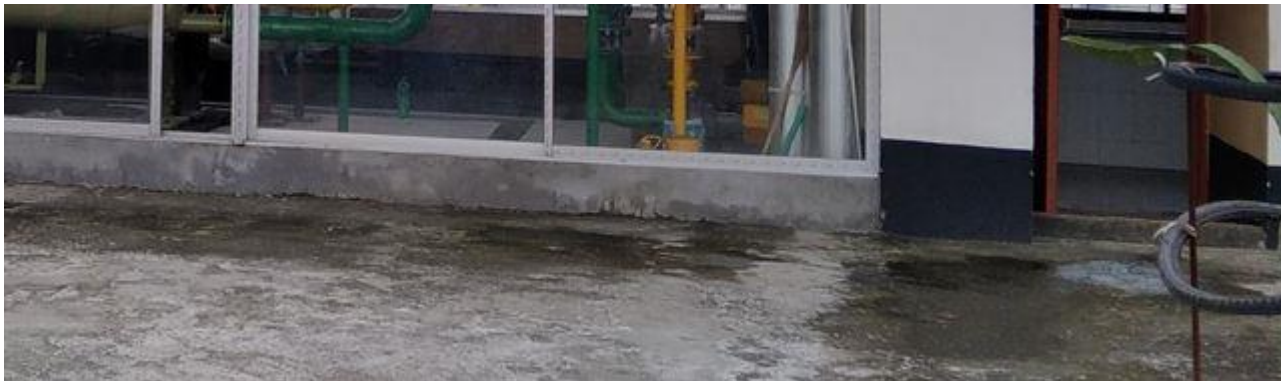
**Water ponding on roof**

Factory is required to develop proper drainage system on roof with adequate slope and apply water proofing compound on roof slab to resist water ingress.

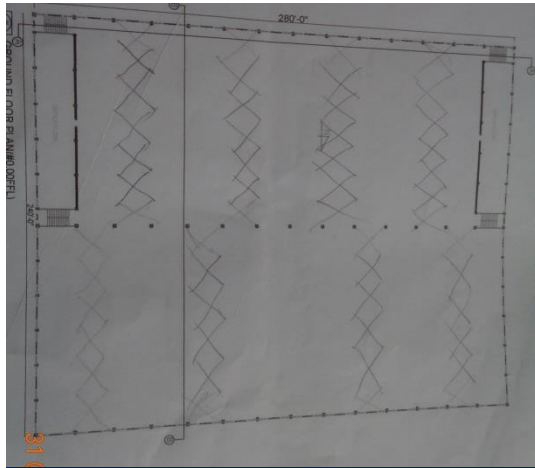
Bracing layout missing

Number of column grid did not match with provided drawings. Roof bracing layout, void in floor, stair steel framing and ground floor accessories rooms were missing in the provided drawings. The factory engineer is required to survey the structure and prepare a set of as-built drawings accordingly.

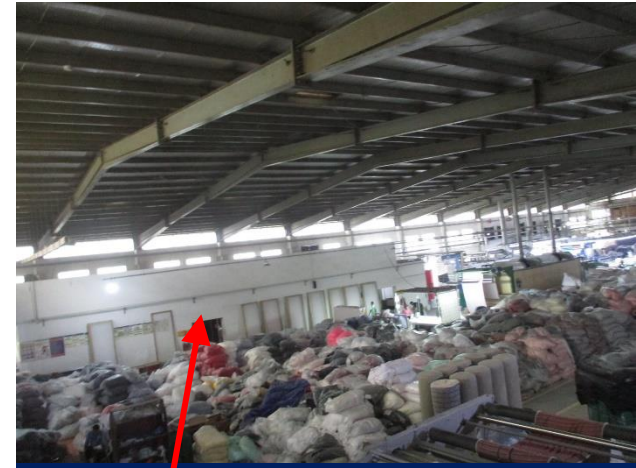
14 column grid onsite

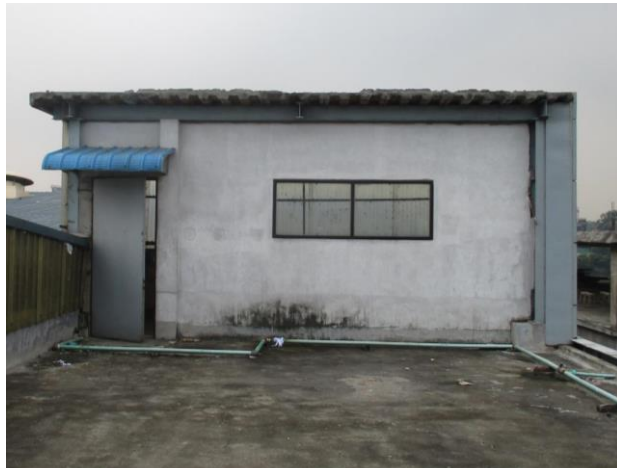
Steel frame not shown in drawing

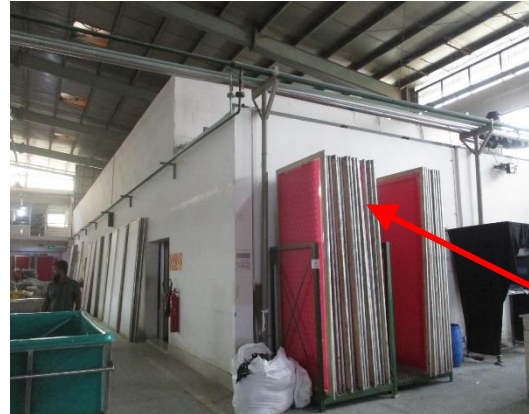
This room not shown in drawing

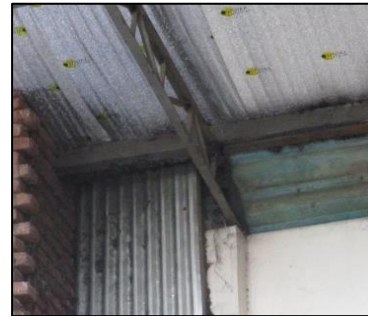
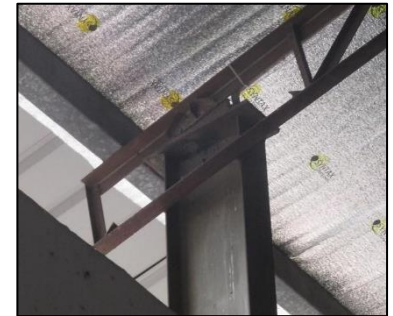
Poor connections

No bracing and lateral load transfer media is provided in the roof of this structure. Also, poor connection details of truss observed. The factory engineer is required to check lateral stability of the structure and suggest necessary measure accordingly.

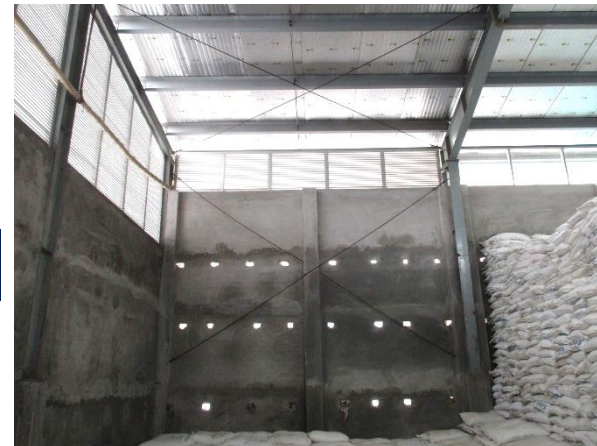
Vertical (wall) bracing

The column in red marked area is SC1 but in drawing it shown as SC2. The column web in blue marked area is placed along the frame but in drawing it shown as perpendicular to the frame. Wall bracing was observed onsite but only the roof bracing layout was shown in drawings. The factory is required to prepare the as-built drawings.

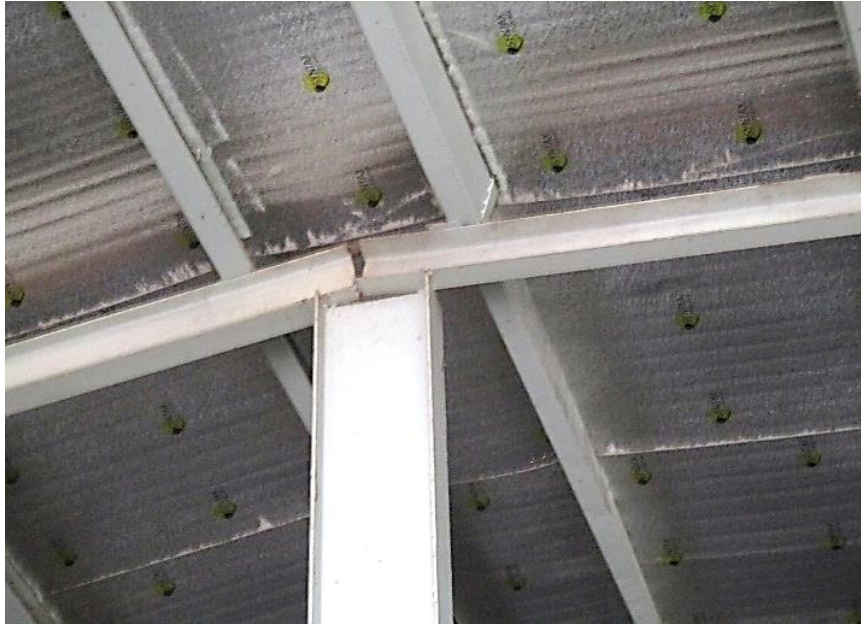
Poor connection

The rafter is deflected and there is no bracing system in part-A of Shed-4. The factory engineer is required to check the adequacy of the rafter and connections for gravity and lateral forces. Also, check the lateral stability of the structure and suggest necessary remedial actions accordingly.

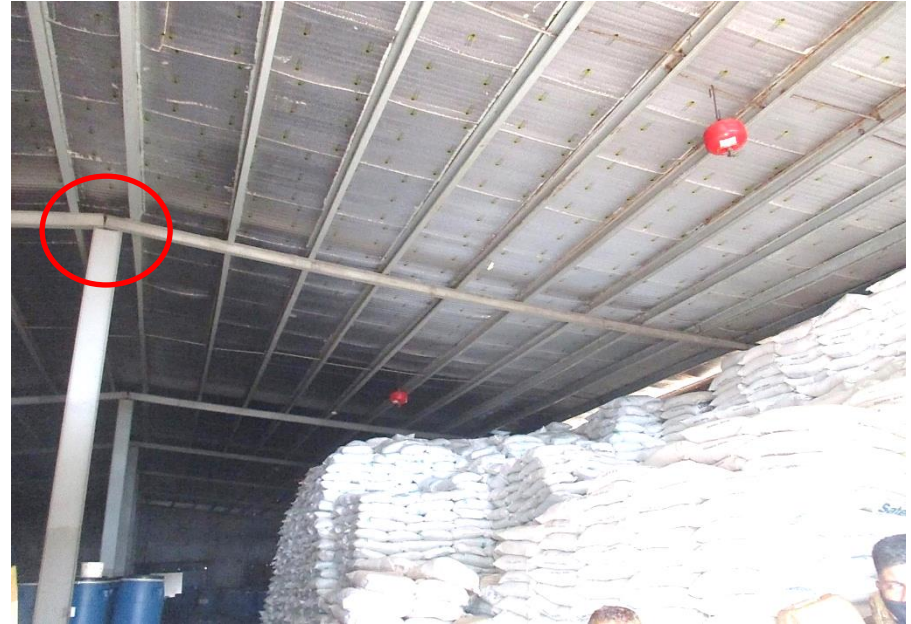
No bracing system; Rafter deflection at roof level in Part-A

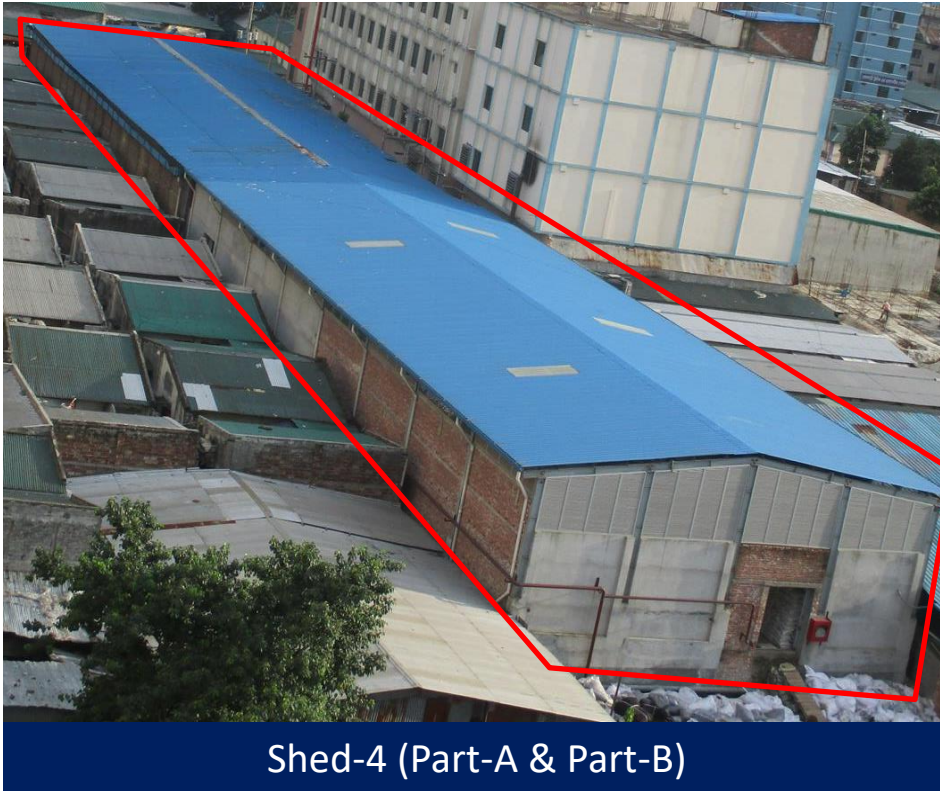
Shed-4 (Part-A & Part-B)

Only structural drawings were available for shed-4. As per BNBC, every building designed shall have its design documents prepared in accordance with the provision of Section 1.9.1. The design document shall include a design report, and a set of structural drawings, which shall be prepared in compliance with section 1.9.1.1 and section 1.9.1.2 as per BNBC. However, the factory is required to prepare and submit the design report to RSC for review.
