# KAC Fashion Wear Ltd (Extension)

12/13 Tetui Bari, Sarabo, Gazipur

14<sup>th</sup> September and 11<sup>th</sup> October 2021

# Observations

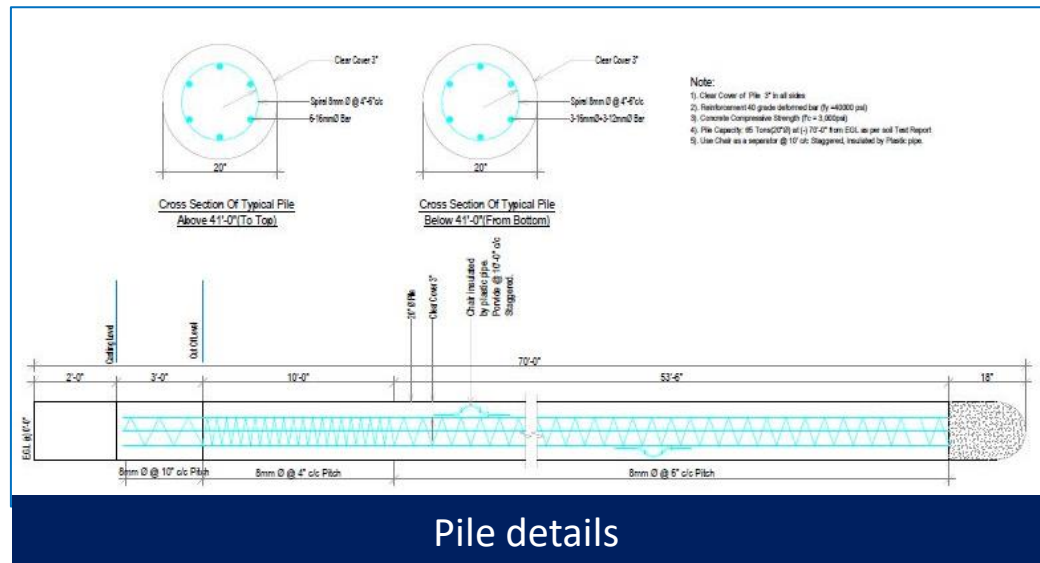
Cursory calculation indicates that bearing capacity of pile exceeds the normal design limit under dining area, considering 3 kPa live load on typical floors. Factory Engineer to review design, loads and foundation stresses.

In case of cast in situ piles, use Bored R.C.C. piles of 18" dia & 73' length, from EGL. It's bearing capacity = 100 Kips/pile.

In case of cast in situ piles, use Bored R.C.C. piles of 20" dia & 73' length, from EGL. It's bearing capacity = 125 Kips/pile.

The bearing capacity of the bored R.C.C. Pile, as recommended above, must be confirmed from the Load Tests.

| Item No. | Observation | Recommended Action Plan | Recommended Timeline |
|---|---|---|---|
| 01 | Foundation stressed above normal design limits. [Fashion-2] | Factory Engineer to review design, loads, and footings stresses. | 6-weeks |

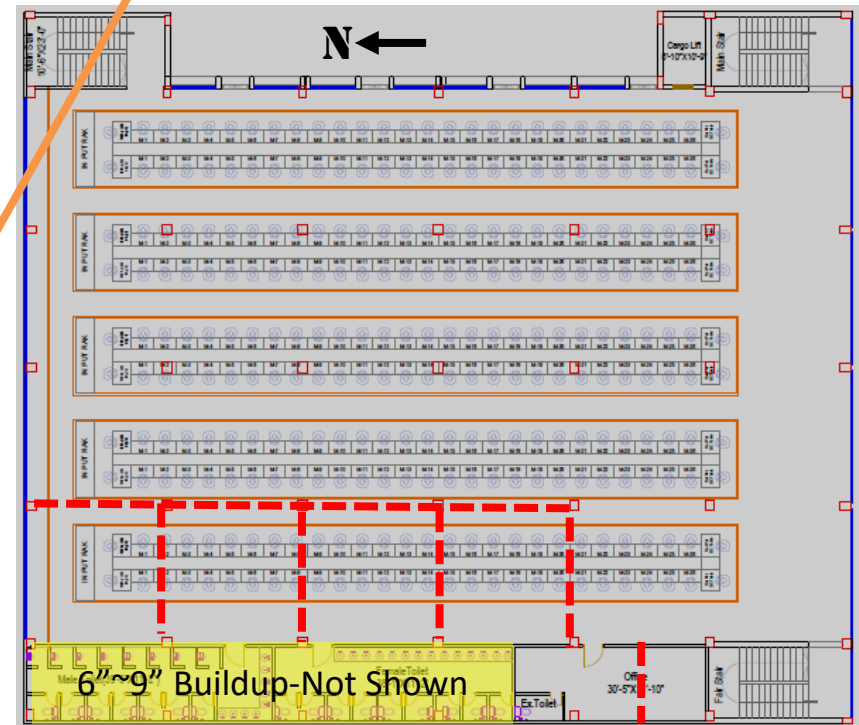
1<sup>st</sup> & 2<sup>nd</sup> floor layout plan

OHWT (not shown in drawing)

Dining shed (not shown in drawing)

Southside cantilever portion at 3<sup>rd</sup> floor (not shown in drawing)

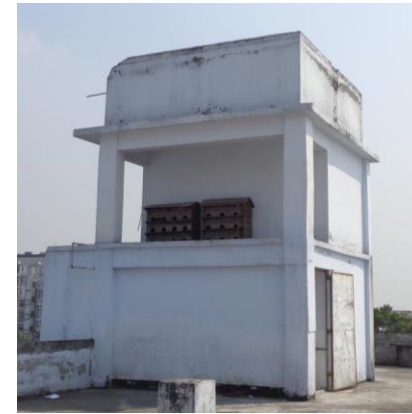
OHWT Loading

Cursory calculation indicates that columns are stressed above normal design limit considering observed 2 kPa live load and minimum concrete strength (14.1 MPa) based on aggregate type. Factory engineer is required to review design, load & column stresses of the building.

| Item No. | Observation | Recommended Action Plan | Recommended Timeline |
|---|---|---|---|
| 12 | High stress in foundation and column. [Fashion 3] | Factory Engineer to review design, loads and column stresses in all column and foundations. | 6-weeks |

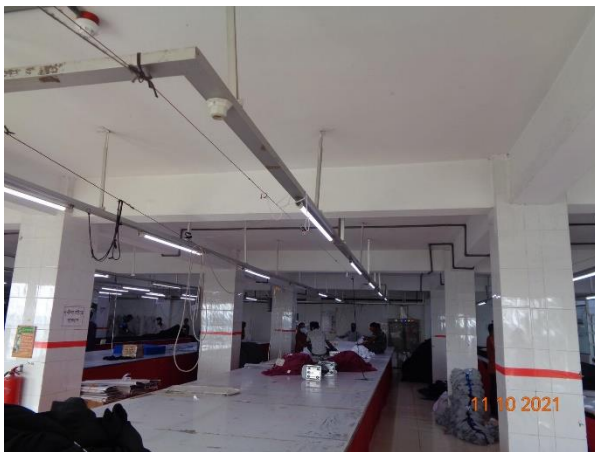
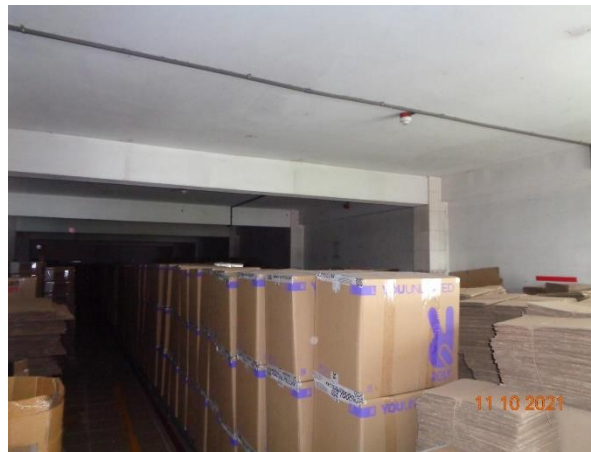
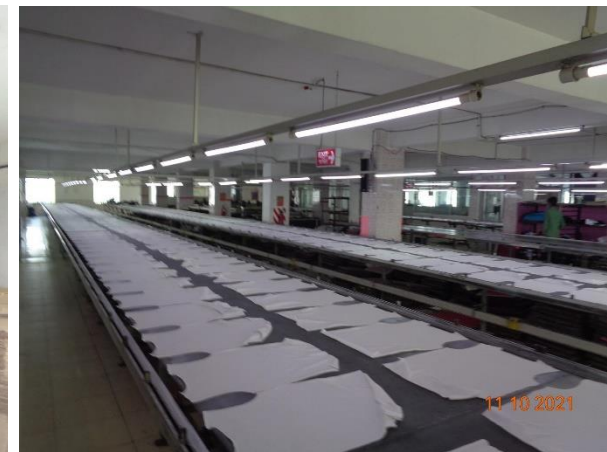
Floor Loading

Cursory calculation indicates that red marked footings are stressed above normal design limit considering observed live load (2 kPa), minimum concrete strength (14.1 MPa) based on aggregate type and ultimate soil bearing capacity 6.88 ksf (330 kPa). Factory engineer is required to review design, load & footing stresses of the building and suggest remedial actions accordingly.

| Item No. | Observation | Recommended Action Plan | Recommended Timeline |
|---|---|---|---|
| 13 | High stress in foundation and column. [Fashion 3] | Produce and actively manage a loading plan for all floor plates within the factory building considering floor, column and foundation capacity. | 6-weeks |

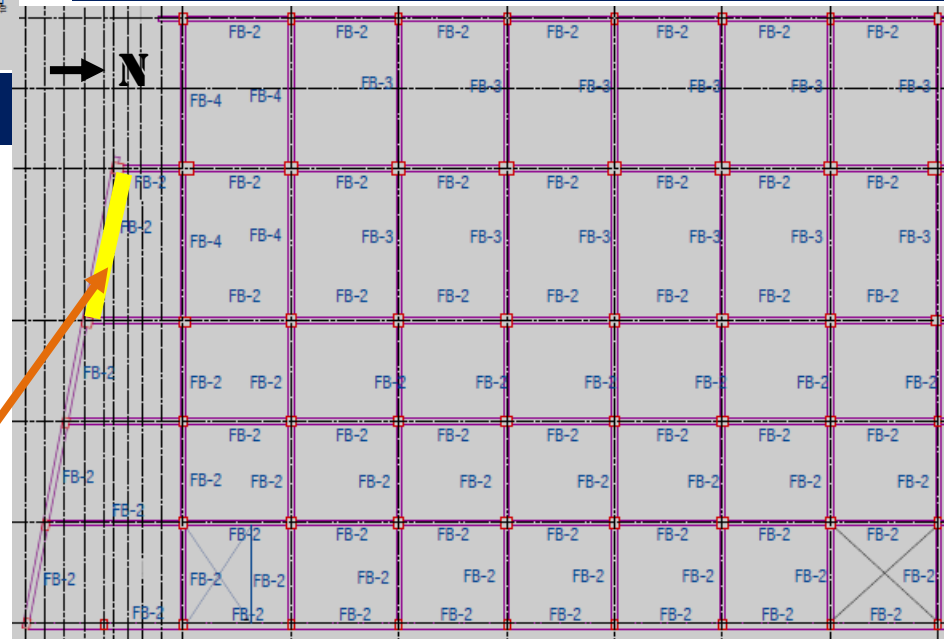
3<sup>rd</sup> & 4<sup>th</sup> floor roof beam layout plan

150~275 mm Buildup at each floor toilet area

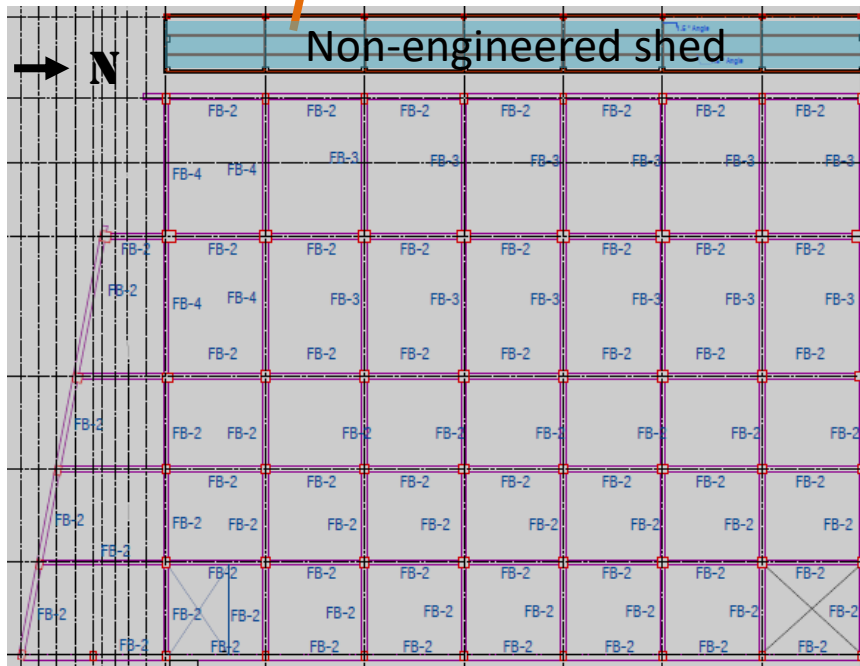
3<sup>rd</sup> & 4<sup>th</sup> floor room beam layout plan

**Non-engineered shed at 1<sup>st</sup> floor**

Roof sheet worn out

Factory engineer is required to check the member adequacy of the shed for both gravity and lateral forces or replace the shed by an engineering structure.
