# Prudent Fashions Ltd

Gazir Chart Alia Madrasa, Kaichabari Road, Dhamsona Ashulia, Dhaka-1344  
(23.947001N, 90.269128E)  
12 October 2021

# Observations

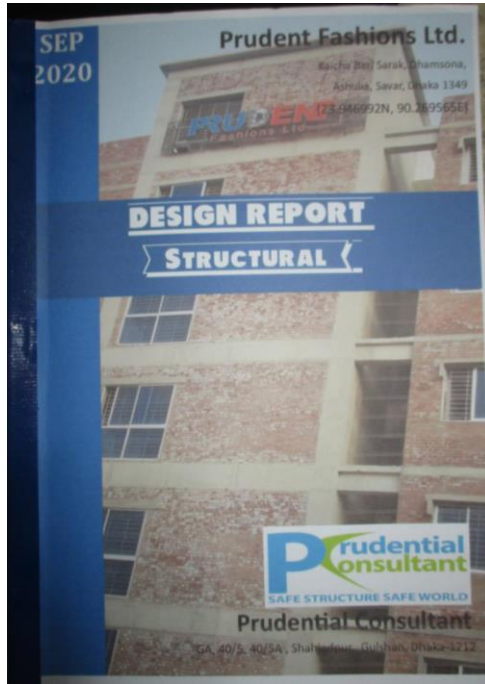
**Design Report needs to be reviewed**

The building engineer to incorporate irregularities check in the design report and suggest required recommendations.

| Item No. | Observation | Recommended Action Plan | Recommended Timeline |
|---|---|---|---|
| 03 | Design Report needs to be reviewed. Building-1 | As part of Engineering Assessment (EA), building engineer to incorporate irregularities check in the design report and suggest required recommendations. | 6-weeks |

| Item No. | Observation | Recommended Action Plan | Recommended Timeline |
|---|---|---|---|
| 05 | Design Report needs to be reviewed. Building-1 | <ul style="list-style-type: none"> <li>Implement the recommendation of EA.</li> </ul> | 6-months |
