# Amigo Bangladesh Ltd.

RS No: 1408 - 1416, Khalapara, Dakkhinbag, Kaliganj, Gazipur-1613  
(23.951914, 90.613541)

3<sup>rd</sup> & 11<sup>th</sup> October 2021

# Observations

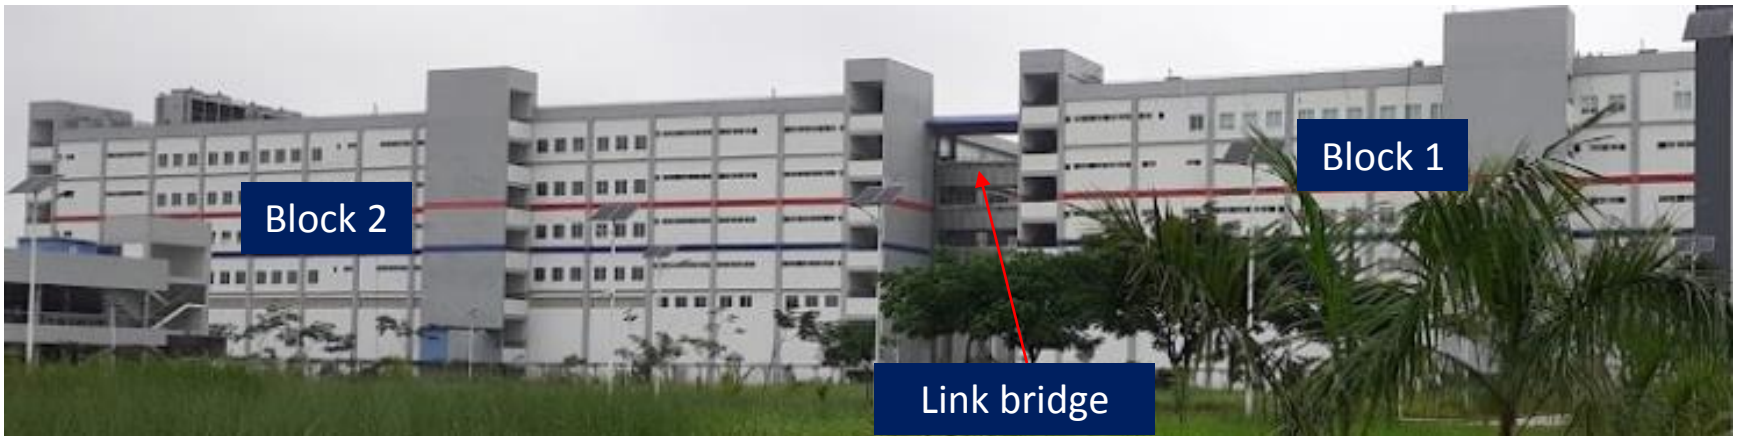
**Structural design report not available**

As per BNBC every building or structure designed shall have its design documents prepared in accordance with the provision of Section 1.9.1. The design document shall include a design report, and a set of structural drawings, which shall be prepared in compliance with section 1.9.1.1 and section 1.9.1.2 as per BNBC. Design report was not found which is required to be prepared in compliance with section 1.9.1.1 (part-6, BNBC).

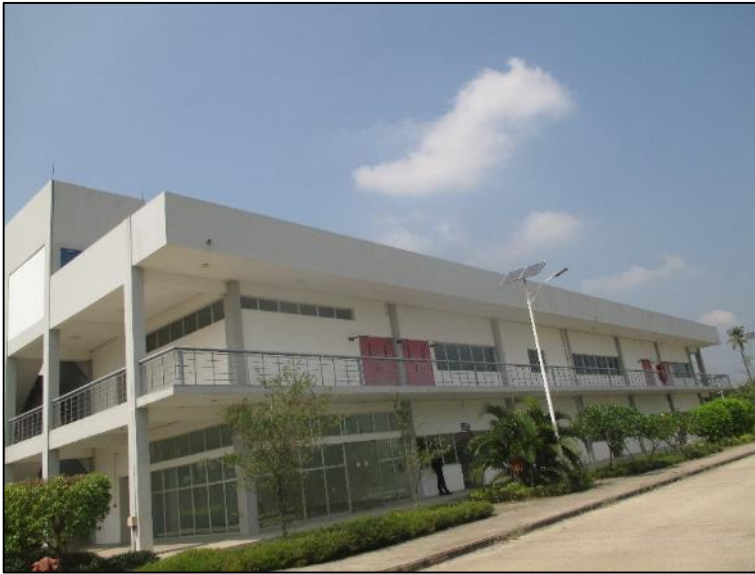
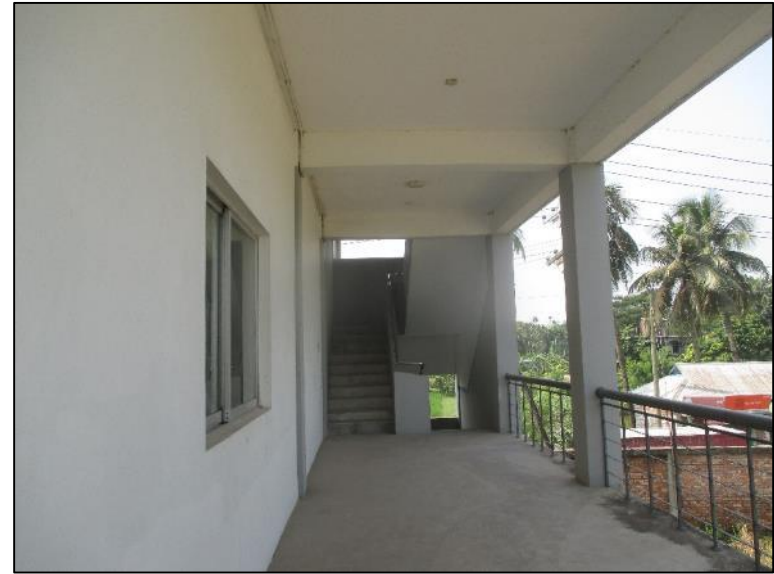
**Structural design report not available**

No design documents were available for General Office Building

As per BNBC, every building or structure designed shall have its design documents prepared in accordance with the provision of Section 1.9.1. The design document shall include a design report, and a set of structural drawings, which shall be prepared in compliance with section 1.9.1.1 and section 1.9.1.2 as per BNBC. At the time of inspection, no design report was available which is required to be prepared in compliance with section 1.9.1.1 (part-6, BNBC).

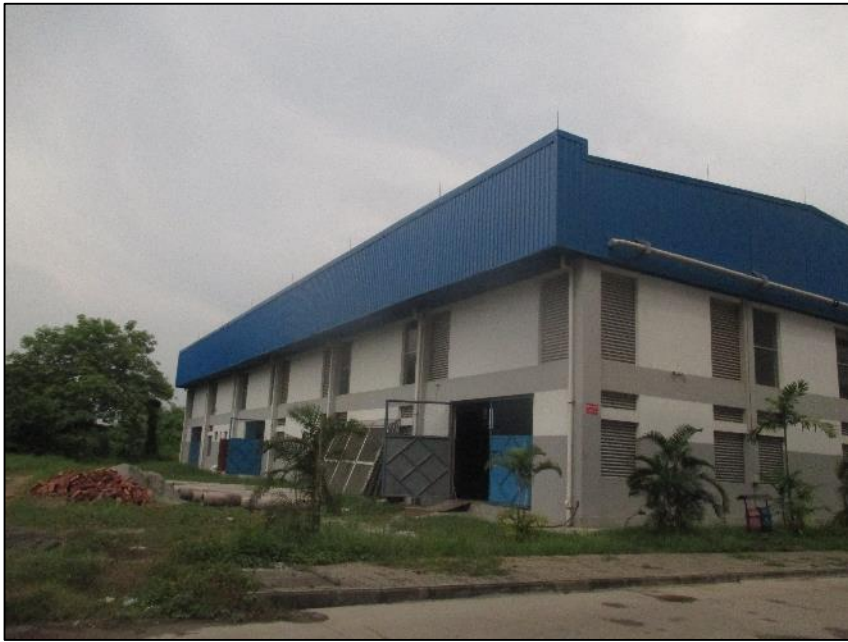
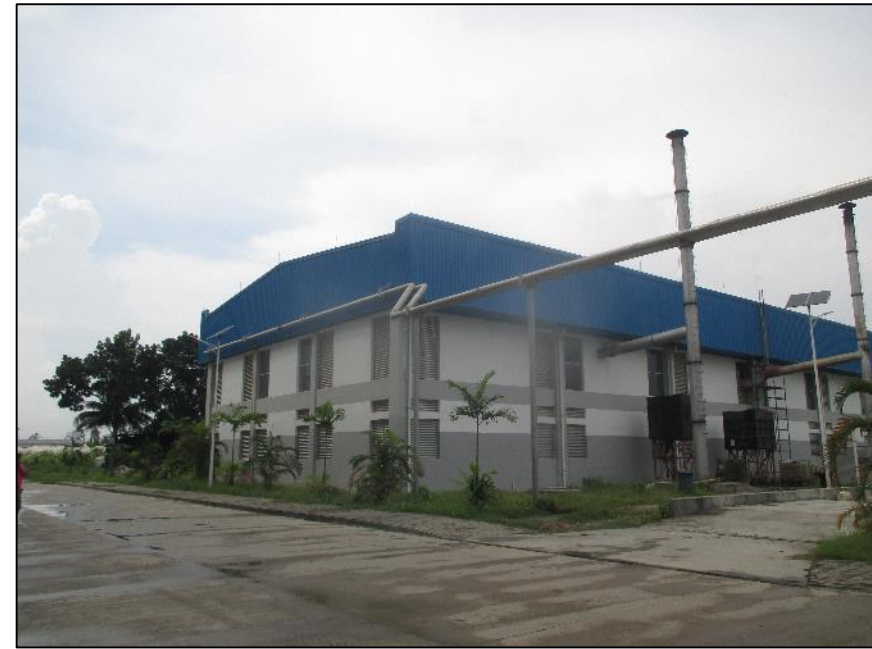
**Structural design report not available**

No design reports were available for Boiler shed Building

As per BNBC, every building or structure designed shall have its design documents prepared in accordance with the provision of Section 1.9.1. The design document shall include a design report, and a set of structural drawings, which shall be prepared in compliance with section 1.9.1.1 and section 1.9.1.2 as per BNBC. At the time of inspection no design report was available which is required to be prepared in compliance with section 1.9.1.1 (part-6, BNBC).

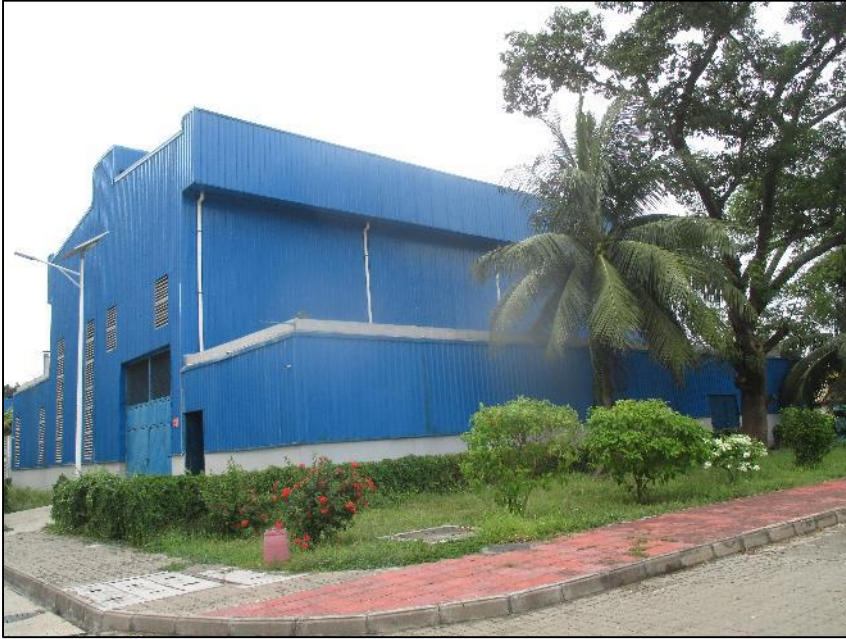
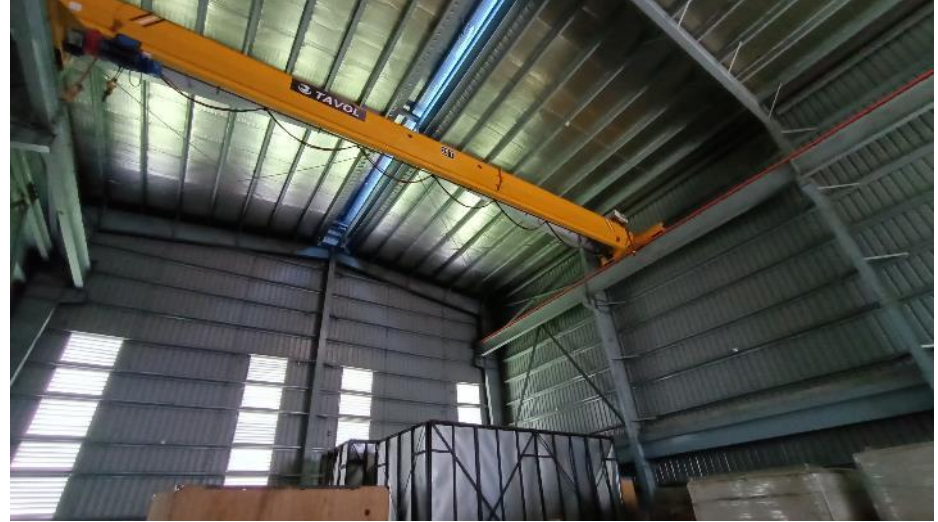
**Structural design report not available**

No design reports were available for power plant building

As per BNBC, every building or structure designed shall have its design documents prepared in accordance with the provision of Section 1.9.1. The design document shall include a design report, and a set of structural drawings, which shall be prepared in compliance with section 1.9.1.1 and section 1.9.1.2 as per BNBC. At the time of inspection no design report was available which is required to be prepared in compliance with section 1.9.1.1 (part-6, BNBC).

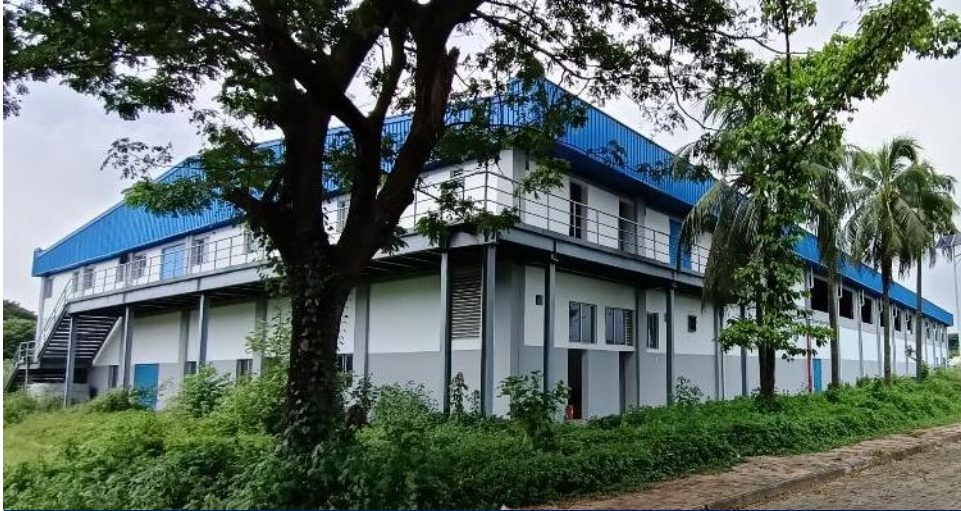
**Structural design report not available**

No design reports were available for  
Washing plant Building

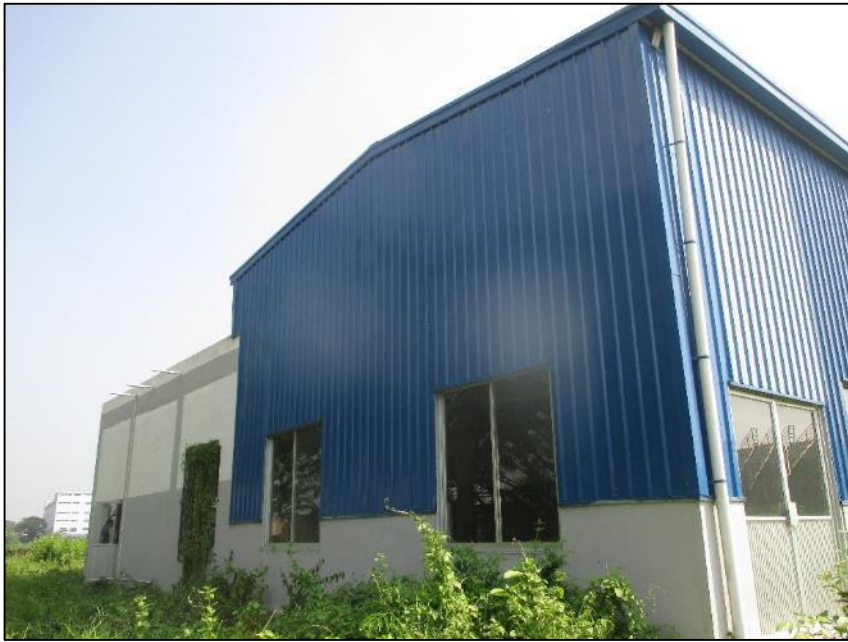
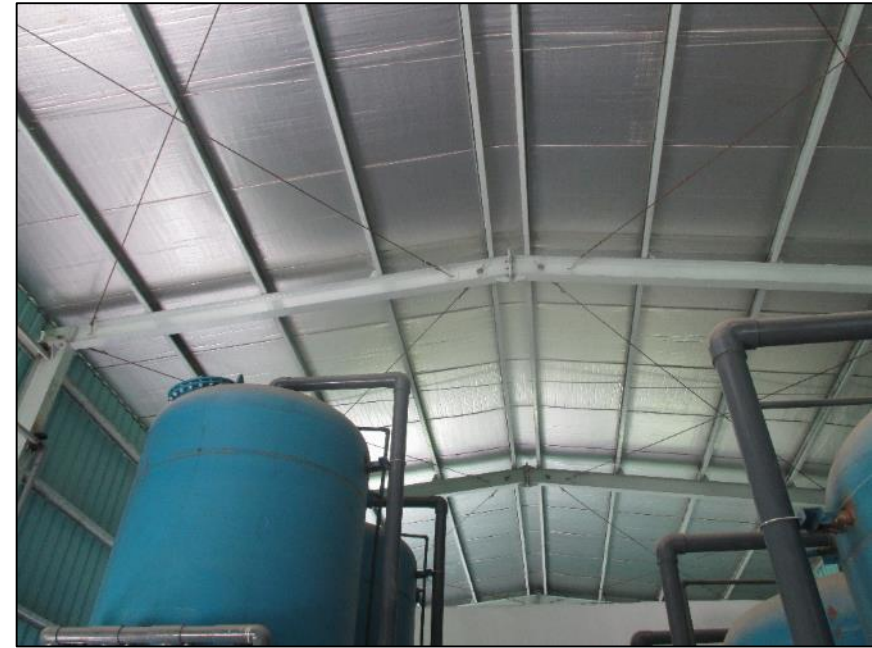
**Structural design report not available**

No design reports were available for WTP Building

As per BNBC, every building or structure designed shall have its design documents prepared in accordance with the provision of Section 1.9.1. The design document shall include a design report, and a set of structural drawings, which shall be prepared in compliance with section 1.9.1.1 and section 1.9.1.2 as per BNBC. At the time of inspection, no design report was available which is required to be prepared in compliance with section 1.9.1.1 (part-6, BNBC).
