# Sadma Fashion Wear Ltd. (Extension)

Mouchack, KaliaKoir, Gaziupr

4<sup>th</sup> October 2021

# Observations

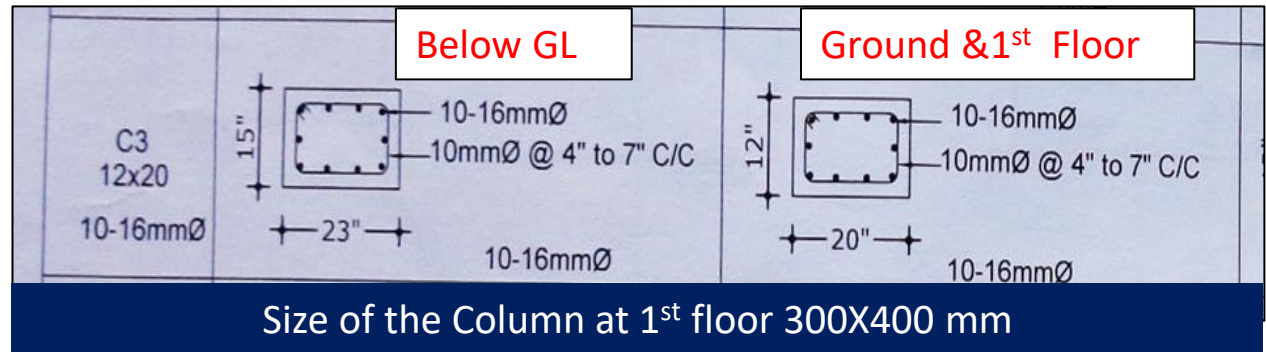
Size of the Column was measured 375X575mm

Ground floor columns are 5.55 m in length and 375X575 mm in size. The length/width=14.8 indicates that the columns are critical for slenderness effect.  
So, the factory engineer is required to check and address this issue in the design report.

| Item No. | Observation | Recommended Action Plan | Recommended Timeline |
|---|---|---|---|
| 15 | Column appears to be slender (Utility Building) | Implement the recommendations if required. | 6-months |

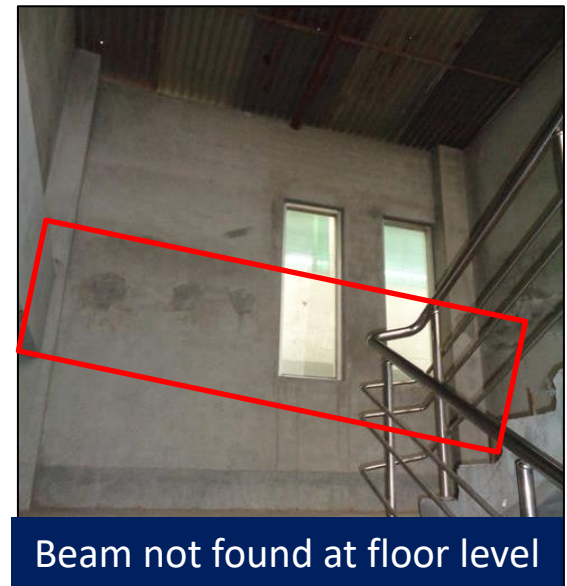
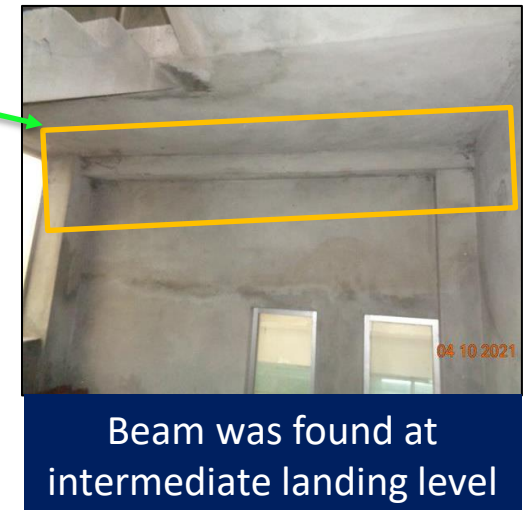
Beam was found at intermediate landing level instead of floor level. Factory engineer is required to update the structural drawing.

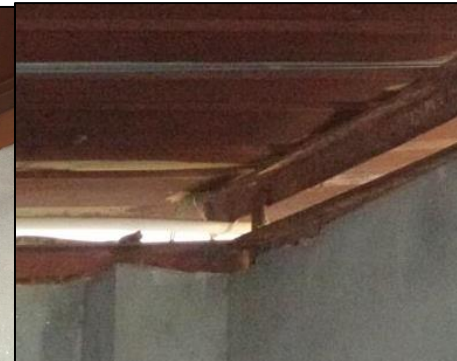
Connection seems to be inadequate for roof shed

Light weight steel roof shed was found at staircase and roof top. The light-weight steel roof is made of steel angle section. There is no apparent load path to transfer the lateral loading. Poor connection details observed at joints. Building Engineer is required to check the lateral stability of the light-weight steel shed otherwise, replace the shed with engineered one.
