# Liberty Knitwear Co. Ltd. (9501)

Ramarbagh, Kutubpur, Fatullah, Narayangani, Bangladesh

27.MARCH.2014

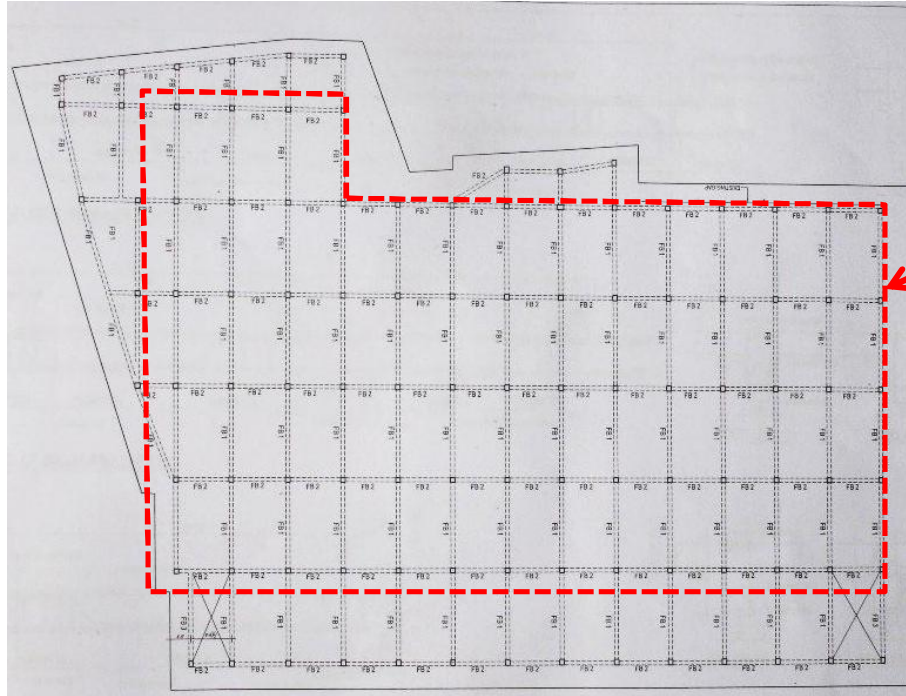
Cracks in beam - capacity check is required

The cause of cracks occurred on long span beam as shown on 4th floor plan seems to be from uncontrolled heavy load.

Cracks appeared along slab soffit and beam, capacity check is required prior to repairing.

Cracks in beams (building 1, 4<sup>th</sup> floor ) capacity checks are required.

- Request the detail engineering assessment of factory to be carried out and a suitable method of repair is to be established.
- Simply plastering over is not allowed.

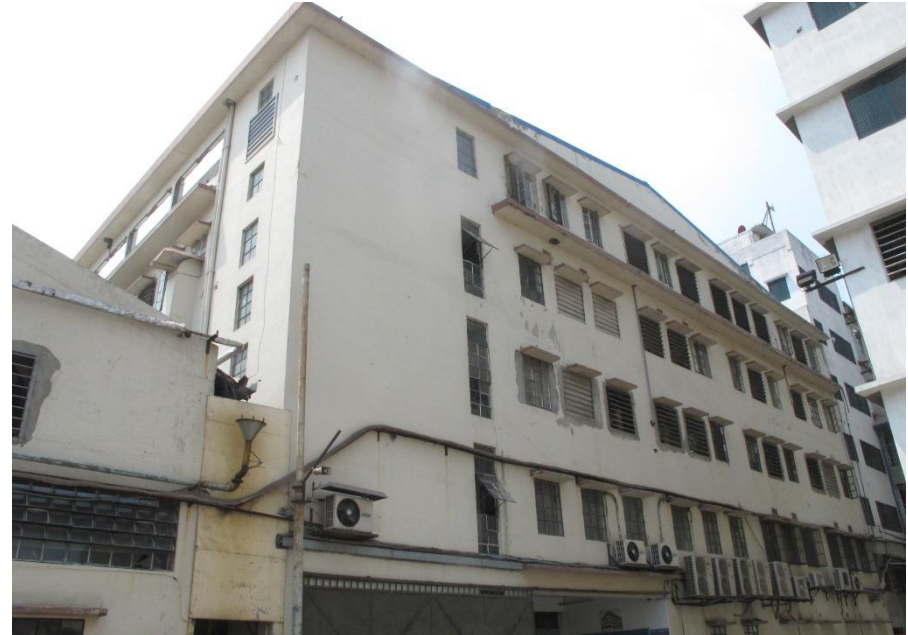
Concerns on the stability system for lateral loading and seismic loading. Façade brickwork with little capacity; lack of moment capacity in connection between columns and beams.

A further Detail Engineering Assessment is required to assess whether such a system can resist lateral loads from wind & earthquakes

**ITEM 4: (Priority 2) Stability system and foundations to be assessed in more detail.**

- A Detail Engineering Assessment to be carried out, in particular stability and foundation aspects to be investigated in detail.

- Implement any structural changes or repair works deemed necessary by the aforementioned assessment.
