P.A Knit Composite (Extension)

Jamirdia, Habir Bari, Valuka, Mymensingh-2240

12th, 25th October & 29th November 2021

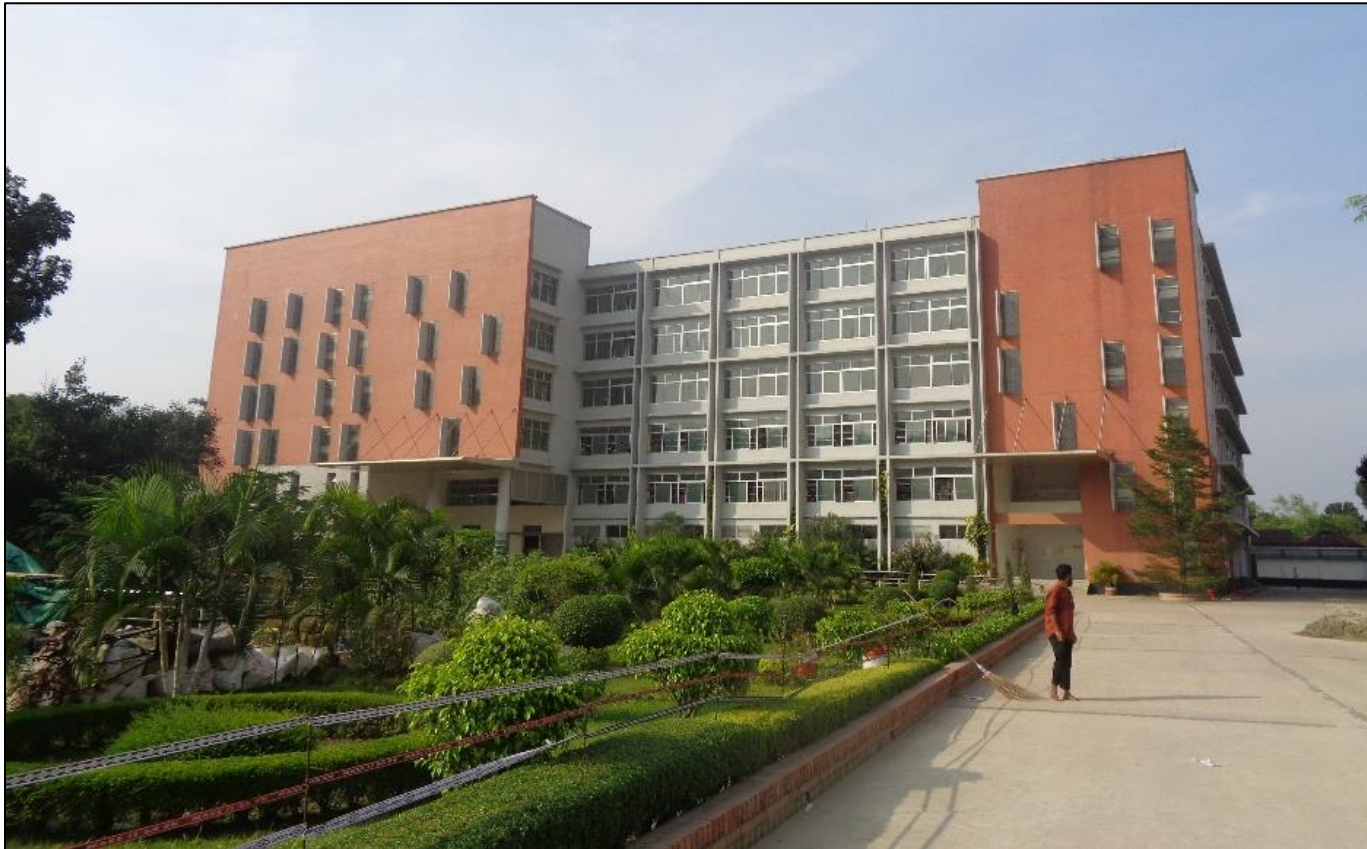
Stress in foundation exceeds normal design limit

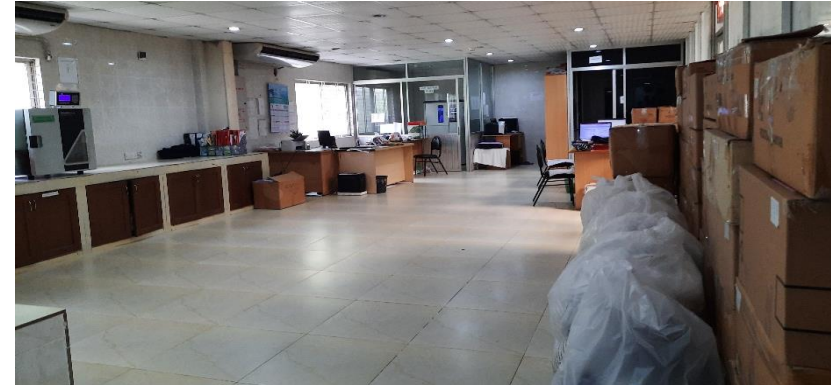
Floor Loading

This building was constructed between May 2014 and October 2015. Soil test report was not available for the structure.

Cursory calculation indicates that footings are stressed above normal design limit considering 3 kPa floor live load (mezzanine) and minimum allowable bearing capacity 2 ksf (BNBC Ch-3, Table -6.3.5). The building engineer is required to review design, load, column & footing stress.

| Item No. | Observation | Recommended Action Plan | Recommended Timeline |
|---|---|--|---|
| 01 | Stress in foundation exceeds normal design limits (Building-1: Dyeing Shed 2) | As part of Detail Engineering Assessment (DEA) Building engineer is required to review design, load & footing stress. | 6-weeks |
| 02 | Stress in foundation exceeds normal design limits (Building-1: Dyeing Shed 2) | Prepare soil investigation report for the structure. | 6-weeks |
| 03 | Stress in foundation exceeds normal design limits (Building-1: Dyeing Shed 2) | Produce and actively manage a set of floor loading plan within the factory building considering foundation, column and floor capacity. | 6-weeks |
| 04 | Stress in foundation exceeds normal design limits (Building-1: Dyeing Shed 2) | Carry out remedial works as per DEA recommendations. | 6-months |
| 05 | Stress in foundation exceeds normal design limits (Building-1: Dyeing Shed 2) | Implement floor load plan. | 6-months |

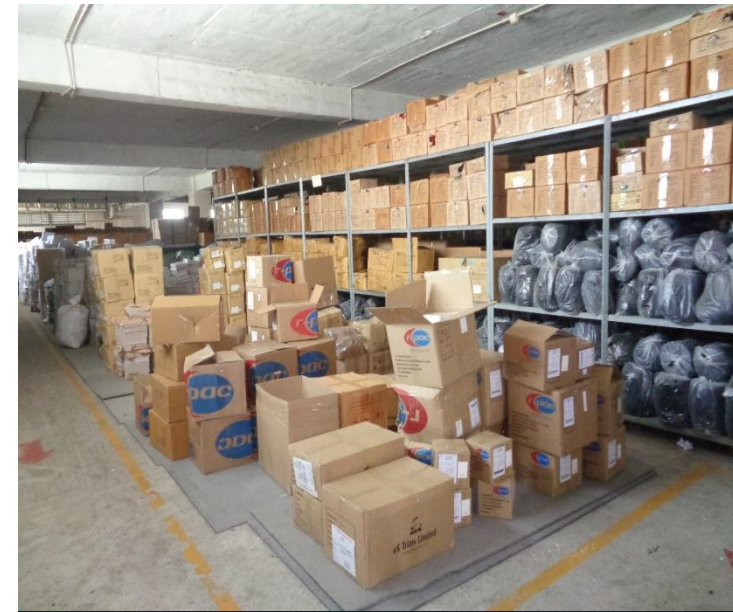
Stressed column/foundation layout

Stress in column and foundation exceeds normal design limit

Cursory calculation indicates that stress exceeds the normal design limit for both columns & foundations in marked location-1 and only for column at marked location-2 considering the floor live load (7 kPa for first & second floor, 4 kPa for typical floors as per load plan), minimum concrete strength based on aggregate type and allowable soil bearing capacity 20 T/m². Building engineer is required to review the design, loads and column/foundation stresses based on in-situ concrete strength.

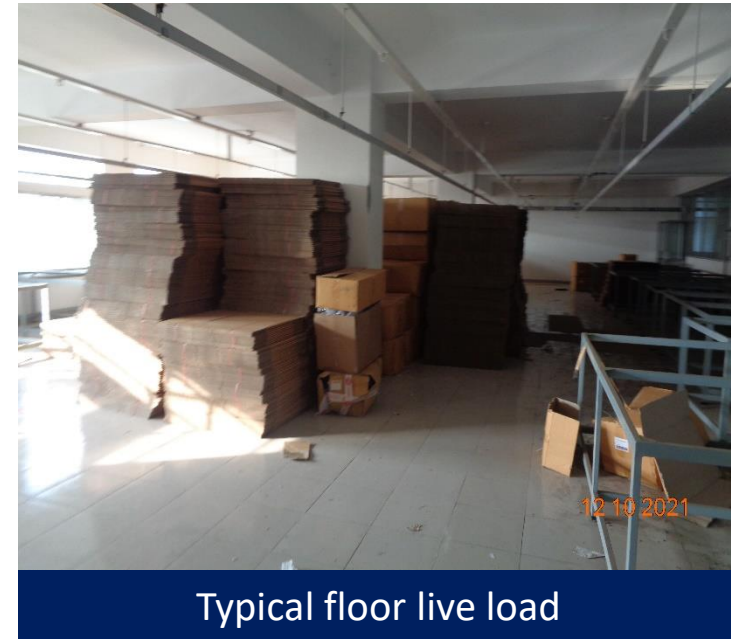
Stressed column/foundation layout

Cursory calculation indicates that stress in column and foundation exceeds the normal design limit at the marked location considering the floor live load 6 kPa for typical floors (mentioned on slab layout), minimum concrete strength based on aggregate type and allowable soil bearing capacity 14 T/m². Building engineer is required to review the design, loads and column/foundation stresses based on in-situ concrete strength.

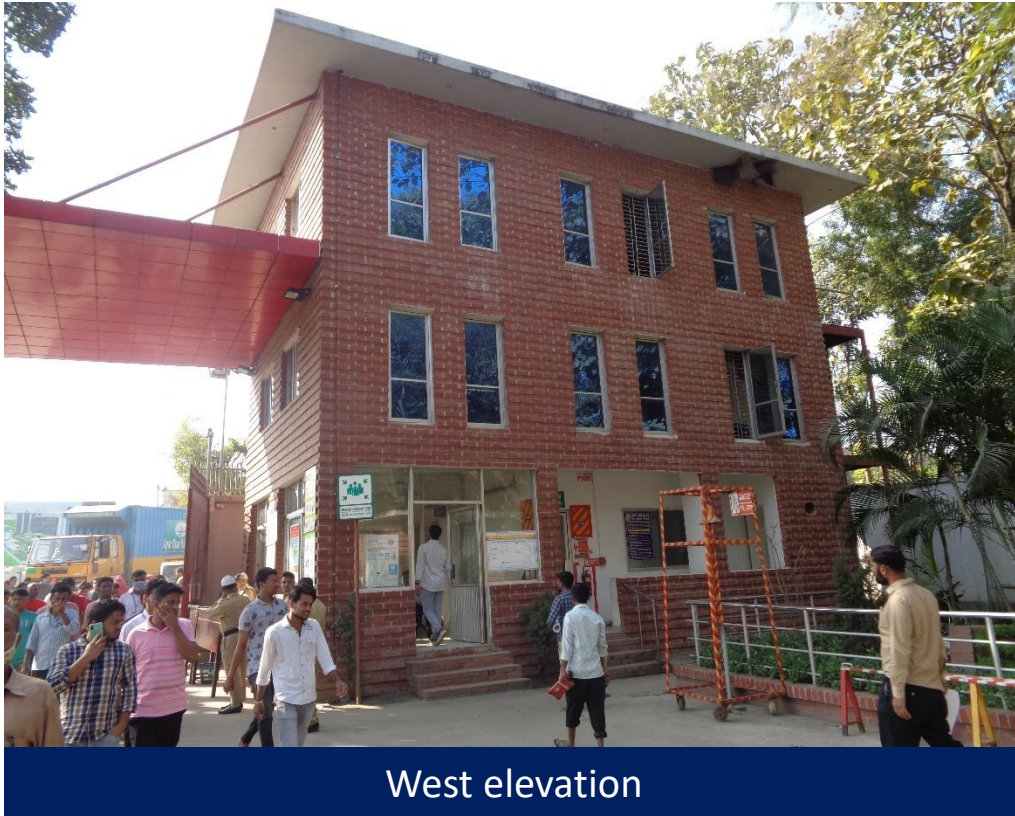
Design Report needs to be prepared

As per BNBC, every building or structure designed shall have its design documents prepared in accordance with the provision of Section 1.9.1. The design document shall include a design report, and a set of structural drawings, which shall be prepared in compliance with section 1.9.1.1 and section 1.9.1.2 as per BNBC. At the time of inspection, only as-built drawing was available, but no design report was available which is required to be prepared in compliance with section 1.9.1.1 (part-6, BNBC).

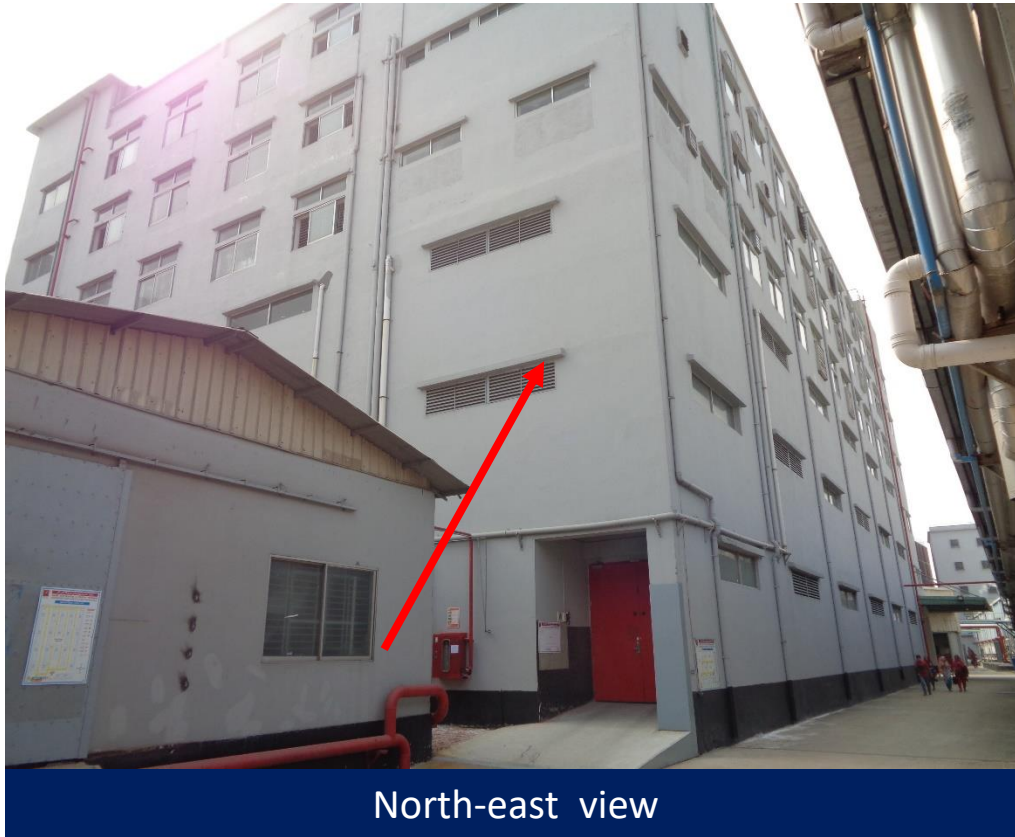
North-east view

As per BNBC, every building or structure designed shall have its design documents prepared in accordance with the provision of Section 1.9.1. The design document shall include a design report, and a set of structural drawings, which shall be prepared in compliance with section 1.9.1.1 and section 1.9.1.2 as per BNBC. At the time of inspection, only as-built drawing was available, but no design report was available which is required to be prepared in compliance with section 1.9.1.1 (part-6, BNBC).

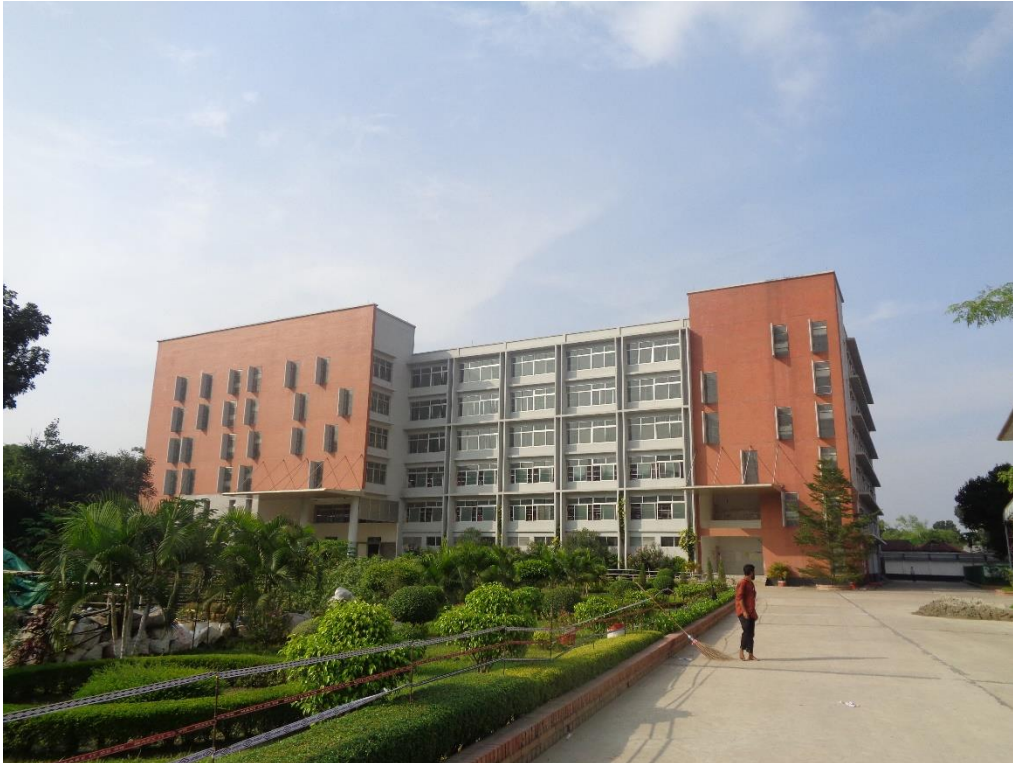
Front view

As per BNBC, every building or structure designed shall have its design documents prepared in accordance with the provision of Section 1.9.1. The design document shall include a design report, and a set of structural drawings, which shall be prepared in compliance with section 1.9.1.1 and section 1.9.1.2 as per BNBC. At the time of inspection, only as-built drawing was available, but no design report was available which is required to be prepared in compliance with section 1.9.1.1 (part-6, BNBC).

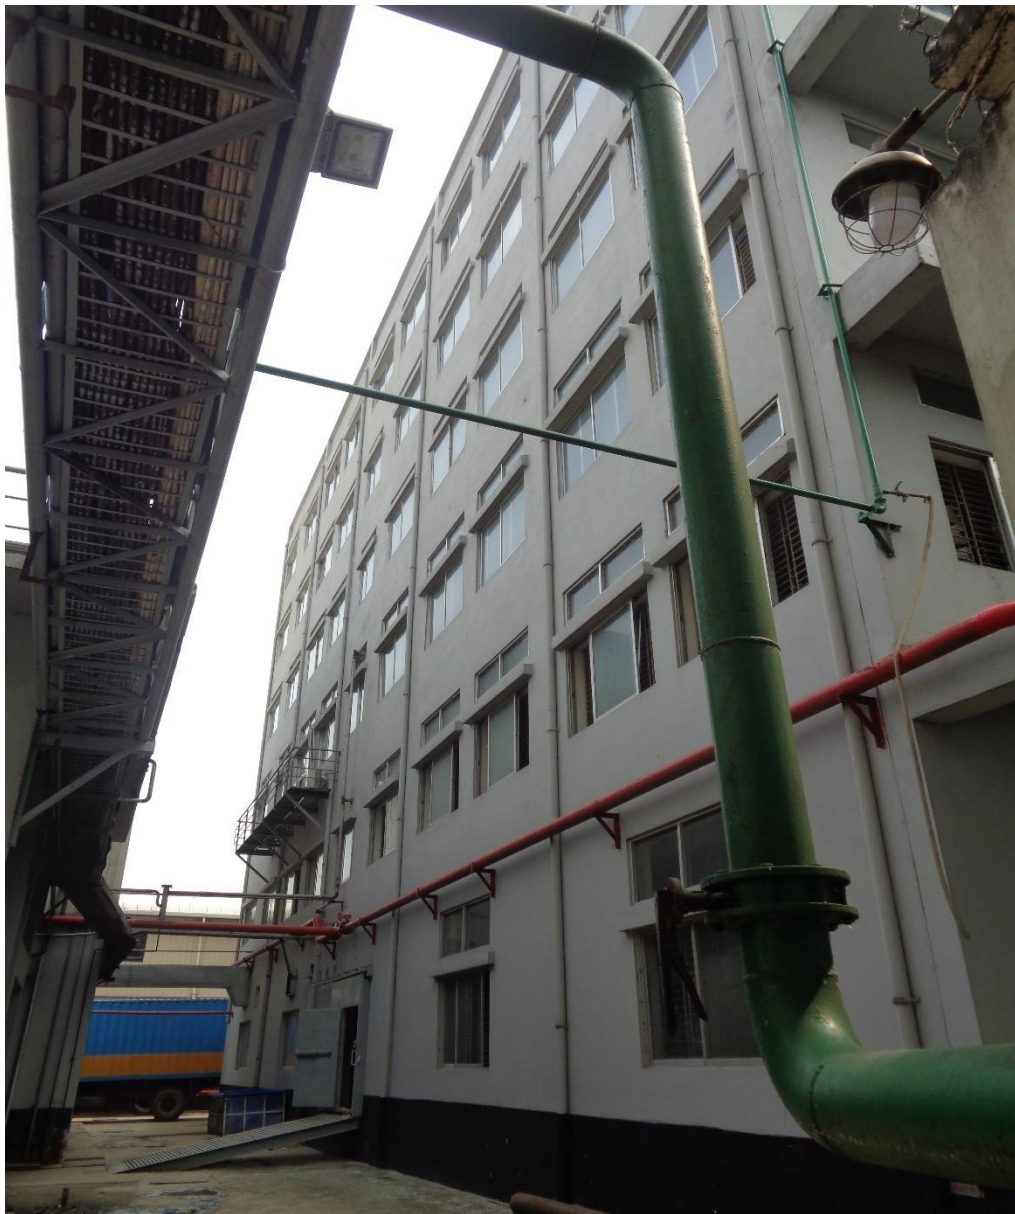
North view

As per BNBC, every building or structure designed shall have its design documents prepared in accordance with the provision of Section 1.9.1. The design document shall include a design report, and a set of structural drawings, which shall be prepared in compliance with section 1.9.1.1 and section 1.9.1.2 as per BNBC. At the time of inspection, only as-built drawing was available, but no design report was available which is required to be prepared in compliance with section 1.9.1.1 (part-6, BNBC).

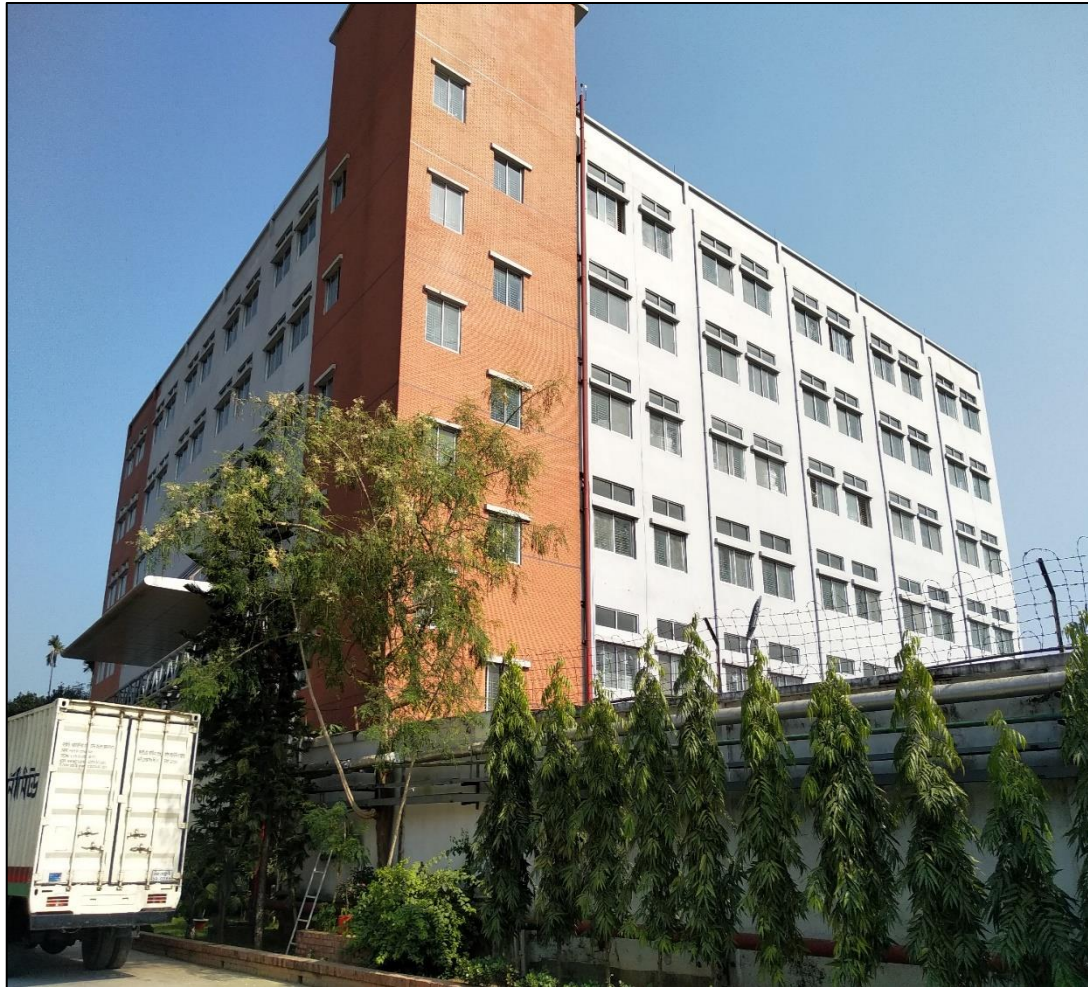
West-south Elevation

As per BNBC, every building or structure designed shall have its design documents prepared in accordance with the provision of Section 1.9.1. The design document shall include a design report, and a set of structural drawings, which shall be prepared in compliance with section 1.9.1.1 and section 1.9.1.2 as per BNBC. At the time of inspection, only as-built drawing was available, but no design report was available which is required to be prepared in compliance with section 1.9.1.1 (part-6, BNBC).

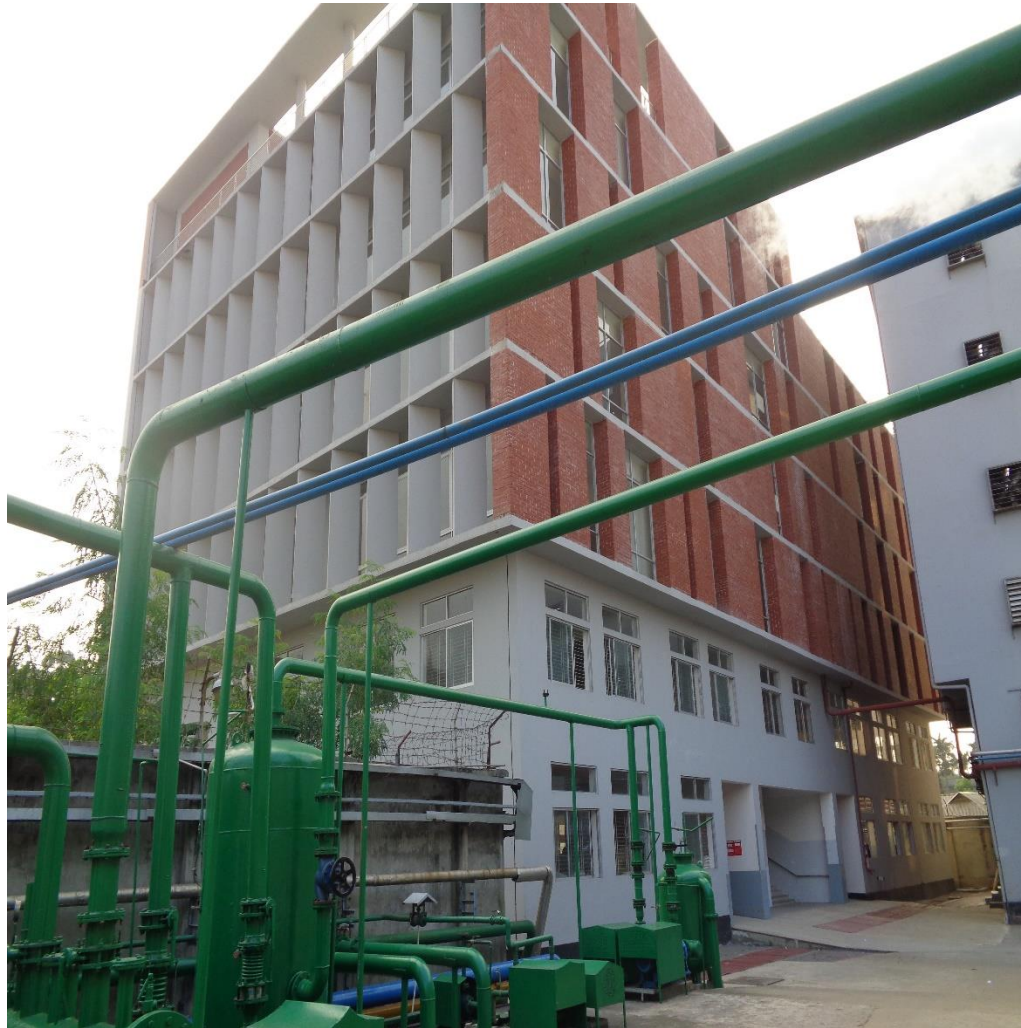
North-east view

As per BNBC, every building or structure designed shall have its design documents prepared in accordance with the provision of Section 1.9.1. The design document shall include a design report, and a set of structural drawings, which shall be prepared in compliance with section 1.9.1.1 and section 1.9.1.2 as per BNBC. At the time of inspection, only as-built drawing was available, but no design report was available which is required to be prepared in compliance with section 1.9.1.1 (part-6, BNBC).

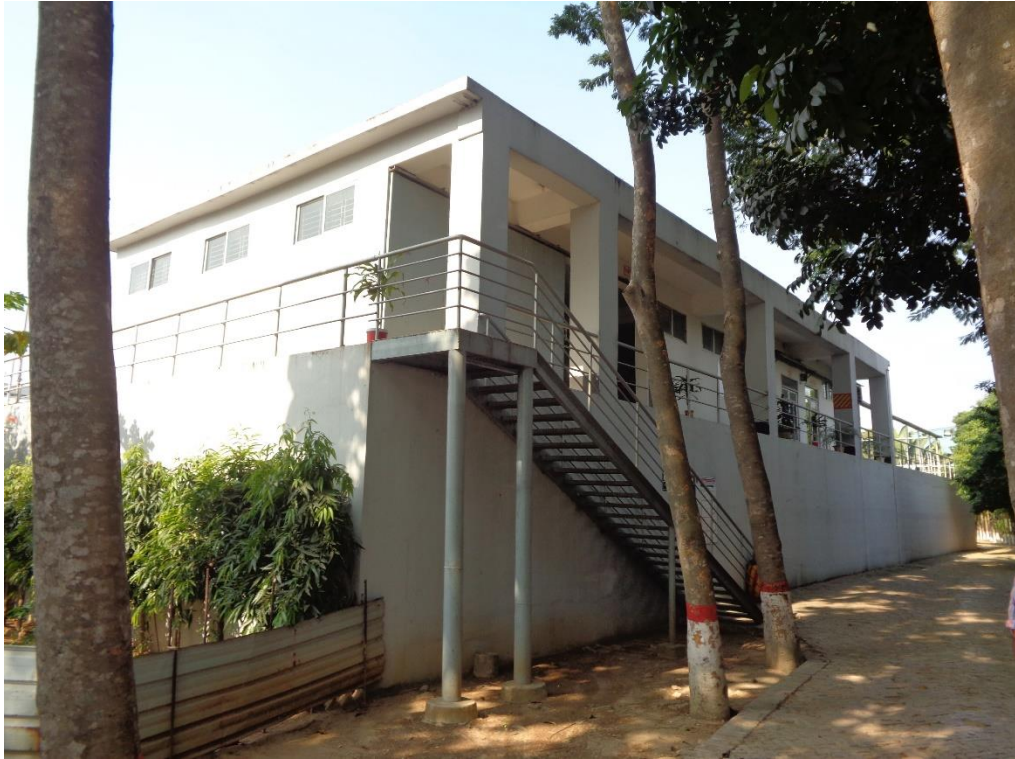
South-east elevation

As per BNBC, every building or structure designed shall have its design documents prepared in accordance with the provision of Section 1.9.1. The design document shall include a design report, and a set of structural drawings, which shall be prepared in compliance with section 1.9.1.1 and section 1.9.1.2 as per BNBC. At the time of inspection, only as-built drawing was available, but no design report was available which is required to be prepared in compliance with section 1.9.1.1 (part-6, BNBC).

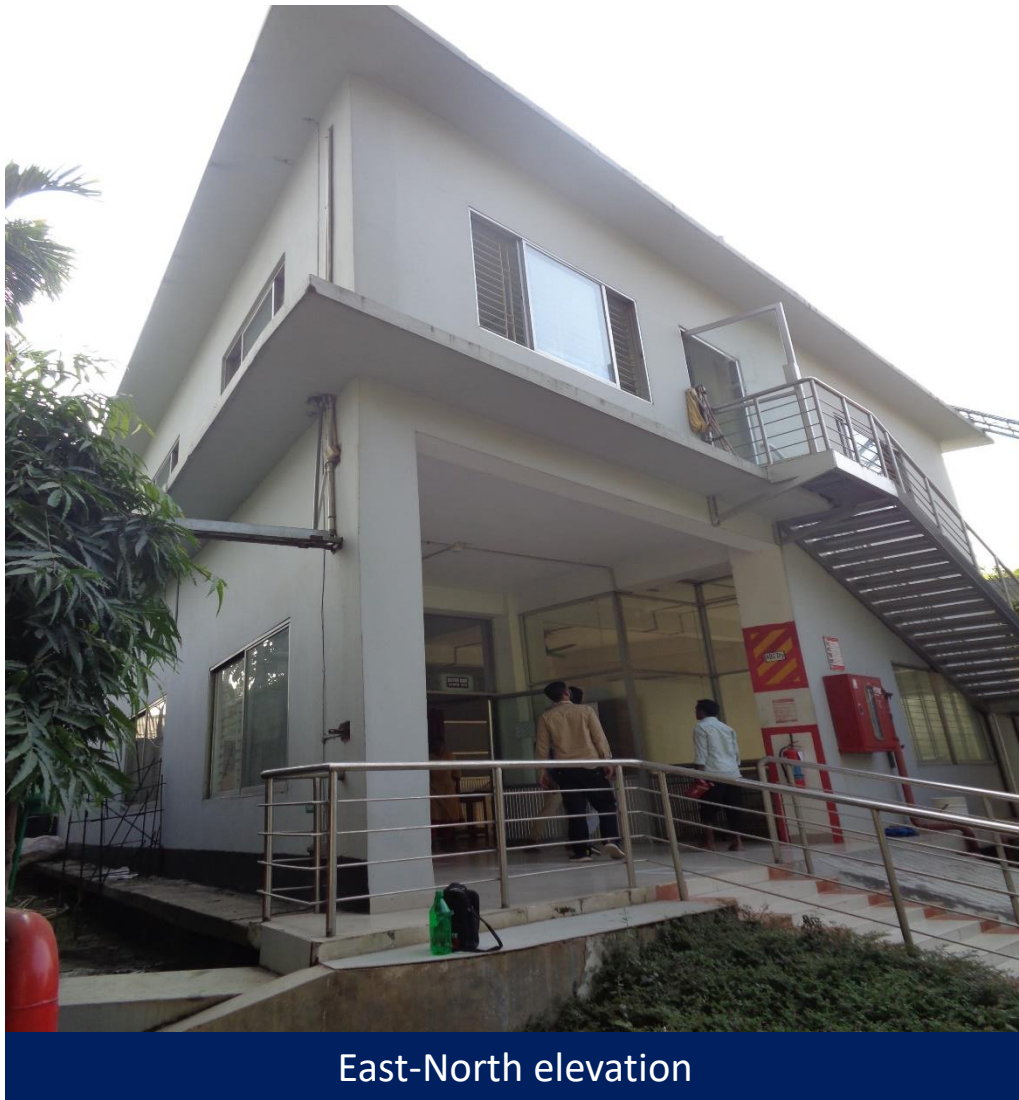
As per BNBC, every building or structure designed shall have its design documents prepared in accordance with the provision of Section 1.9.1. The design document shall include a design report, and a set of structural drawings, which shall be prepared in compliance with section 1.9.1.1 and section 1.9.1.2 as per BNBC. At the time of inspection, only as-built drawing was available, but no design report was available which is required to be prepared in compliance with section 1.9.1.1 (part-6, BNBC).

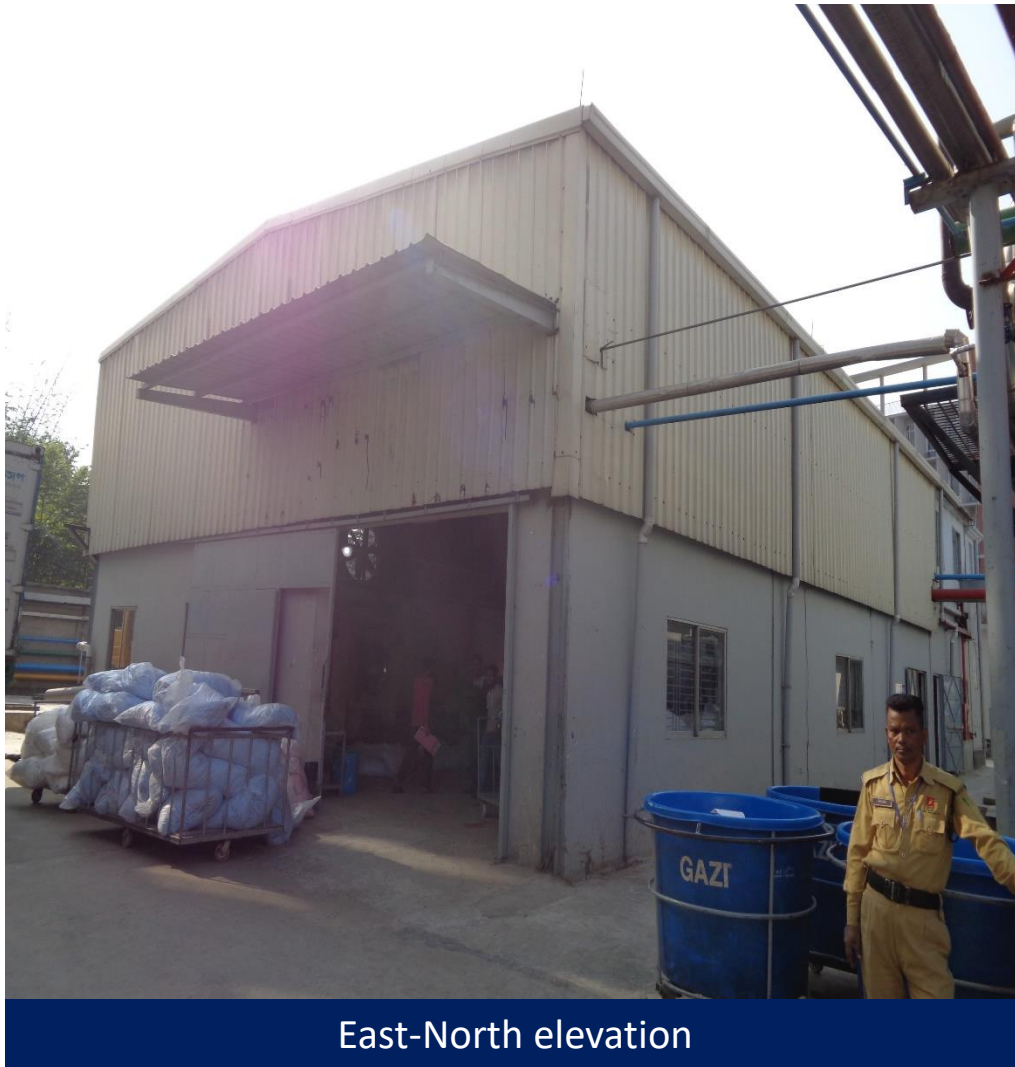
As per BNBC, every building or structure designed shall have its design documents prepared in accordance with the provision of Section 1.9.1. The design document shall include a design report, and a set of structural drawings, which shall be prepared in compliance with section 1.9.1.1 and section 1.9.1.2 as per BNBC. At the time of inspection, only as-built drawing was available, but no design report was available which is required to be prepared in compliance with section 1.9.1.1 (part-6, BNBC).

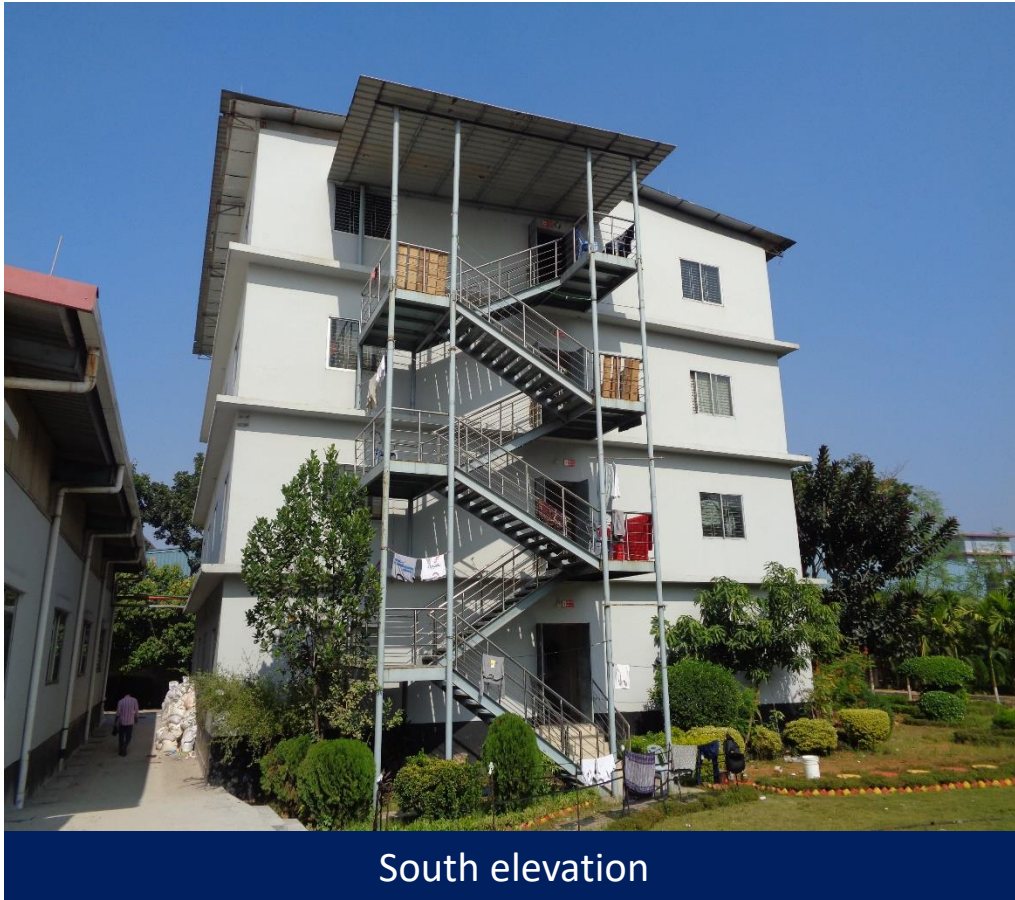
South elevation

As per BNBC, every building or structure designed shall have its design documents prepared in accordance with the provision of Section 1.9.1. The design document shall include a design report, and a set of structural drawings, which shall be prepared in compliance with section 1.9.1.1 and section 1.9.1.2 as per BNBC. At the time of inspection, only as-built drawing was available, but no design report was available which is required to be prepared in compliance with section 1.9.1.1 (part-6, BNBC).

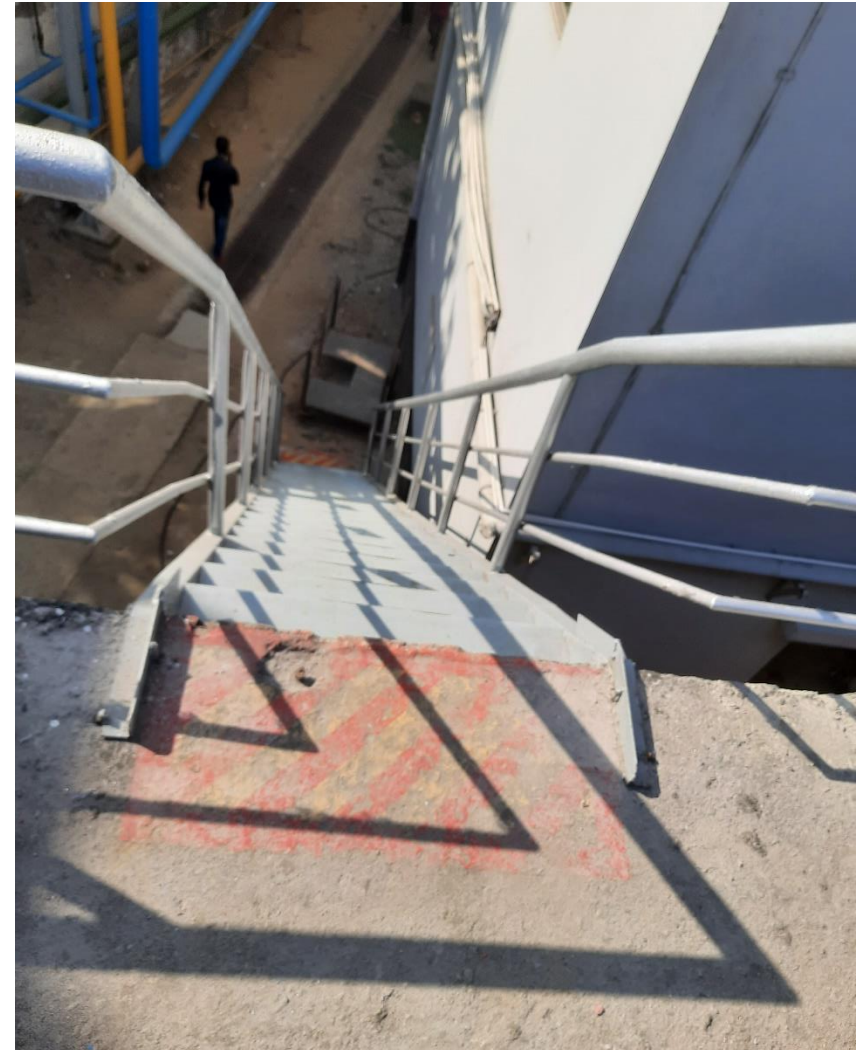
Steel Stair

Apparently inadequate steel member size and no stability system provided.

| Item No. | Observation | Recommended Action Plan | Recommended Timeline |
|---|--|--|---|
| 23 | Apparently inadequate connection of steel stair (Building-4: Cooling Tower) | Building engineer is required to carry out stress & stability check of the steel stair. | 6-weeks |
| 24 | Apparently inadequate connection of steel stair (Building-4: Cooling Tower) | Implement remediation work where necessary. | 6-months |

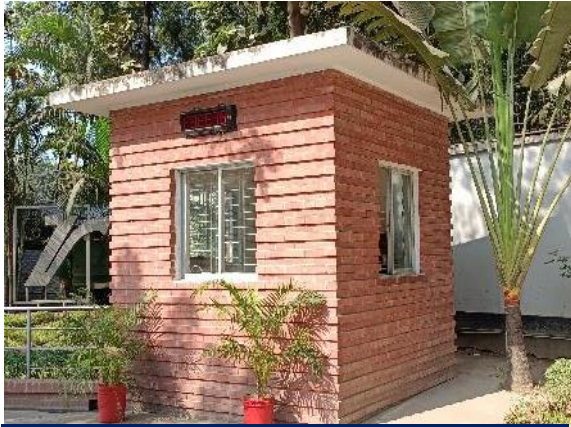
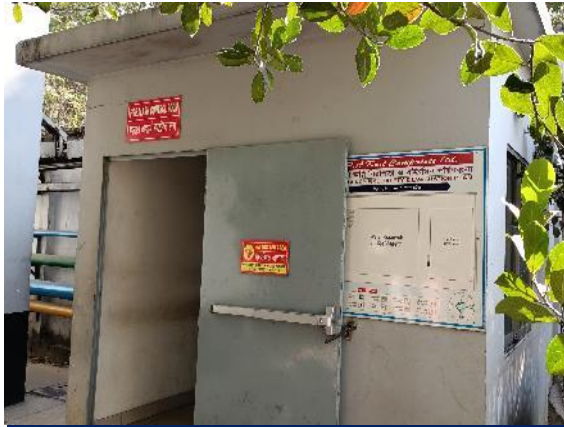
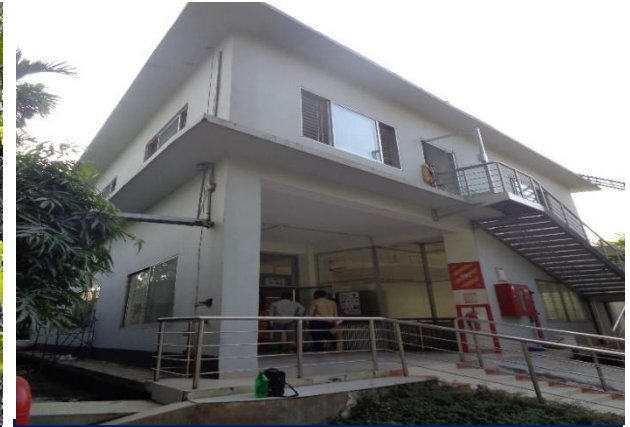
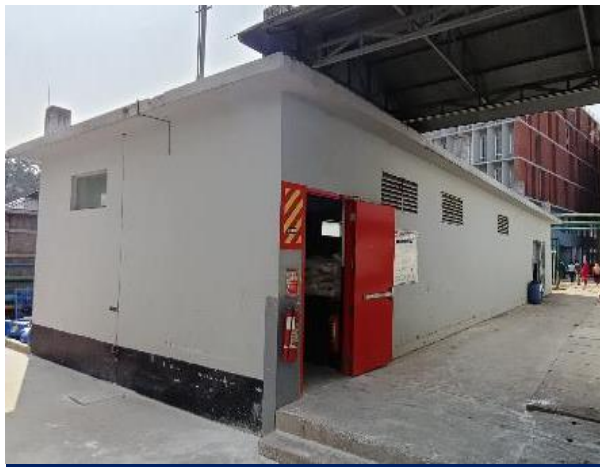
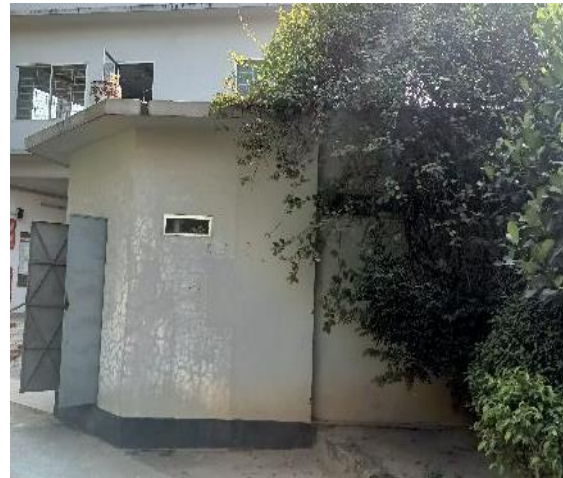
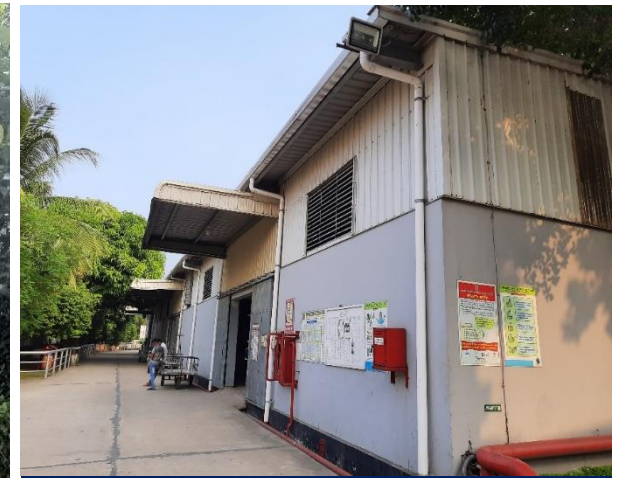
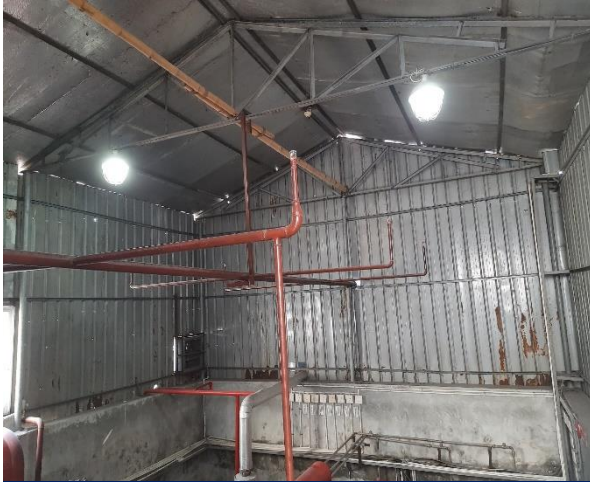
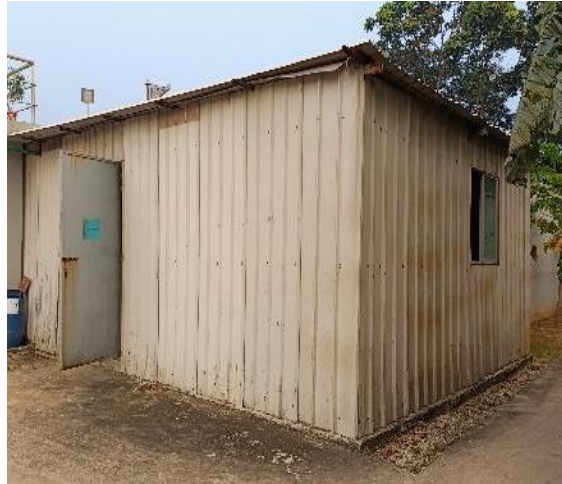
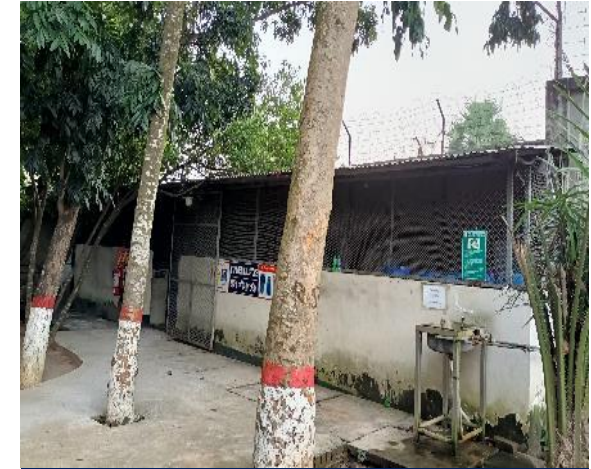
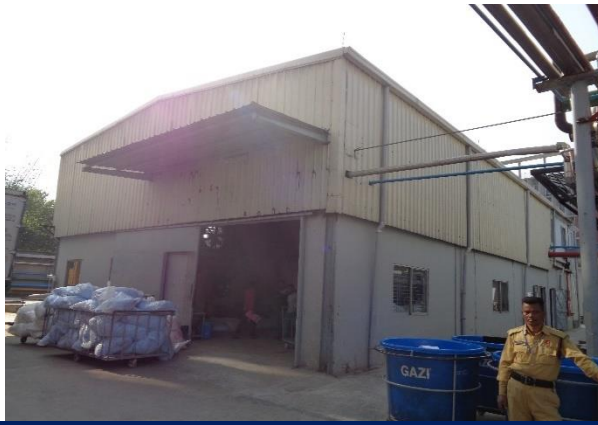
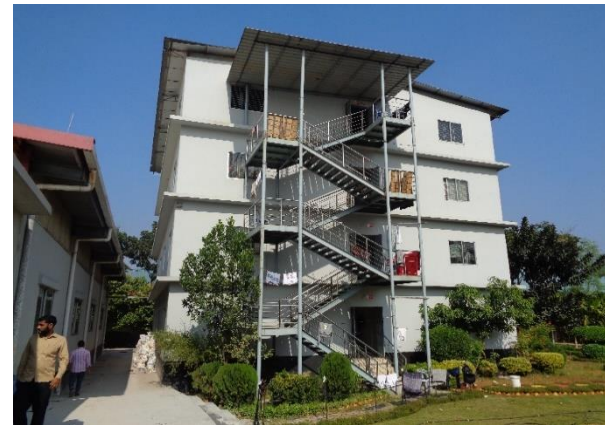
Lack of structural drawings

Structural drawings were not available for these structure. Building engineer is required to produce as-built drawing reflecting the as constructed condition.

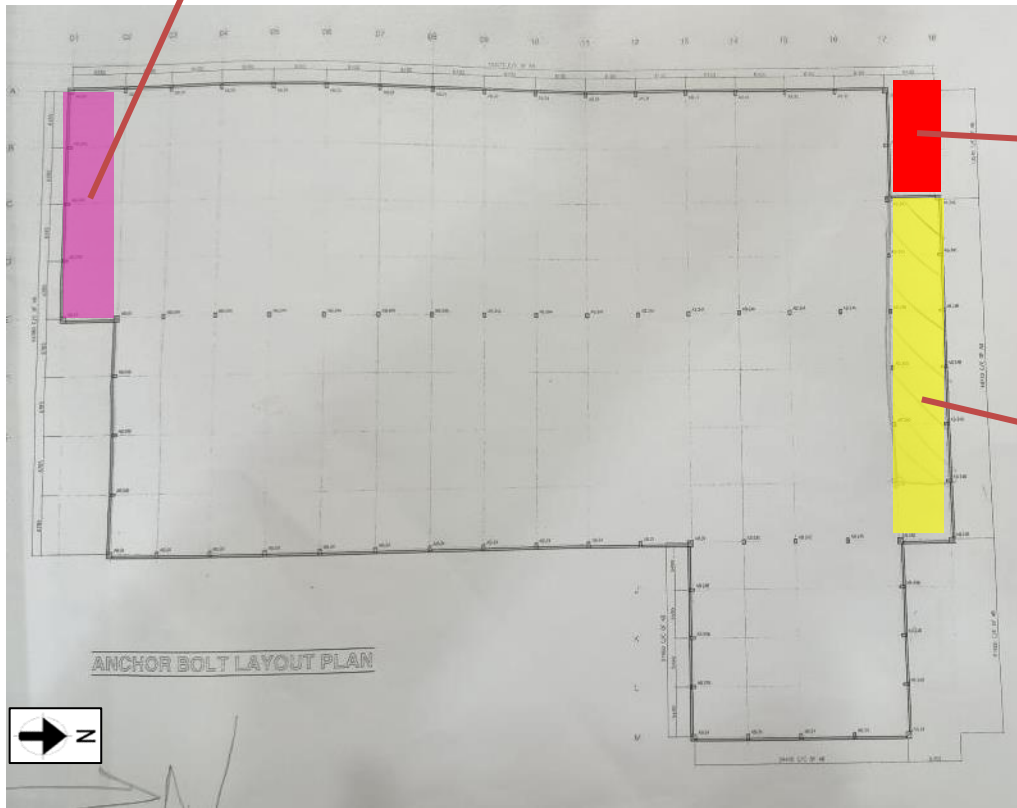
Layout Plan

No structural drawings details were found for the mezzanine floor. Undocumented extension was observed at Northwest corner. Also, connection details were not available in the provided drawings. Moreover, a separate single storied chemical building was found inside the shed.

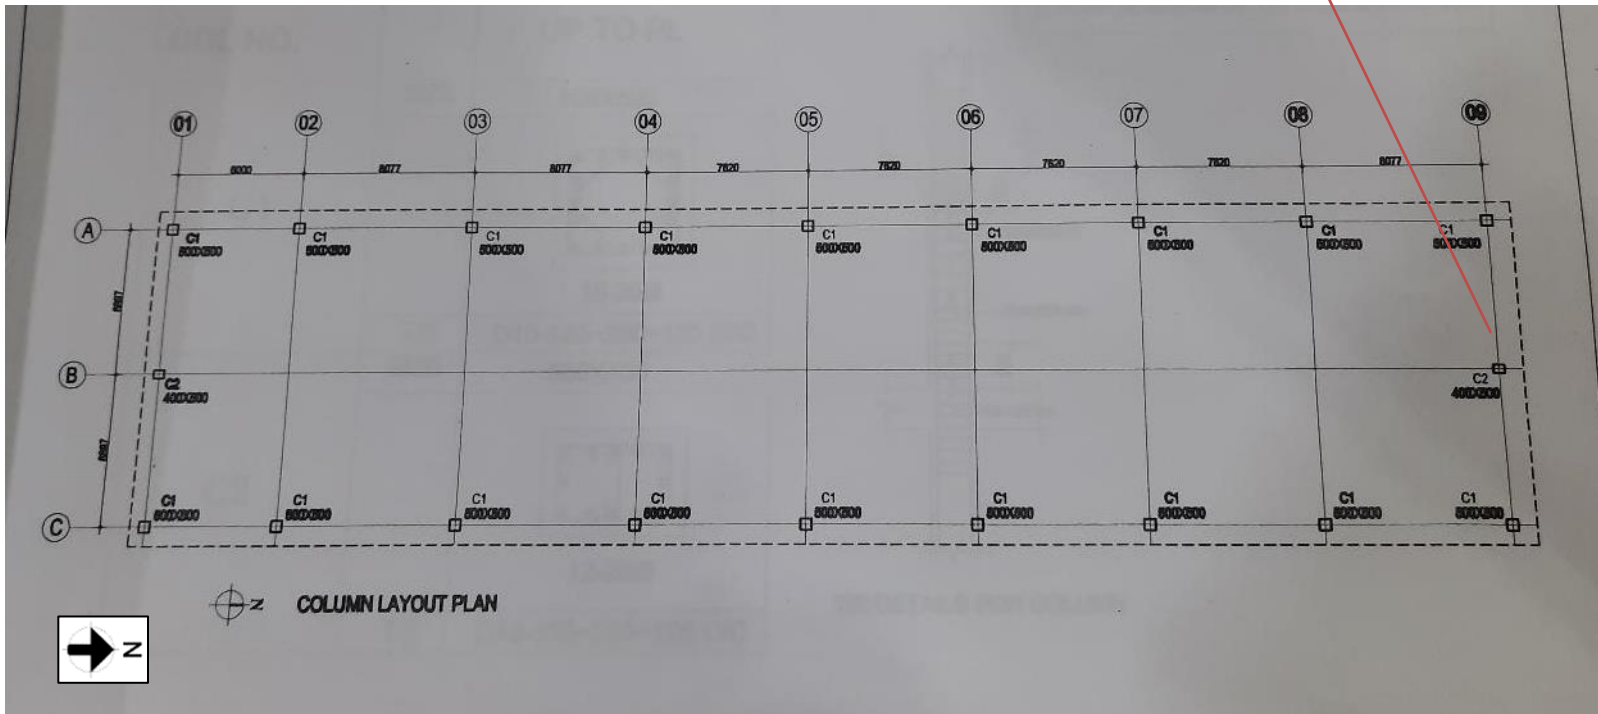
Section of Grid 9

Architectural of the shed were not found. Also, connection details and sectional details of Grid 9 were not available in provided drawings.

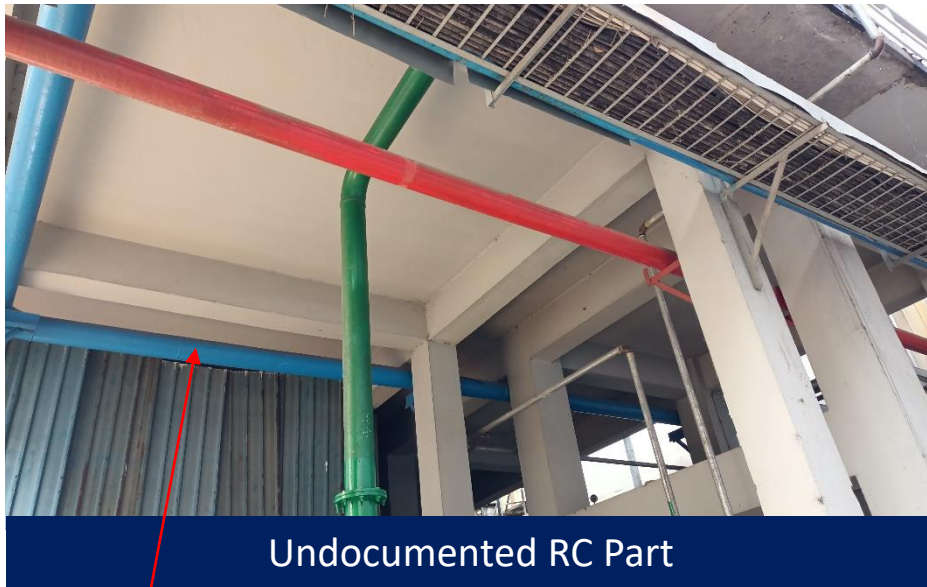
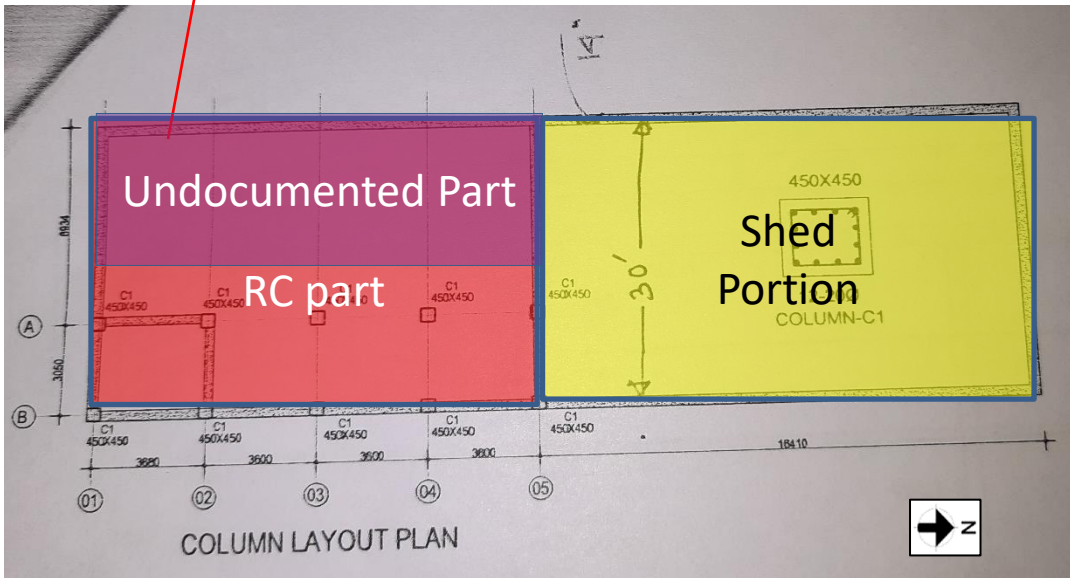
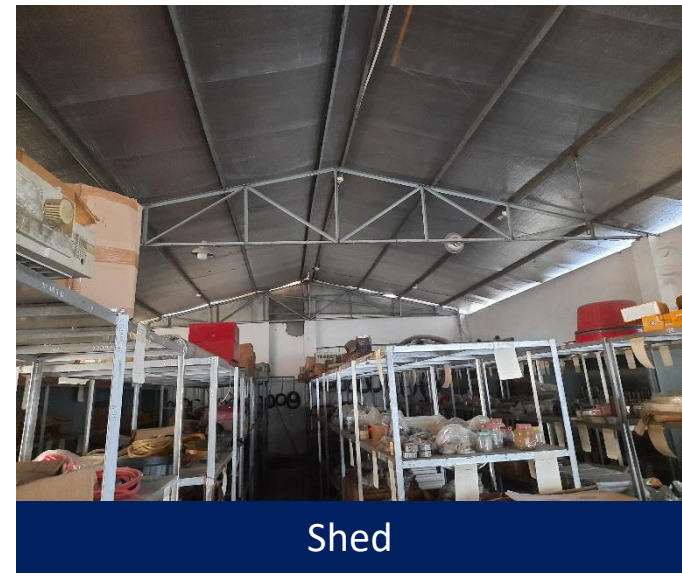
Structural drawings were found incomplete for RC part. No drawing details were available for the shed portion. Building engineer is required to produce full set of as-built drawing with connection details which reflects the as constructed condition.
