P.A Knit Composite (Extension)

Jamirdia, Habir Bari, Valuka, Mymensingh-2240

12th, 25th October & 29th November 2021

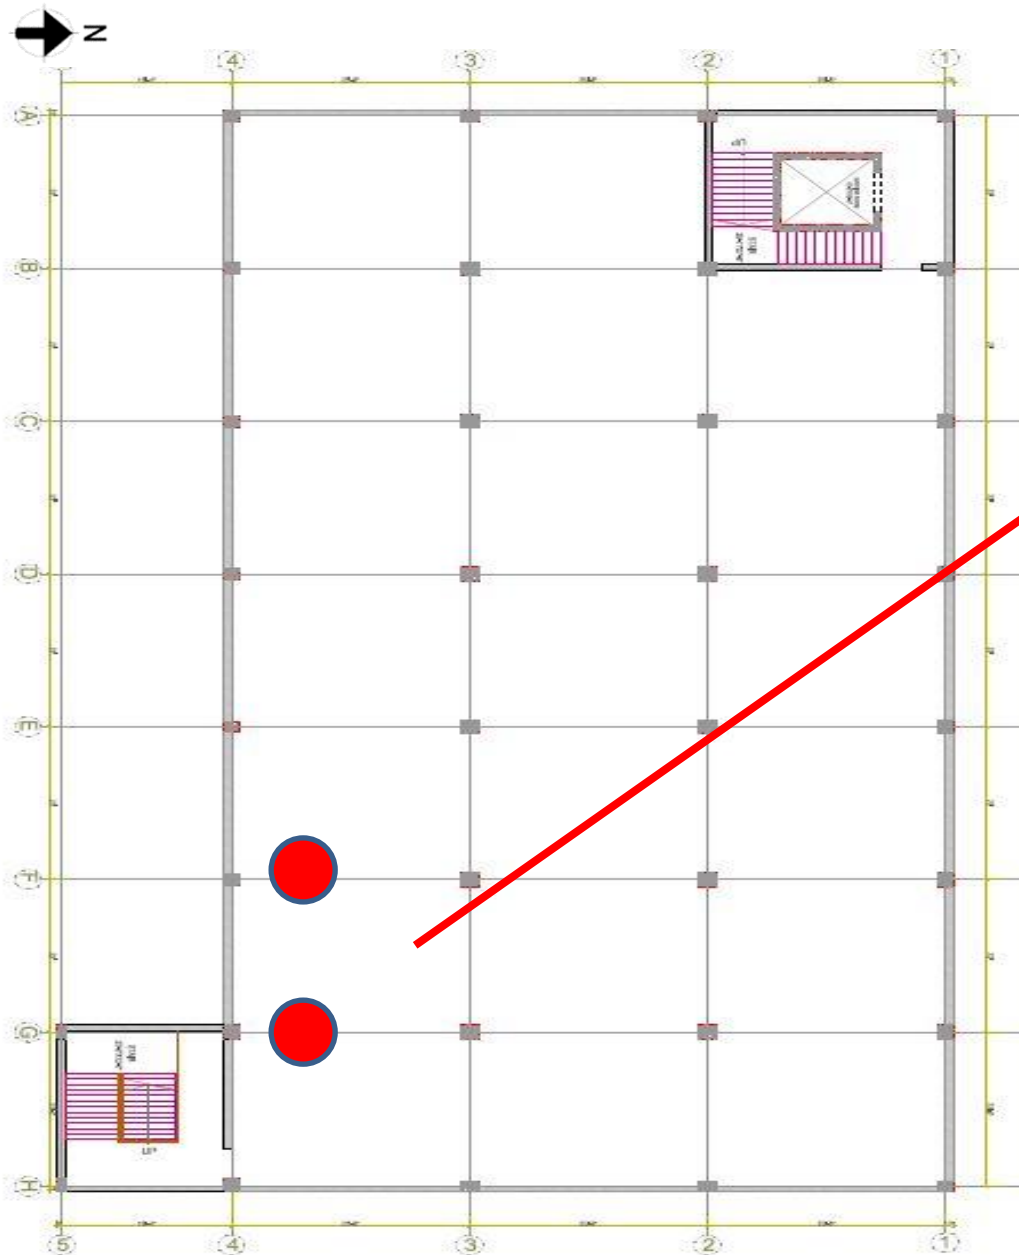
Roof layout

Two plastic water tank having capacity of 5000 litre each found on roof slab which were not shown in roof layout. Building engineer is required to update the as-built drawing as well as check the capacity of roof beam-slab considering the point load.
