Revision: Issue 1  
Date: 25.01.2022

# Saiham Knit Composite Ltd. (Extension Area)

Saiham Nagar, Noyapara, Madhabpur, Hobigonj  
(24.18375, 91.35222)

2<sup>nd</sup> June & 26<sup>th</sup> August 2021

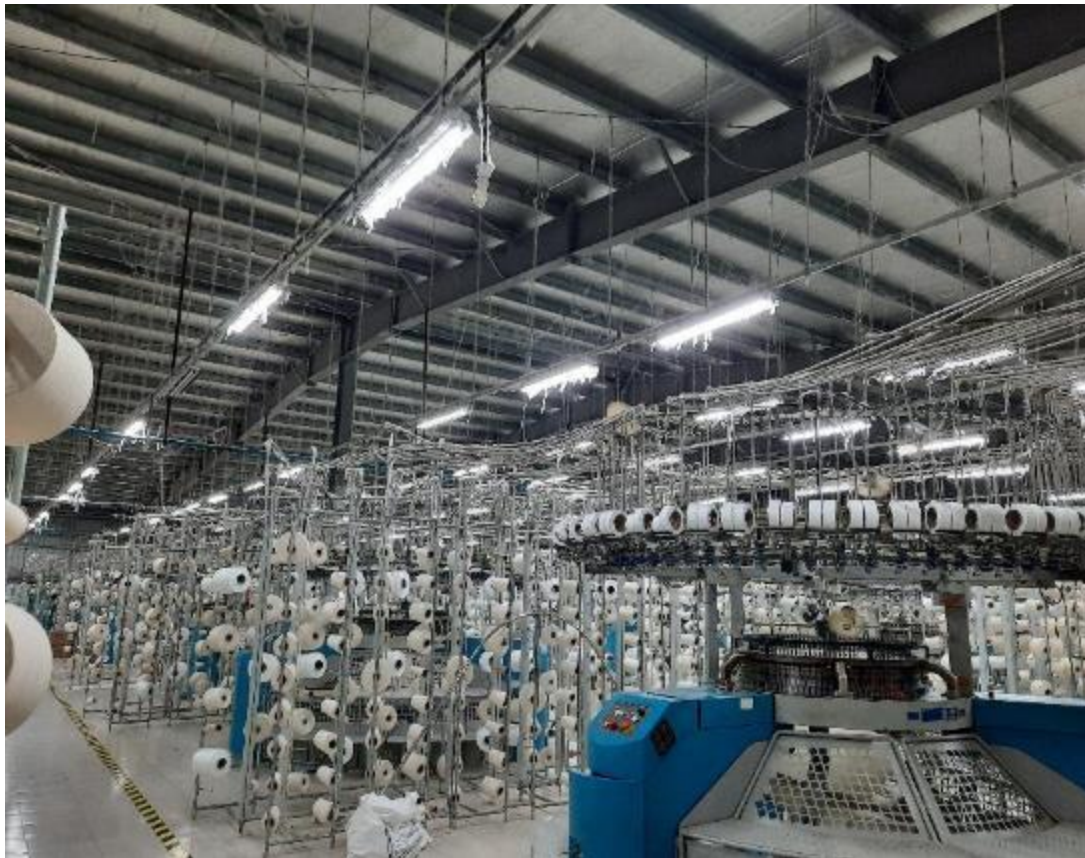
**Design report not available**

*Design Certified*

**A A STEEL LTD.**

| Item No. | Observation | Recommended Action Plan | Recommended Timeline |
|---|---|---|---|
| 16 | Design report not available (Building 4 -Knitting Shed) | Carryout recommendations of design report where necessary. | 6-months |

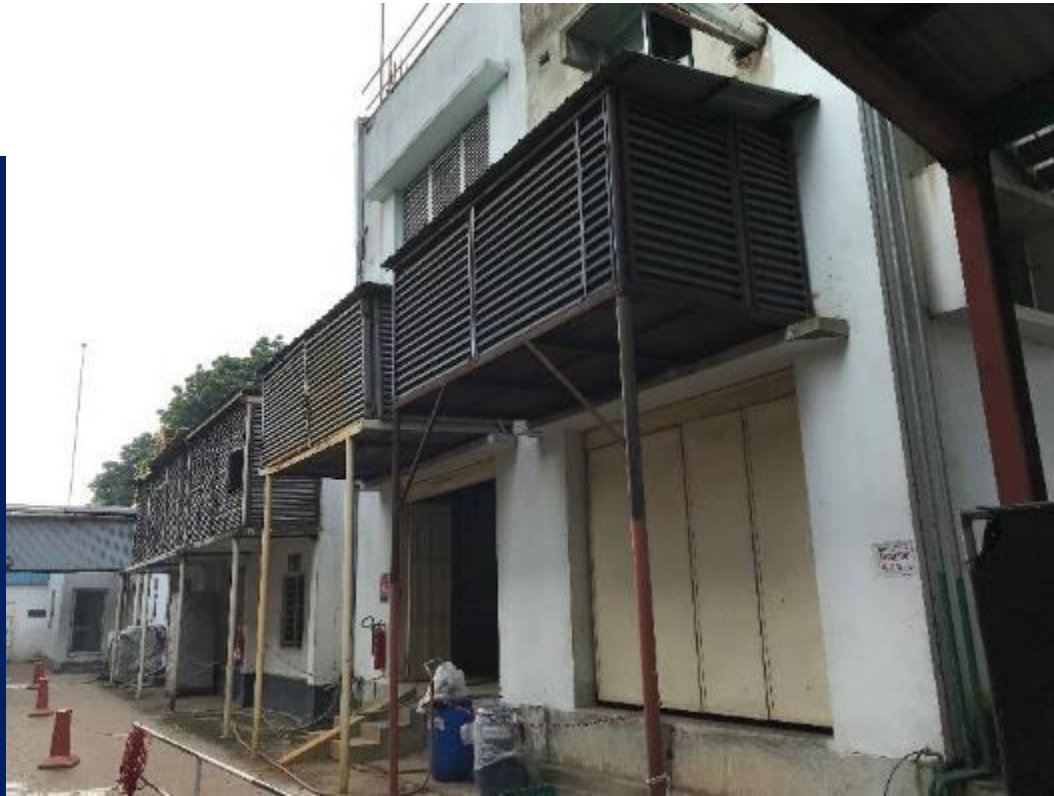
**As-Built documents not available**

As per BNBC, every building or structure Designed shall have its design documents Prepared in accordance with the provision of Section 1.9.1 The design document shall include a design report, and a set of structural drawings, which shall be prepared in compliance with Section 1.9.1.1 and section 1.9.1.2 as per BNBC. No credible as built drawing were available on site. Building engineer is required to prepare design report in compliance with section 1 9 1 1 (part 6 BNBC)

| Item No. | Observation | Recommended Action Plan | Recommended Timeline |
|---|---|---|---|
| 28 | As-Built documents not available. (Building 9 -Generator) | Carryout recommendations of EA. | 6-months |

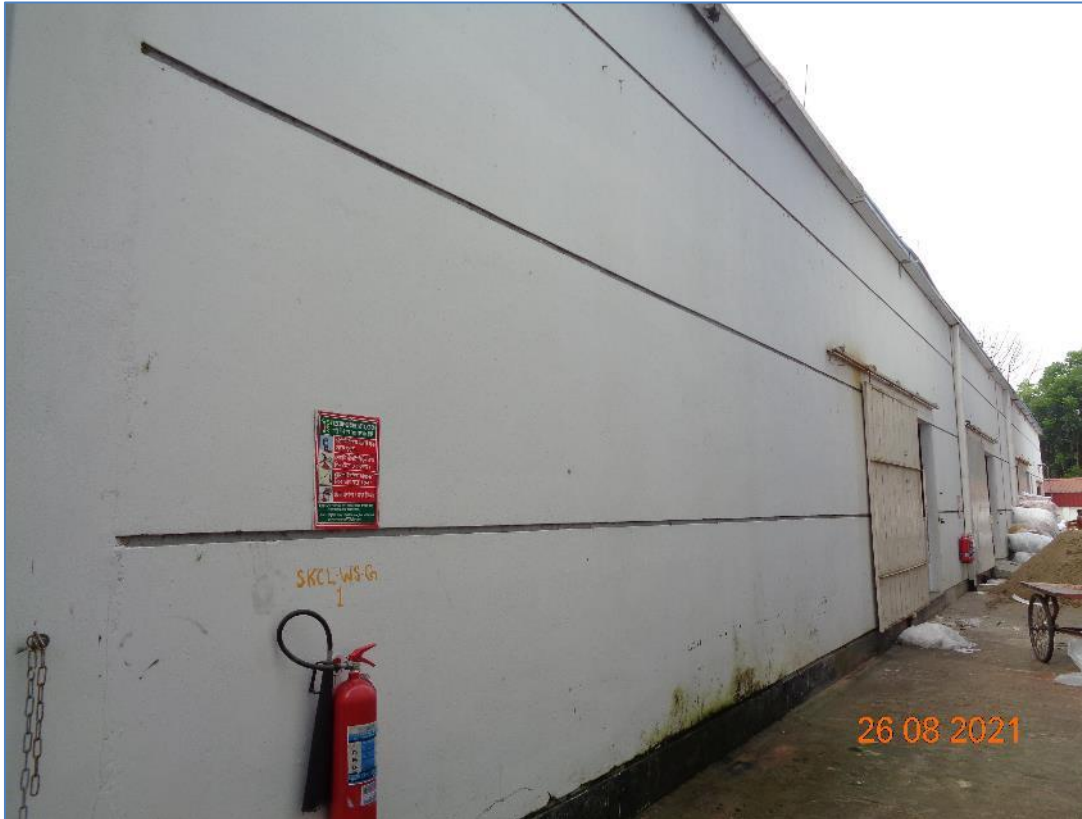
**Design report not available**

As per BNBC, every building or structure designed shall have its design documents prepared in accordance with the provision of Section 1.9.1. The design document shall include a design report, and a set of structural drawings, which shall be prepared in compliance with section 1.9.1.1 and section 1.9.1.2 as per BNBC. At the time of inspection, only a design certificate was available on site, but no design report was available which is required to be prepared in compliance with section 1.9.1.1 (part-6, BNBC).

| Item No. | Observation | Recommended Action Plan | Recommended Timeline |
|---|---|---|---|
| 30 | Design report not available (Building 11- Wastage Go-down) | Carryout recommendations of design report where necessary. | 6-weeks |
