# Lantabur Apparels Ltd (Extension Unit)

Kewa, Boherarchala Sreepur, Gazipur  
(24.1969 N, 90.4071 E)

26 December 2021 & 23 January 2022

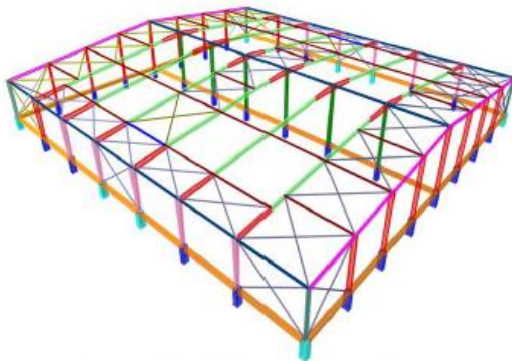
Figure 2.1.1: 3D View of Analytical Model

The structural system of the building is a RC beam-column frame structure. The building is classified as an ordinary moment resisting frame structure. General 3D view of the building has been presented in Figure 2.1.1.
