Victoria Intimate Limited

Dakkhin Vangnahati, Boiragirchala, Sreepur Gazipur

24th January 2022

Observations

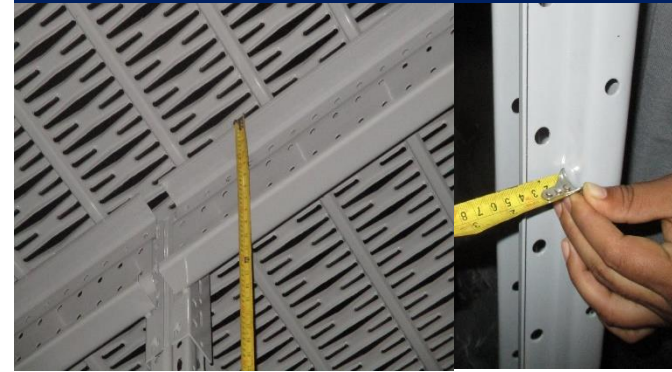
**No design documents available for
steel mezzanine floor**

Column directly connected to ground slab; No foundation

Bracing in rack frame

Chequered plate, beam and column

As per BNBC, every building designed shall have its design documents prepared in accordance with the provision of Section 1.9.1. The design document shall include a design report, material specifications and a set of structural drawings.

During inspection, the steel mezzanine floor was being used for storage. The structure has no foundation isolated foundation. However, the factory engineer is required to survey the structure and prepare a set of design documents in compliance of BNBC.

Item No.	Observation	Recommended Action Plan	Recommended Timeline
05	No design documents available for steel mezzanine floor. (Production Building)	Carry out remedial works where required.	6-months
06	No design documents available for steel mezzanine floor. (Production Building)	Implement final loading plan.	6-months
07	Lateral load resisting system consideration in design. (Admin Building)	The building engineer is required to check the lateral load resisting system and revise the design report in compliance of BNBC 1.9.1	6-weeks
08	Lateral load resisting system consideration in design. (Admin Building)	Implement the remedial works where necessary.	6-months
