# Azim & Son (Pvt) Ltd Unit 2 (Extension)

Gacha Road; Fakir Market; Gazipur  
(23.936126, 90.377798)

7<sup>th</sup> February 2022

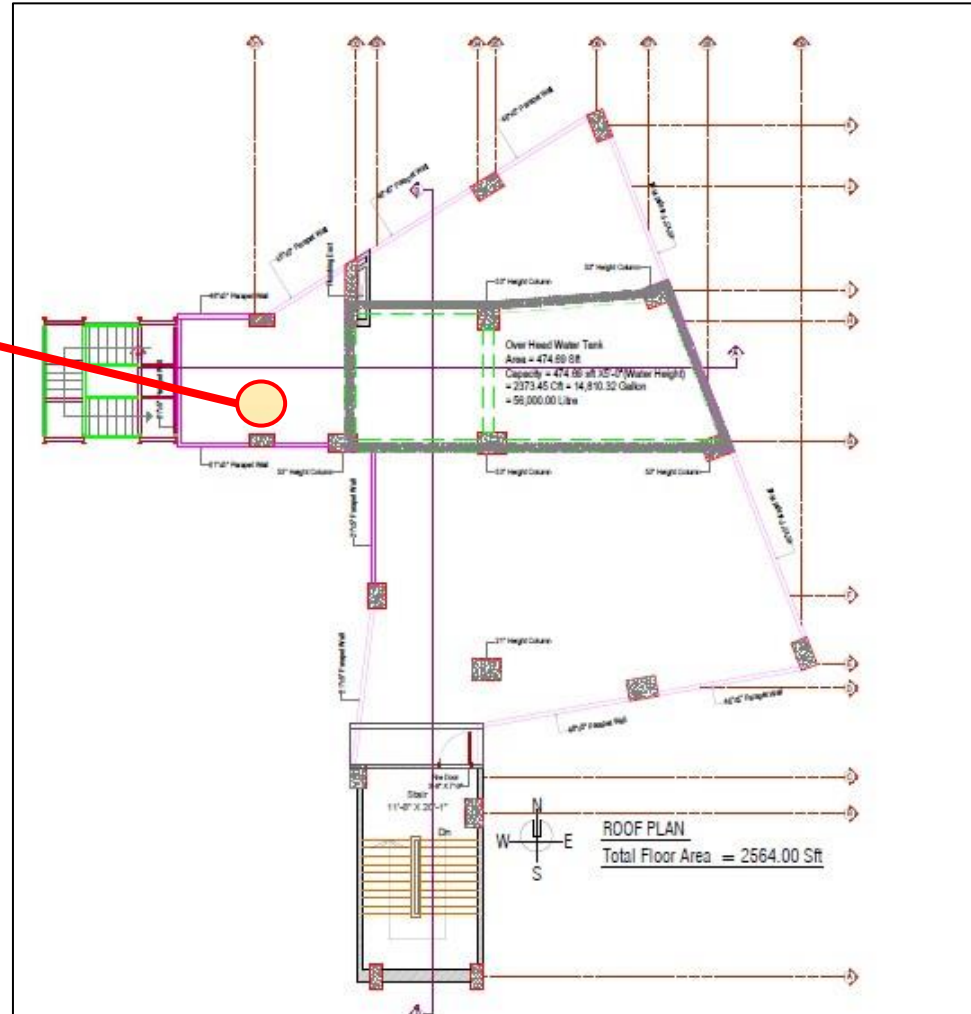
Roof Layout plan

Undocumented 2000L water tank

An undocumented plastic water tank was found at roof. Factory engineer is required to survey the whole structure and update the as-built drawing. The loading from the plastic water tank is required to be considered during an adequacy check of slab.
