Crosswear Industries Limited

Ashu/Shilpa-16, Ward-01, Kathgara, Zirabo, Ashulia, Dhaka-1341, Bangladesh
(23.916381 N, 90.294261 E)

20 February 2022

Observations

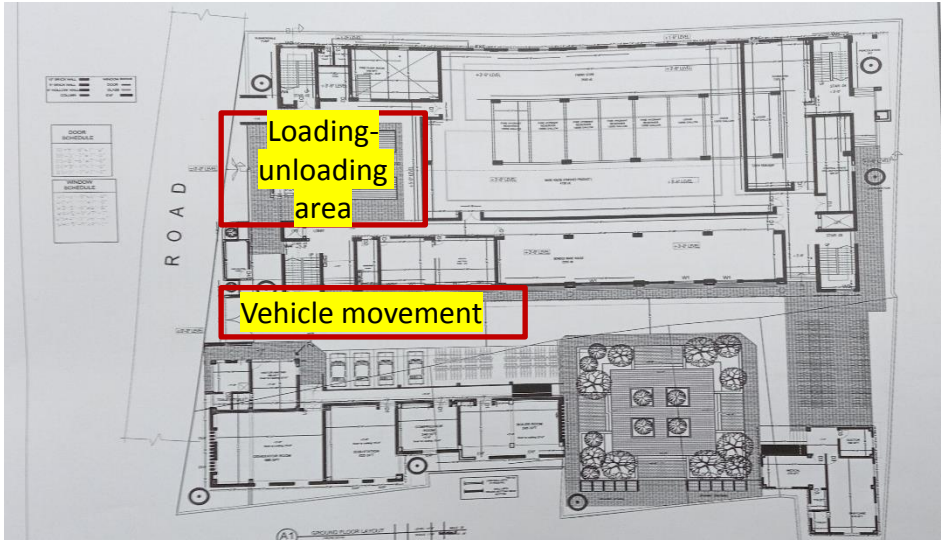
Ground floor plan

**Columns & beams are susceptible
to vehicle impact**

1st floor beam- susceptible to vehicle impact

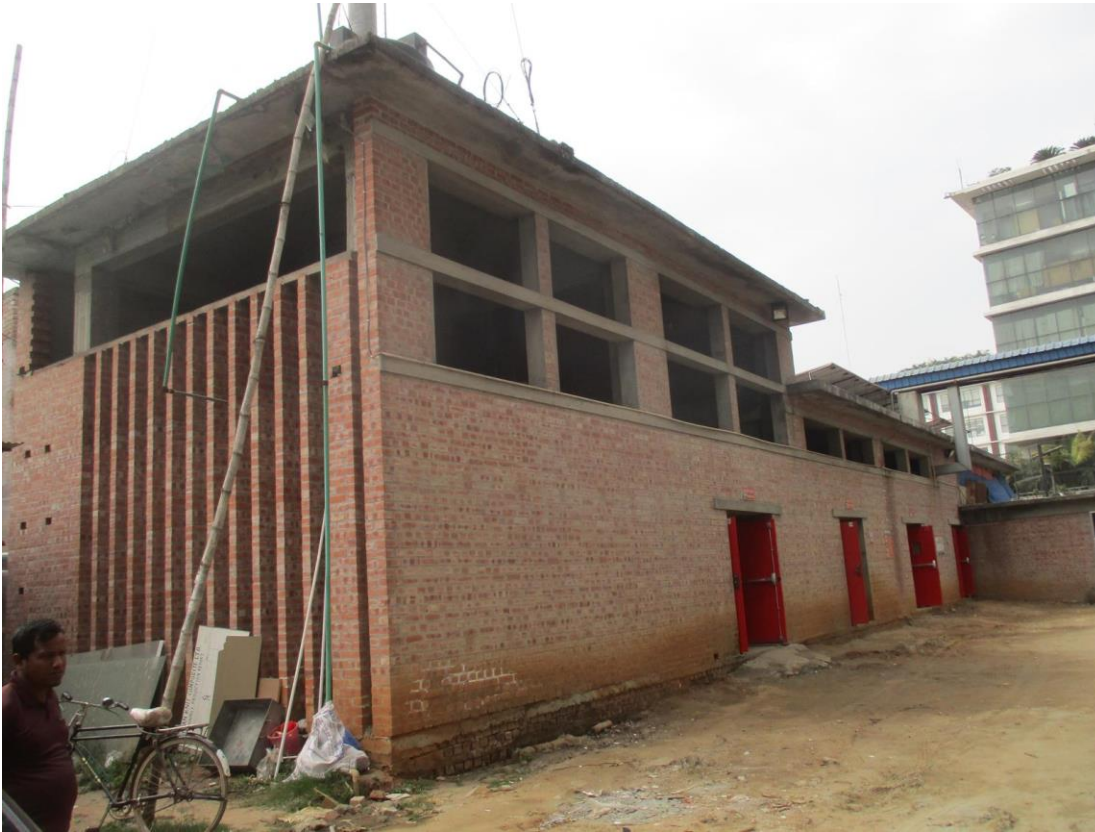
Utility Building

Absence of design report

As per BNBC, every building or structure designed shall have its design documents prepared in accordance with the provision of Section 1.9.1. The design document shall include a design report, and a set of structural drawings, which shall be prepared in compliance with section 1.9.1.1 and section 1.9.1.2 of part-6, BNBC.

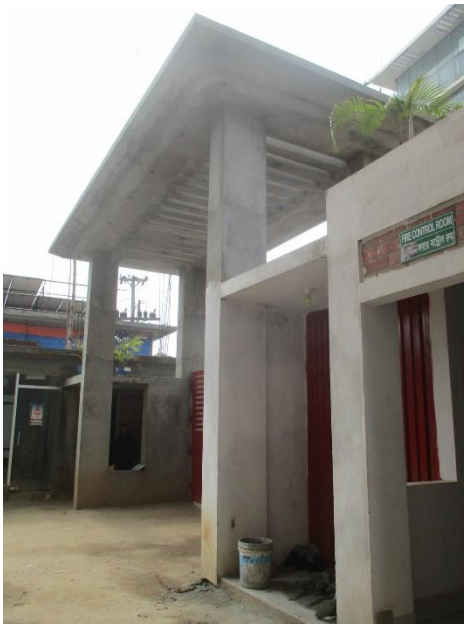
Gate structure is structurally connected with utility building at south and adjacent security room at north.

The structural connection details were not available in the drawings. The building engineer is required to produce detail of structural connections and incorporate in the as-built documents.
