# Liz Knitting & Printing Industry.

Holding-1,Block-C, Shaheed Mosharaf Hossain Road,  
Purbo Chandora, Sofipur, kaliakoir, Gazipur.  
(24.032036 N, 90.270180 E)  
28 February 2022

# Observations

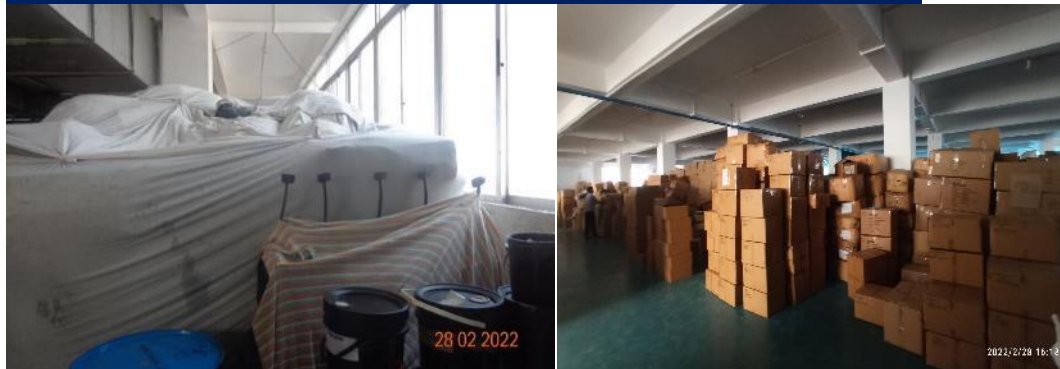
4<sup>th</sup> floor layout plan

Load consideration on 4<sup>th</sup> floor (5 kPa)

Uncontrolled loading on floors

| Item No. | Observation | Recommended Action Plan | Recommended Timeline |
|---|---|---|---|
| 01 | Floor load plan management (Building-2) | The building engineer is required to check the occupancies and update the floor live loading plan for the building based on BNBC loading requirements and capacity of building floor, column & foundations. | 6-weeks |
