# KM Nobely Garments Ltd (Extension Building)

8/1 Zorun, Konabari Gazipur- 1702

24<sup>th</sup> May 2022

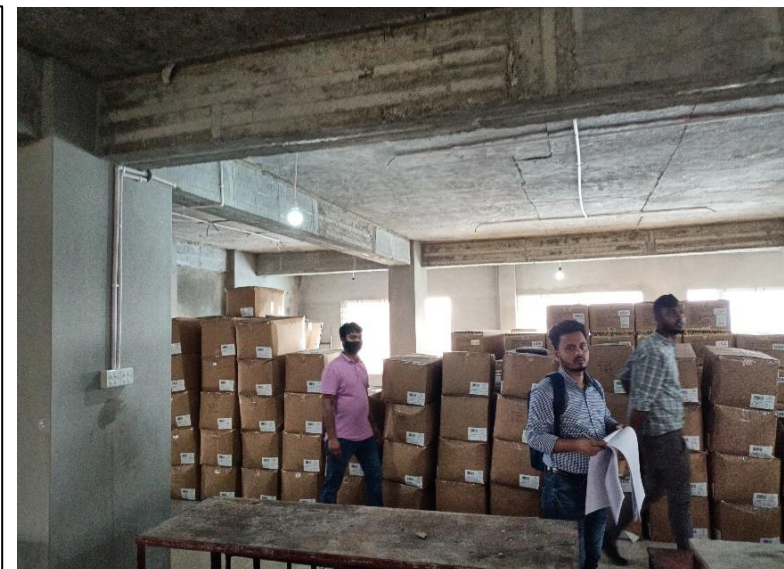
Floor Loading

Floor live load plan with 105 psf (5 kN/m<sup>2</sup>) loading limit

As per factory management, the 3<sup>rd</sup> & 4<sup>th</sup> floor is allotted for finished goods area. As per BNBC, the minimum floor live load for light storage is 6 kN/m<sup>2</sup> (125 psf). The storage in this building is designed for 5 kN/m<sup>2</sup> live loads.

The building engineer is required to revise the storage live load limit and related design documents accordingly based on BNBC requirement.

| Item No. | Observation | Recommended Action Plan | Recommended Timeline |
|---|---|---|---|
| 03 | Design report needs to be revised (6 storied RC Building) | Implement the recommendations of design report. | 6-months |
