# Square Apparels Limited.

Mamarishpur, Mallikbari, Bhaluka, Mymensingh  
(24.27937, 90.36931)

06 June 2022

# Observations

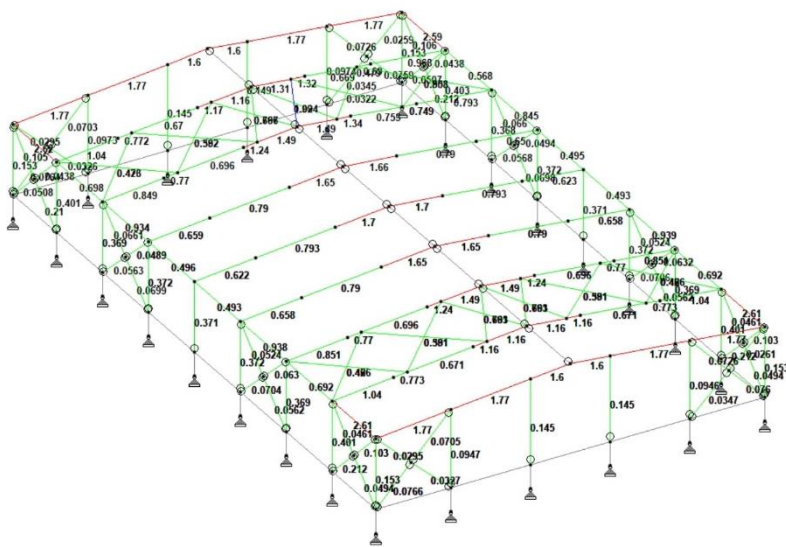
## Stress Member Ratio

In DEA report, overstress has been found in steel members. Also, it has been noted that pedestal RC columns of the building are inadequate. Remedial actions has not been carried out as per recommendation of DEA report.

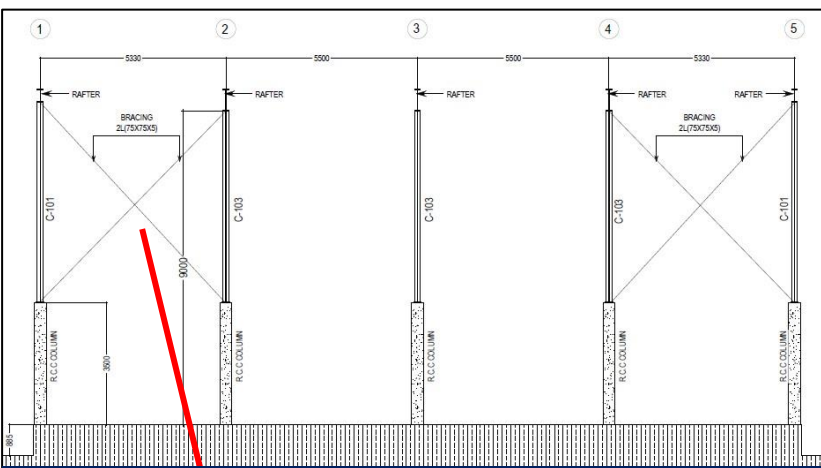
Bracing Layout plan (elevation)

**Lack of lateral stability system**

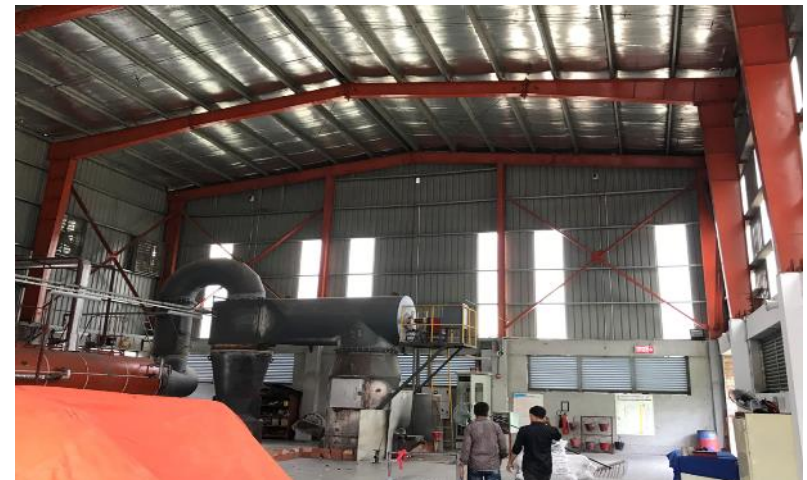
Angle bracing at end bays

Lateral load transfer media (compression strut) along the long direction is missing. Building engineer to check the lateral stability of the structure.
