Pretty Composite Textiles Ltd (extension of S.Suhi Industrial Park Ltd) Oxford Colours Ltd.

Holding # Hazi Liakot Mir Road, Zamgora, Ashulia, Savar, Dhaka-1349 (Beside Fantasy kingdom).

26 June 2022

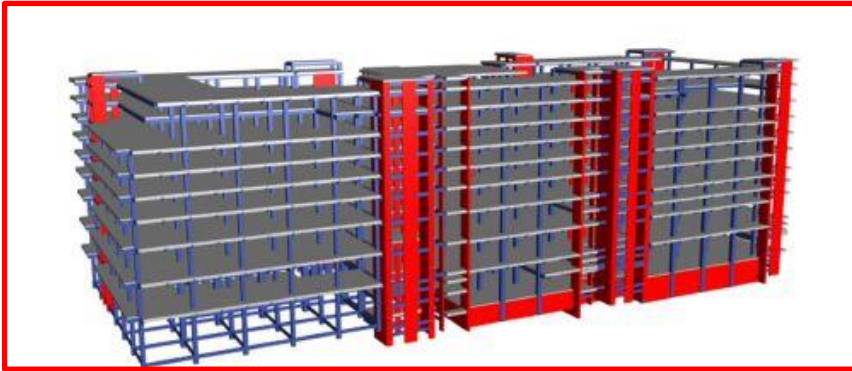
Building is designed as 8 storied

The building has permit drawing for 6 storied and factory is conducting vertical extension.

The building has permit drawing for 6 storied and factory is conducting vertical extension at all tree parts. Factory is required to seek approval from local authority before conducting extension above 6 storied. Also, a Detail Engineer Assessment (DEA) is required to completed before the construction above 6-storied.

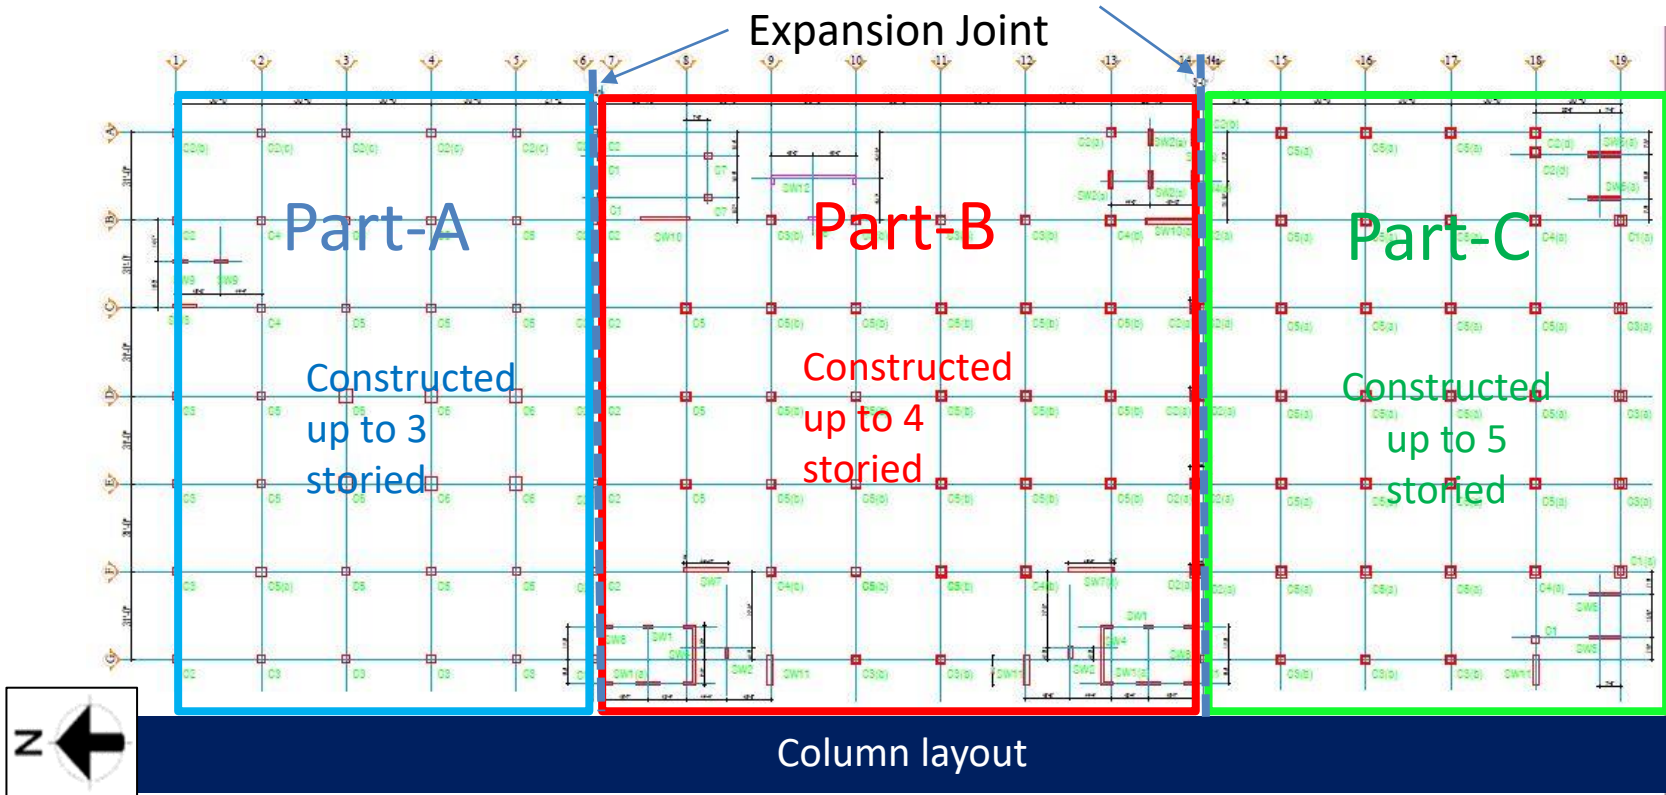
COLUMN LAY-OUT PLAN (BELOW GL)

Building is currently partially 5 storied
