# A.T.S. Apparels Ltd

414, Kouchakuri, Telirchala, Mouchak, Kaliakoir, Gazipur - 1751  
(24.01690N, 90.30266E)

25 March 2014

# Observations

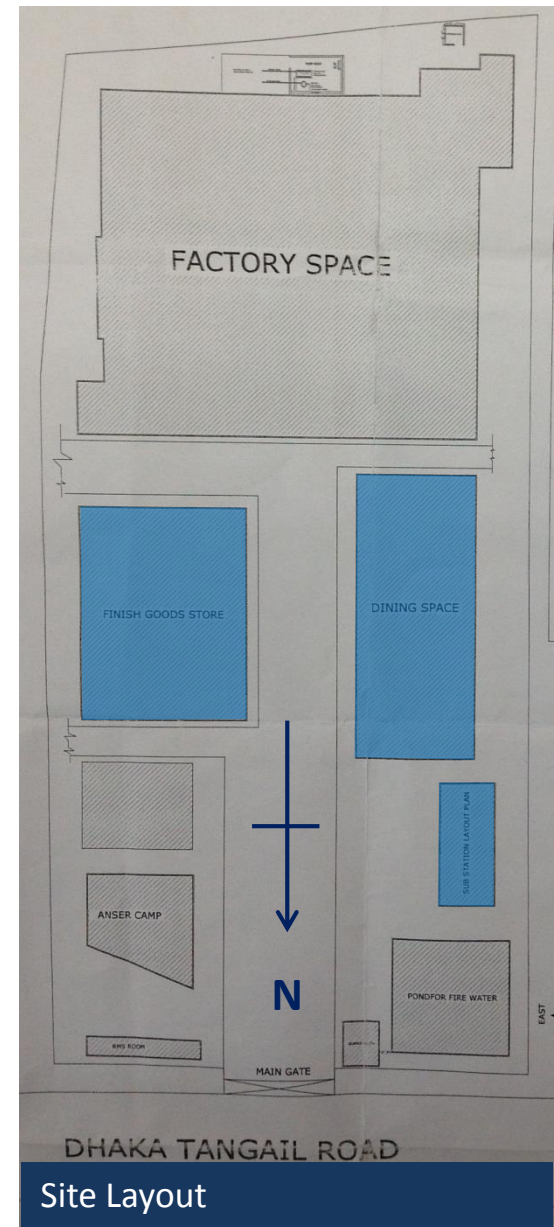
Site Layout

**Design check required for the single storey buildings to confirm their adequacy to support wind loading (pressure / suction and uplift)**

Capacity of lightweight roof structures for Ancillary buildings to resist uplift loading due to wind to be checked, with particular emphasis on connections and lateral stability.
