Texpro Eco Apparel Ltd

89/13, Ward-1, Block-C, Birulia Savar Road, Kaliakoir, Savar, Dhaka
(23.8516, 90.2918)
27 July 2022

Buildings Information

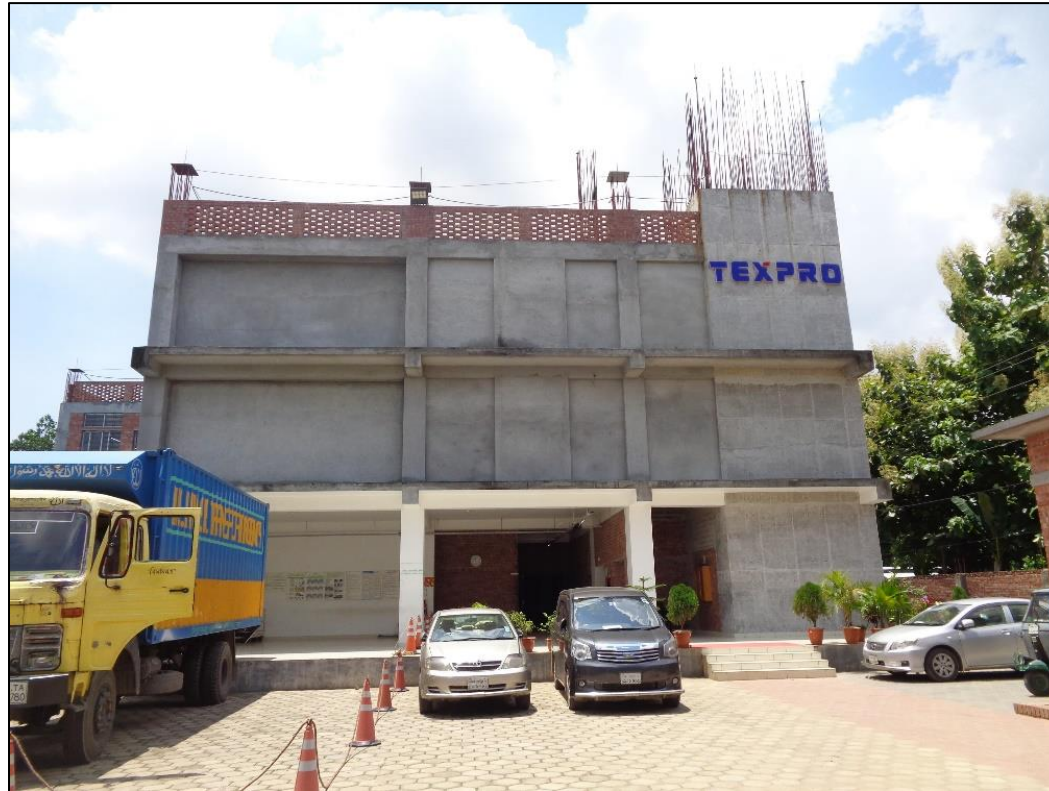
Concrete cylinder test report for column

Concrete strength of column considered 27.5 MPa (4000 psi) in the design report

Concrete strength of column is considered as 27.5 MPa in the design report. However, at the time of inspection, only 2 cylinder test report was available from column which doesn't comply the frequency of testing requirement of BNBC (chapter-5). Building engineer is required to verify in-situ material strength and revise the design report accordingly.

Item No.	Observation	Recommended Action Plan	Recommended Timeline
01	Verify in-situ material strength. (Building-1: Main Production Building)	Building engineer is required to check the lateral stability system of the shed against the lateral loadings and suggest necessary alternatives.	6-weeks
02	Verify in-situ material strength. (Building-1: Main Production Building)	Carry out suggested remedial works where required.	6-months
03	Lack of lateral stability system (Building-4: Dining Shed)	Building engineer is required to check the lateral stability system of the shed against the lateral loadings and suggest necessary alternatives.	6-weeks
04	Lack of lateral stability system (Building-4: Dining Shed)	Carry out suggested remedial works where required.	6-months
05	Lack of as-built drawing (Building 6: Wastage Shed)	Factory engineer is required to prepare full set of as-built drawings as per BNBC (part-6, section 1.9.1.2).	6-weeks
