# INITIAL STRUCTURAL INTEGRITY ASSESSMENT REPORT (SIAR)

Factory Name: **ADURY APPARELS LTD**  
Address: **Karardi, Shibpur, Narsingdi, Narsingdi Dhaka  
Bangladesh**  
Assessor: **Bureau Veritas**  
Date: **10 May 2013**

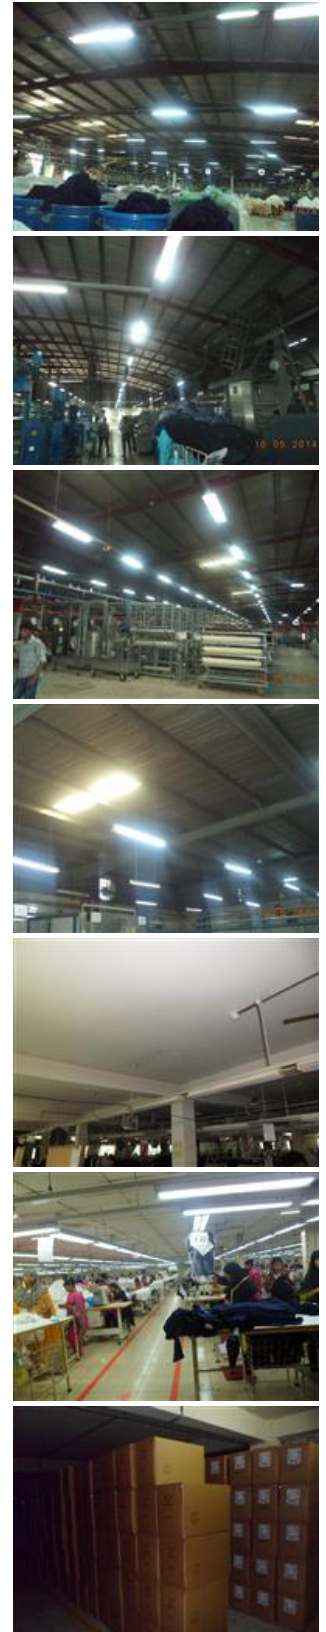
Question:	Structural System Type as defined by 2006 BNBC Part 6 Chapter 1 Table 6.1.2.
Priority Level:	
Non-Compliance Level:	
Description:	Building 01, 04 and 06: All buildings are moment resisting RCC framed structures. Building 02: is steel structure and also moment resisting framed structure . Shed 01, 02, 05 07: All sheds structural system is tapered column and tapered rafter with purlins , wire bracing and profile roof sheeting.
Source of Findings:	Visual Assessment: Visually Confirmed
Suggested Plan of Action:	
Suggested Deadline Date:	
Standard:	2006 BNBC Part 6 Chapter 1 Table 6.1.2

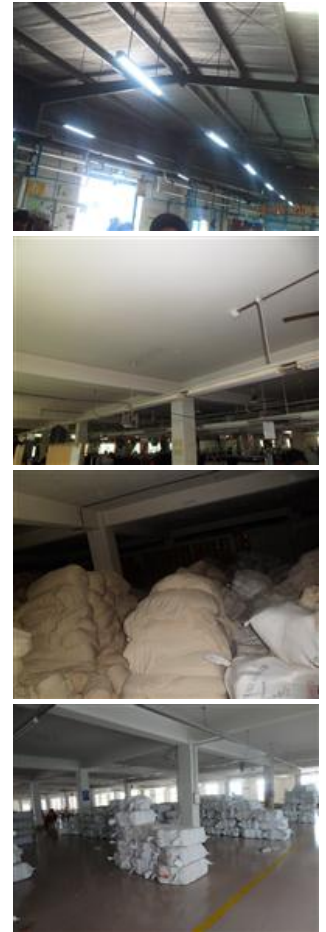
Question:	Are the available FoS for the columns adequate based on Preliminary calculation?
Priority Level:	High
Non-Compliance Level:	3
Description:	FoS for the columns: Building-01 (6 Storied RCC) for Alliance standard value Central: 2.40 Corner : 3.65 Edge : 1.72 Building-04 (5 storied RCC) for Alliance standard value Central: 2.34 Corner : 2.86 Edge : 2.01 Building-05 (4 storied RCC) for Alliance standard value Central: 2.49 Corner : 4.29 Edge : 3.25 Building-06 (3 storied RCC) for Alliance standard value Central: 4.03 Corner : 5.21 Edge : 3.55
Source of Findings:	Document Review: Stress Calculation Sheet
Suggested Plan of Action:	Conduct destructive core test to validate the in-situ concrete compressive strength of the structural elements of building-01.
Suggested Deadline Date:	30 Jan 2015
Standard:	Provide results of preliminary calculations in space provided. a) column capacity; FoS > 1.86 - Safe b) column capacity; FoS 1.5 -1.86 - Needs Evaluation c) Column capacity; FoS 1.25-1.5 - Needs Evaluation d) Column

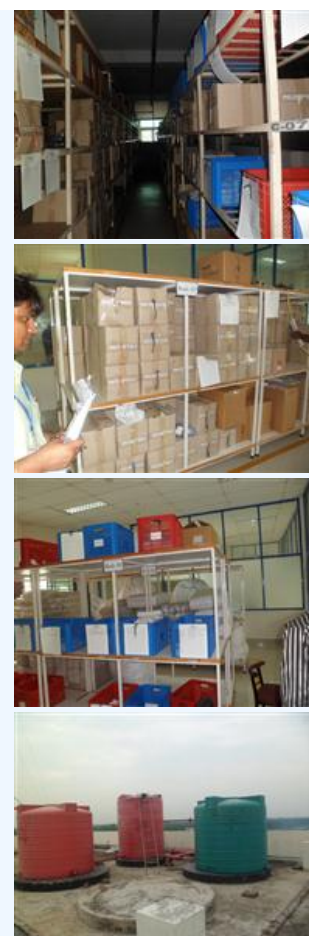
Question:	Are all non-structural elements suspended from, attached to, or resting atop the structure adequately anchored and braced to resist earthquake forces?
Priority Level:	Medium
Non-Compliance Level:	2
Description:	In 1st floor of six storied building (building-1) and 4th floor of five storied building (building-3), there are some racks have been found, which are not braced for earthquake force. There are 3 plastic water tanks with considerable height, which are not braced or anchored properly.
Source of Findings:	Visual Assessment: Confirmed visually.
Suggested Plan of Action:	Adequately anchor and brace all non-structural elements to resist earthquake forces to comply with the BNBC and Alliance Standard.
Suggested Deadline Date:	31 Jul 2014
Standard:	Alliance Standards Part 8 Section 8.18 Seismic Bracing of Key Non-Structural Elements and 2006 BNBC Part 6
