# Ahsan Knitting Ltd.

Siddhirgonj Pool, Siddhirgonj Narayangonj.

04<sup>th</sup> October 2022

Ahsan Knitting Building (G+5)

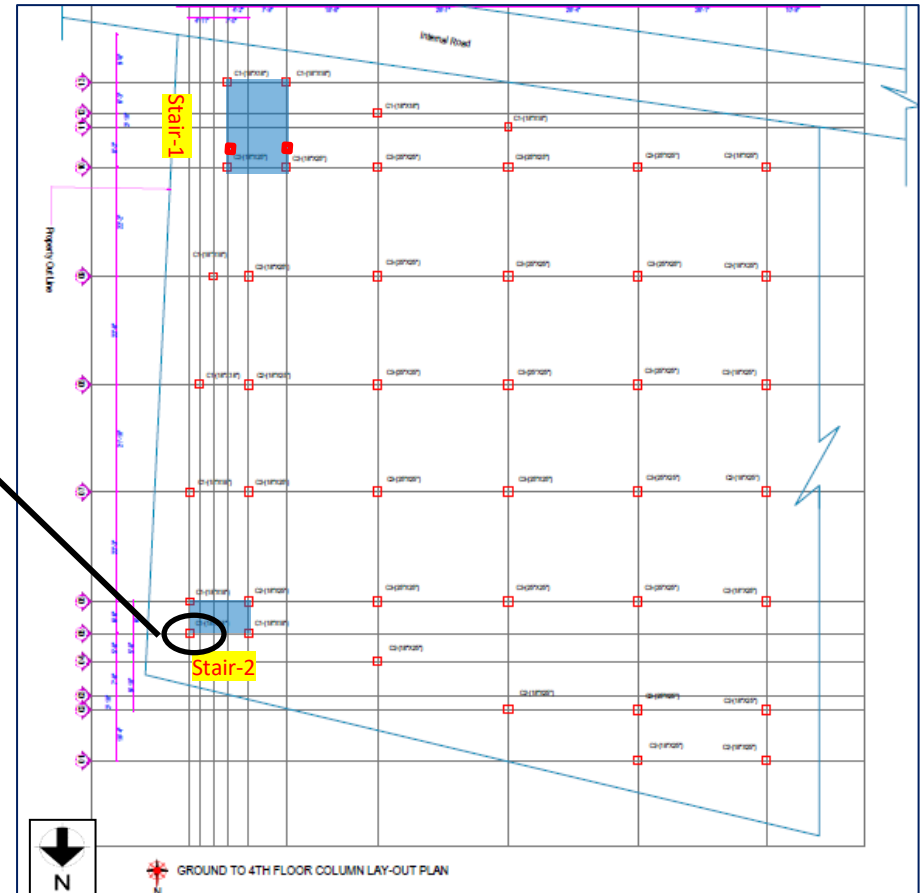
Column Layout

Column and beam layout were not fully matched with drawings near stair-1. Mismatches are shown in the figure.

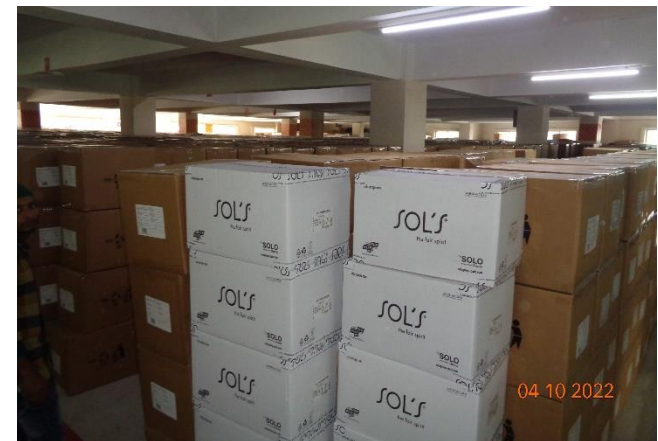
Floor Loading

As per BNBC, the minimum floor live load for light storage is 6 kN/m<sup>2</sup> (125 psf). But, floor load plan for storage areas was found considering 3 kN/m<sup>2</sup>. The building engineer is required to revise the live load plan as per BNBC requirement and prepare the design documents accordingly.

| Item No. | Observation | Recommended Action Plan | Recommended Timeline |
|---|---|---|---|
| 07 | Prepared load plan do not comply with BNBC and lack of design report | Implement the recommendations of design report. | 6-months |

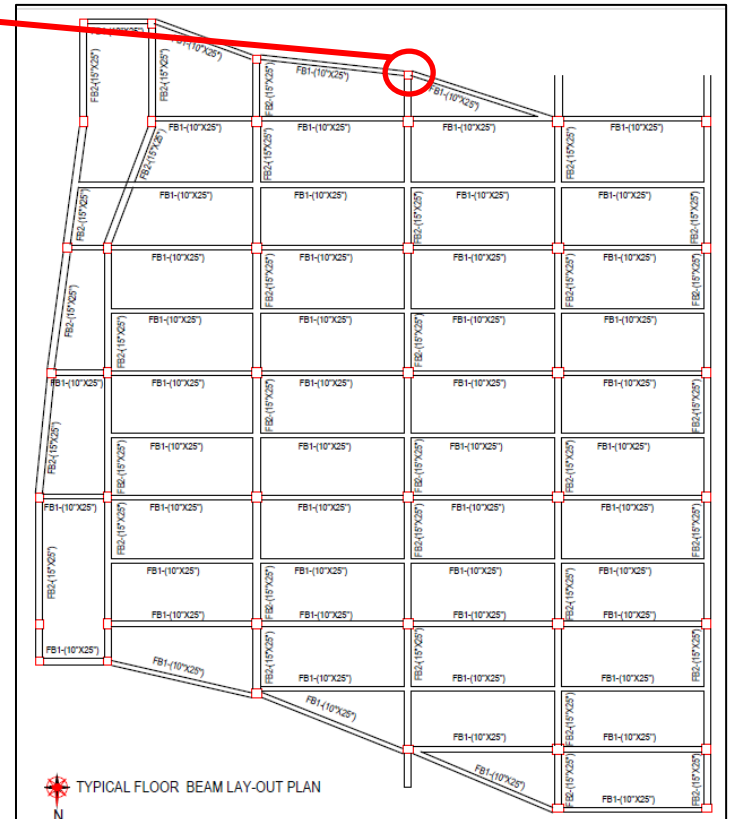
Beam Layout Plan

Crack found in beam-column joint (4<sup>th</sup> floor level) at south side of the building may caused due to poor workmanship. The factory engineer is required to investigate the causes of crack and repair with a suitable method.

| Item No. | Observation | Recommended Action Plan | Recommended Timeline |
|---|---|---|---|
| 09 | Crack in beam-column joint | The building engineer is required to investigate the causes of crack and suggest a suitable remedial method. | 6-weeks |
| 10 | Crack in beam-column joint | Carry out suggested remedial works. | 6-months |
