# Tanima Knit Composite Ltd. (Extension)

10/20, SOUTH DARIAPUR, SAVAR, DHAKA-1340  
(23.833847, 90.254812)  
10 October 2022

# Buildings Information

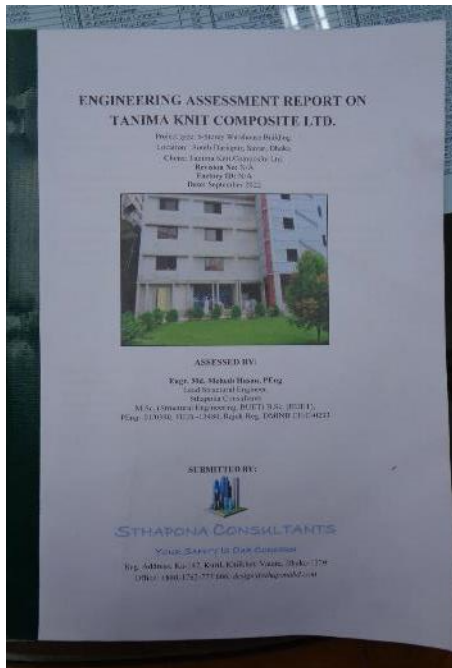
**EA report & remedial scheme to be revised**

There are some mismatch between building information and onsite conditions. The flat plate framing system, basement floor and MAT foundation are not mentioned in the building information. Furthermore, construction year is mentioned as 2021 instead of 2006. Basement floor loading limit was not mentioned in the floor load plan.

There are some mismatch between provided information of construction material and provided concrete core test report. As per EA report in general description the construction material was declared stone chips for foundation column, beam and slab but as per provided concrete core test aggregate types were shown brick chips. Building engineer is required to verify and confirmed the material type and material strength with correct material test report.

The building is required to survey the structure and prepare accurate as-built structural drawings.
